Investigation of Structural Irregularities in Malatya Province After the February 6 Kahramanmaraş Earthquakes in Turkey

Assoc.Prof.Dr. Tuğba İNAN GÜNAYDIN

*Niğde Ömer Halisdemir University, Department of Architecture, Niğde/TURKEY
tinan@ohu.edu.tr ORCID: 0000-0003-0861-4835*

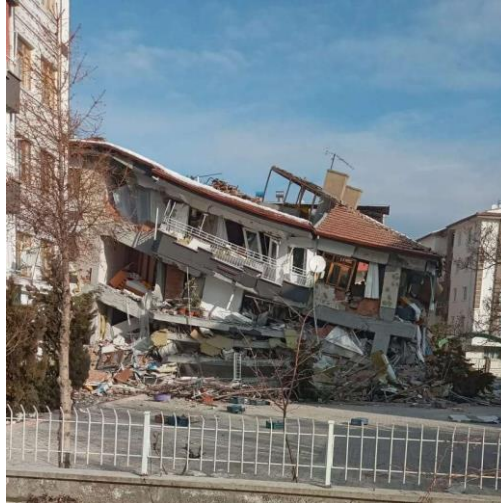
Torsional irregularity, which causes the most damage in all earthquakes in Turkey, manifested itself in the last earthquake of February 6, 2023. Many buildings in Malatya collapsed due to torsional irregularity. Various factors cause torsional irregularity in buildings. The most significant ones are irregularity in plan and structural discontinuities, complex building forms, insufficient or non-existent earthquake joints, insufficiency of shear walls, location of rigid cores, creating rigid and flexible regions in the structure, rigidity not being distributed homogeneously, large overhangs, pounding effects, strength differences between floors, number of floors and poor soil type. The building in Fig. 3 was severely damaged due to torsion caused by the adjacent buildings and heavy console.

Figure 3: Torsional irregularity damages in Malatya

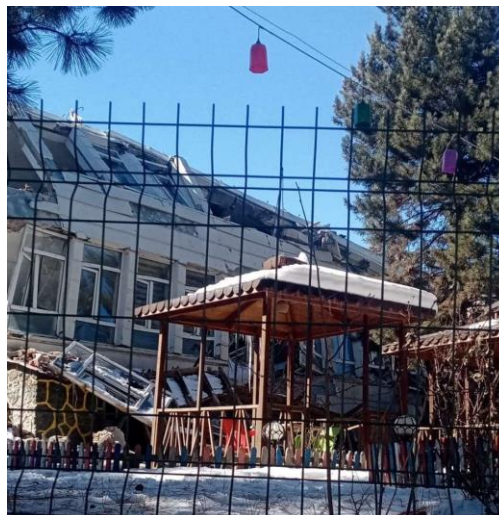
The floor discontinuity is described in the TEBC as the case where the total area of the openings including those of stairs and elevator shafts exceeds $1/3$ of the gross floor area or the cases where local floor openings make it difficult the safe transfer of seismic loads to vertical structural elements and/or the cases of abrupt reductions in the in-plane stiffness and strength of floors. Floor discontinuity caused less damage than other irregularities, especially when heavily damaged or collapsed buildings were examined. The building in Fig. 4 was severely damaged due to the distribution of structural elements between floors and floor discontinuity due to the local floor openings that make it difficult the safe transfer of seismic loads to vertical structural elements.

Figure 4: Floor discontinuity damages in Malatya

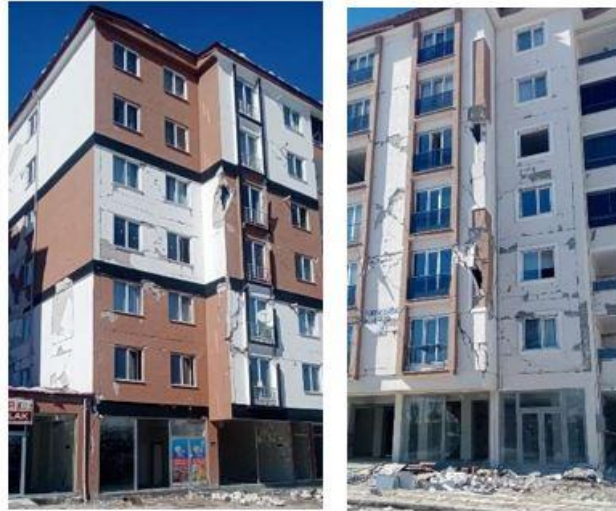
The projection irregularity is defined in the TBEC as the cases where projections beyond the re-entrant corners in both of the two principal directions in plan exceed the total plan dimensions of the building in the respective directions by more than 20%. Open and closed heavy cantilevered buildings caused serious destruction after the Kahramanmaraş earthquakes in Malatya. These type of cantilevers creates projection irregularity in that floor and cause various irregularity such as torsional irregularity, pounding irregularity, stiffness differences between floors, etc. The buildings in Fig. 5 were severely damaged due to the overhangs and projection irregularity.

Figure 5: Projection damages in Malatya

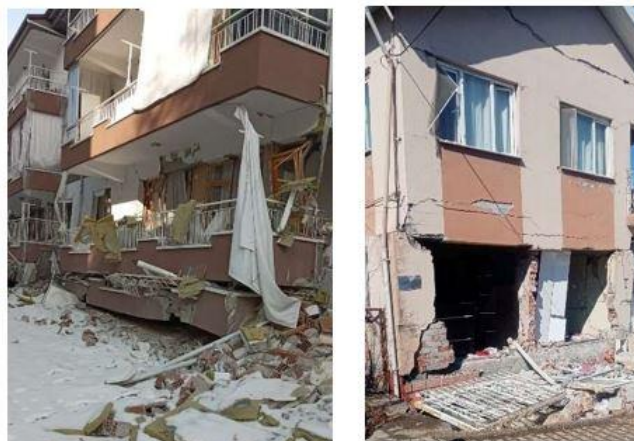
The weak storey irregularity is defined in the TBEC that in reinforced concrete buildings, the case where in each of the orthogonal earthquake directions, Strength Irregularity Factor η_{ci} , which is defined as the ratio of the effective shear area of any storey to the effective shear area of the storey immediately above, is less than 0.80. If the ratio is between 0.8 and 0.6, there exists weak storey irregularity in structure. But, if it is less than 0.6, the structure must be redesigned until appropriate range of values are gained. This irregularity is related on vertical configuration issue in which there is a major reduction in strength between storeys. Although it is so dangerous when it occurs at ground storey due to the greatest load accumulation at this storey, it can be observed at any storey of a building. This irregularity generally occurs due to the lesser strength or major flexibility between stories. If all stories of the building are nearly equal in terms of strength or stiffness, earthquake forces can be distributed nearly equal to each storey under earthquake loading. The buildings illustrated in Fig. 6 were severely damaged due to the weak storey problem.

Figure 6: Weak storey damages in Malatya

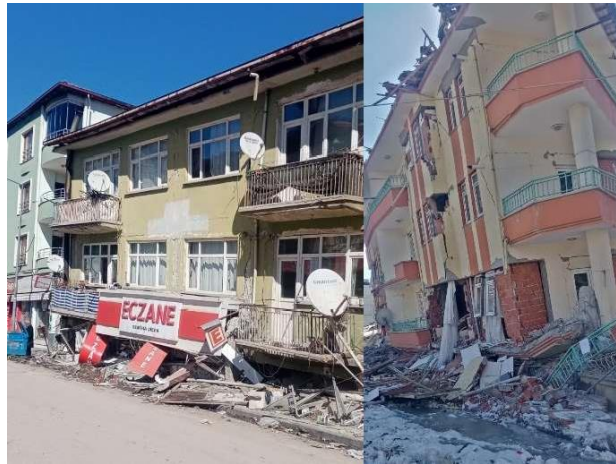
Soft storey irregularity is defined in the TBEC as the case where in each of the two orthogonal earthquake directions, Stiffness Irregularity Factor η_{ki} , which is defined as the ratio of the average storey drift at any storey to the average storey drift at the storey immediately above or below, is greater than 2.0. There are various parameters that cause soft storey irregularity. For instance, a discontinuity between the ground and first floor

cause critical conditions on earthquake behaviour of building. The height difference between the floors is a remarkable one among them. The ground floor of a building is generally designed as higher than the upper floors due to the user requirements. This causes stiffness losses and more displacement in the ground storey. Because, the cross sections of the columns are kept in same size in the ground floor even though there is a height difference is created between the two floors. Therefore, it causes a difference in rigidity or stiffness between the floors. This type of floors is called as the soft storey. It usually occurs due to the architectural requirements. For instance, using open ground storey such as shops, showrooms, banking halls create severe damage. Because, while a great storey drift occurs in the ground floor, the upper floors move like a diaphragm. High stress concentration occurs along the connection line between the ground and first floor that leads to distortion or collapse in structures (Arnold, 2002). The buildings displayed in Fig. 7 were severely damaged due to the weak storey problem.

Figure 7: Soft storey damages in Malatya

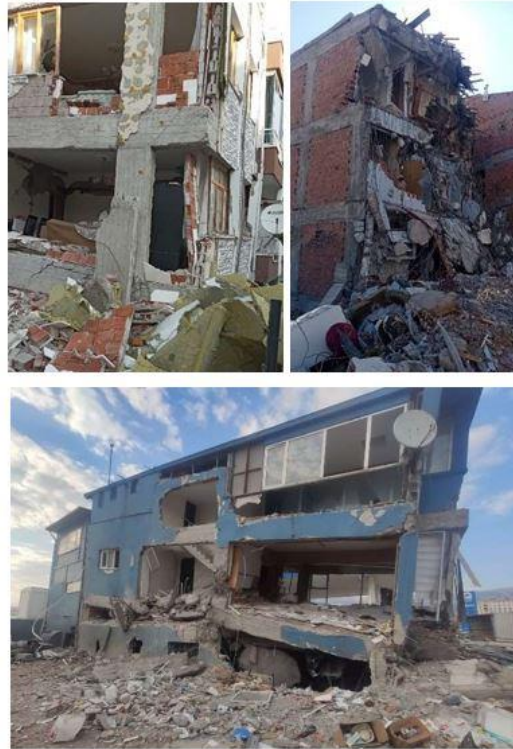
In the TBEC Gusseted columns or the columns which rest on cantilever beams are prohibited. Besides, in no case the shear walls should be allowed to rest under the columns and in no case the shear walls should be allowed to rest on the beams. Some of the vertical structural element problems observed after the Kahramanmaraş earthquakes were illustrated in Fig. 8 and 9. It is a significant issue that must be designed by carefully considering the location of the structural elements in the plan and the adequacy of their cross-sections. If it is not designed symmetrically and with sufficient cross-section in plan, the building will begin to collapse in the area where the structural system elements are insufficient, which are designed to be flexible.

Figure 8: Discontinuity problems in vertical structural elements

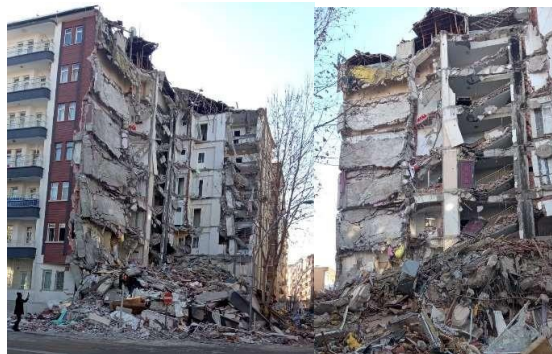
Figure 9: Insufficient design of structural elements

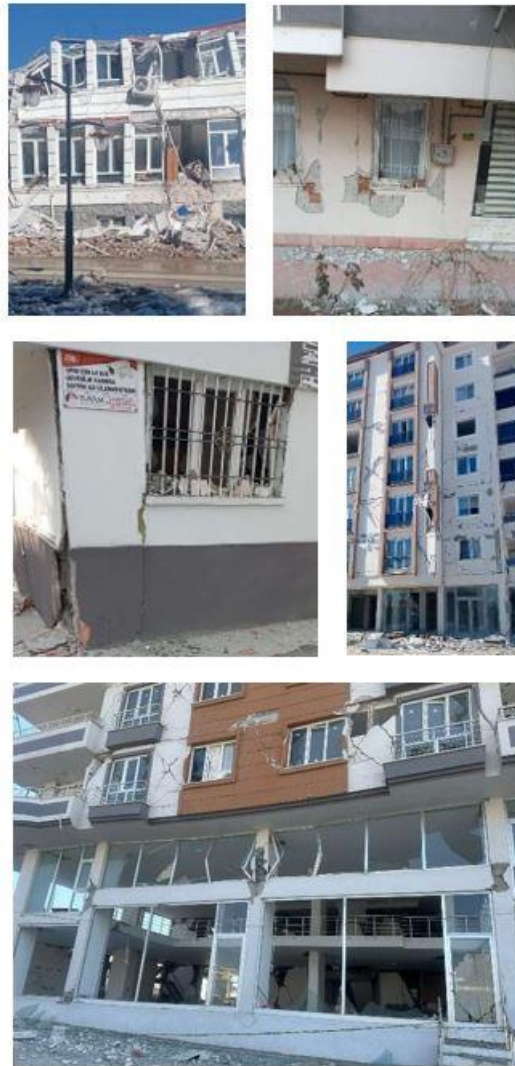
Short columns are defined as the columns that are shorter than the columns on the same floor. When a building has both long and short columns in the same storey, the columns expose to different shear forces due to their height differences. The lateral loads firstly come to the long and flexible columns, after go towards to the short column and accumulate in there. Due to the excessive accumulation of the seismic energy, shear cracks occurs at both ends of the columns. The damage in these short columns is often in the form of X-shaped cracking that occurs due to shear failures. Mezzanine floors, mechanical floor, hillside sides, graded foundation, ribbon windows, partial openings adjacent to the structural elements and stair landings are the most commonly encountered design problems caused short column effect. Short column effects in Malatya after the Kahramanmaraş earthquakes were illustrated in Fig. 10.

Figure 10: Short column effect

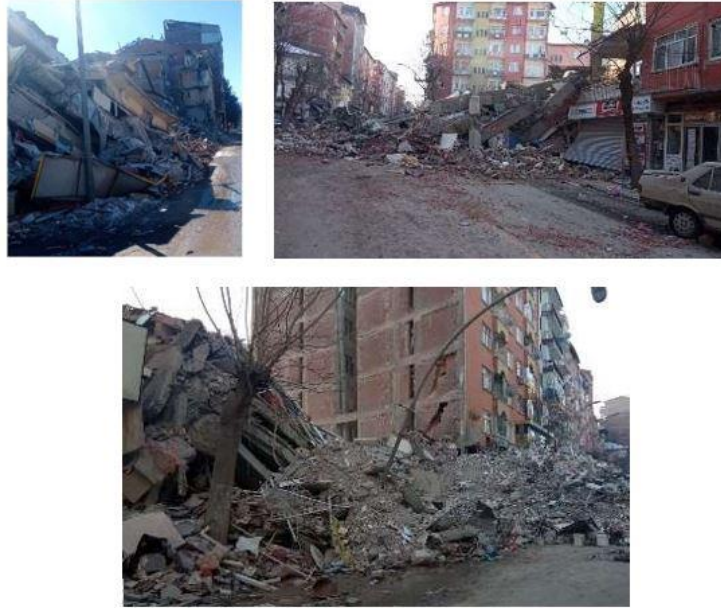
During an earthquake in a building, beams are expected to deform primarily instead of columns. Damage to any column seriously affects the earthquake resistance of the entire building. Plastic hinging at both ends of the columns may initiate a storey displacement or even leading to the overall collapse of the building (Arnold and Reitherman, 2002). The beams should have weakest coupling instead of columns to prevent plastic hinging in columns. This condition can be provided by correctly sizing the structural members and using sufficient amount of steel in them. The building shown in Fig. 11 exposes to great damage in earthquake due to the hollow-tile slab. Hollow-tile slab is usually used in projects to prevent visibility of beams. But, it increases the building weight. Thus, it increases the earthquake forces simultaneously due to the direct proportion between the building mass and earthquake forces.

Figure 11: Weak column-strong beam damages

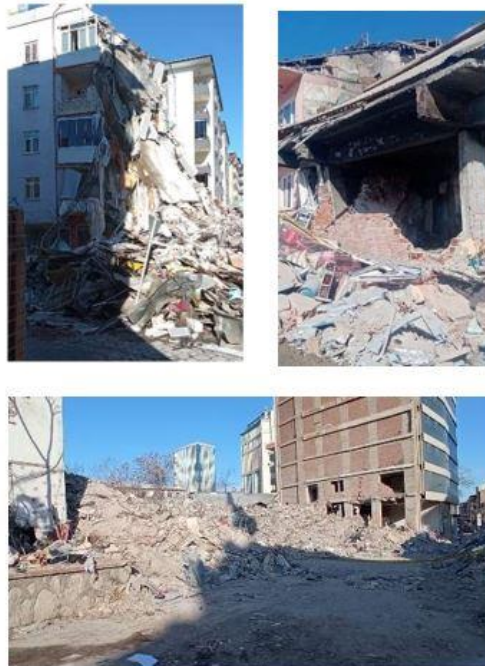
Seismic pounding is a significant design problem that causes serious damage and destruction in buildings under earthquake loads. It commonly occurs due to the insufficient seismic gap or no gap between two adjacent buildings. A sufficient amount of earthquake joints should be left to prevent buildings from colliding, taking into account the floor drifts of the building during an earthquake. If the size of the seismic gap is insufficient based on the expected storey drifts, pounding between adjacent or nearest structures may occur. Some of the seismic pounding problems observed after the Kahramanmaraş earthquakes in Malatya were illustrated in Fig. 12.

Figure 12: Seismic pounding damages

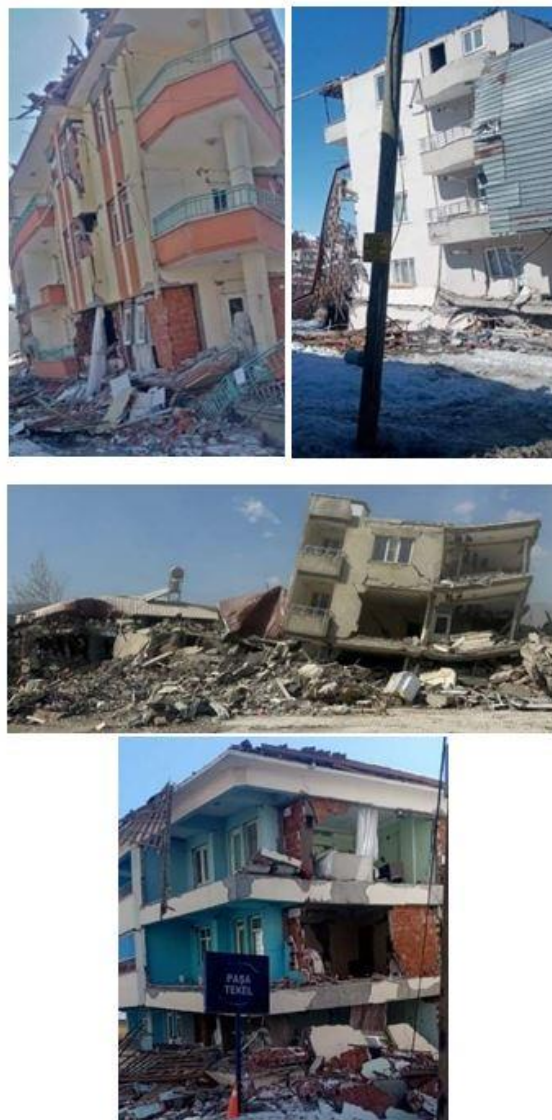
Many buildings are damaged in earthquakes due to poor ground structure in Turkey. Local soil types are divided into six main groups in the TEBC, named from ZA to ZF, from good ground to poor soil. The soil type ZA consists of solid hard rock and ZB consists of slightly weathered, medium- solid rocks. Besides, ZC comprises of considerable dense layers of sand, gravel and hard clay or weathered, highly fractured weak rocks. ZD consists of medium firm, firm sand, gravel or considerable stiff clay layers. Moreover, ZE comprises of loose sand, gravel or soft-solid clay layers. ZF refers to grounds that require site-specific research and evaluation. Buildings with ground liquefaction generally have this soil type. Some of the soil type related damages noticed after the Kahramanmaraş earthquakes in Malatya were shown in Fig. 13. In examinations carried out in areas where collapsed or heavily damaged buildings are located, the fact that there are slightly damaged neighboring buildings on the same ground layer shows that the demolitions are not only caused by the ground.

Figure 13: Soil type related problems

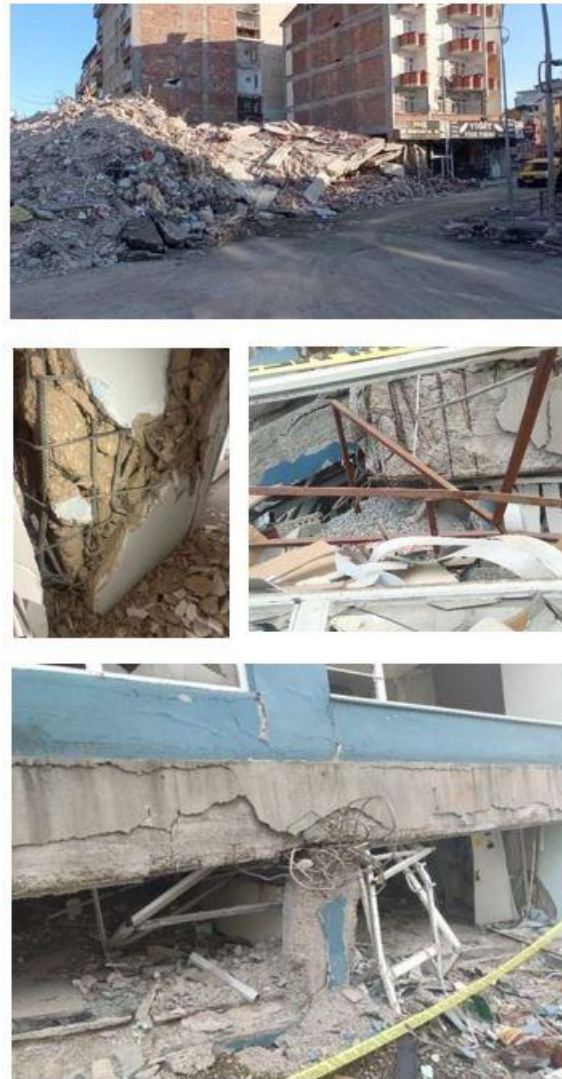
Poor quality of concrete and column-beam connections, failure to tighten the stirrups at the column ends, rusting of reinforcement, damage caused by reinforcement and the usage of coarse aggregates caused heavy destruction of buildings after the Kahramanmaraş

earthquakes. The use of coarse aggregates in buildings has been widely observed, and it has been realized that concrete burns and brittle fractures occur because it is not watered (Fig. 14).

Figure 14: Material problems

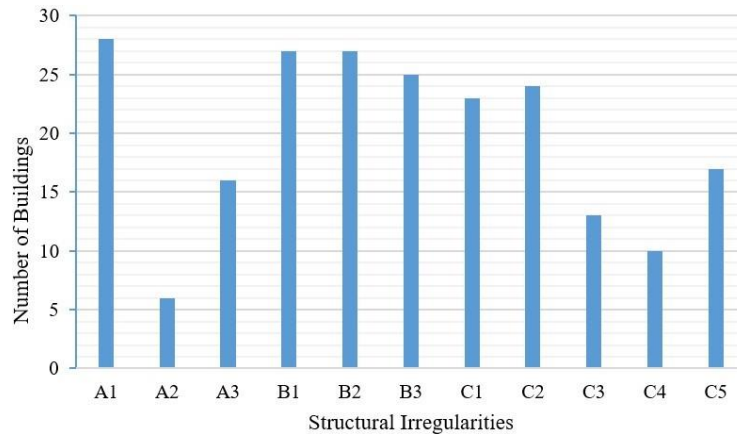
In this section, the main structural irregularities that cause destroying in buildings or taking heavily damage in Malatya province were summarized. The heavily damaged or collapsed buildings presented in Section 3 are examined in this section in terms of all structural irregularities they contain. Because the structures were not destroyed just because of a single structural irregularity, but because they contained many structural irregularities, the structure was the cause of heavy destruction. Examined thirty buildings are presented in Fig. 15 Arnol with all the structural irregularities it contains.

Figure 15: Structural irregularities on investigated buildings in Malatya
