Visual and Comparative Analysis of Stone Surface Deterioration Observed in Gaziantep Stone Fountains

Gaziantep is one of the cities that stands out with its rich historical heritage and traditional stone architecture. In this study, a visual analysis method was applied to two historical fountain examples (Köseç Ahmet Ağa and Kumandan Fountains) located in Gaziantep, and stone surface deterioration was examined in physical, chemical, biological, and anthropogenic categories. Within the scope of the study, the deteriorations observed on the facades of both structures were classified and documented with photographs. The findings reveal that the fountains exhibit different levels of deterioration directly related to their usage status and environmental exposure. At the Köseç Ahmet Ağa Fountain, which is actively used, chemical and biological deterioration due to moisture effects are more prominent, while at the Kumandan Fountain, which is no longer in use, physical and anthropogenic effects are more pronounced. The data obtained show that the accurate documentation of deteriorations observed in stone structures is of critical importance for the healthy restoration and sustainable cons

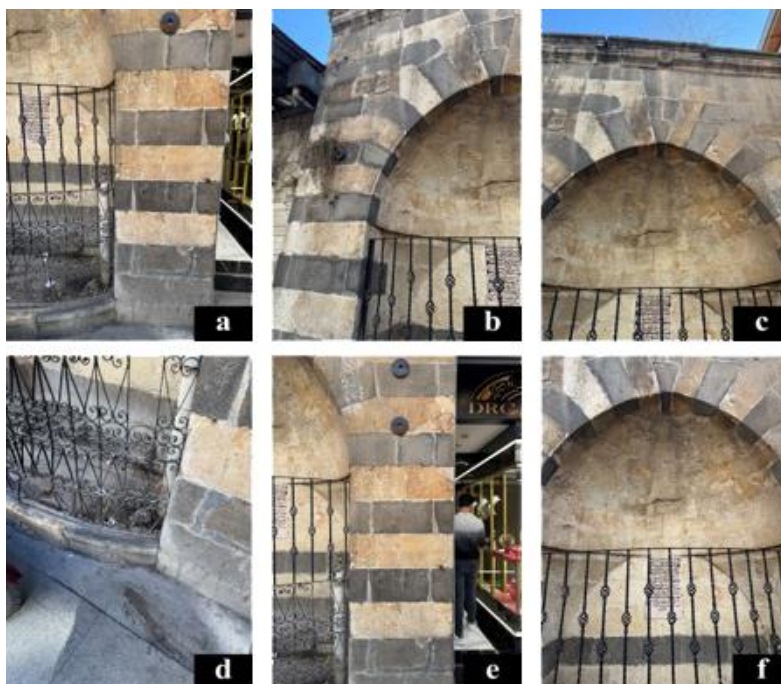
Figure 5. Physical deterioration observed at the Köseç Ahmet Ağa Fountain

The physical deterioration observed at the Köseç Ahmet Ağa Fountain is presented in Figure 5. As a result of the structure being abandoned and exposed to temperature differences,

cracks (Figures 5a, 5b), piece detachments (Figures 5c, 5d), and surface abrasions (Figures 5e, 5f) have formed.

When the types of deterioration were examined, the results obtained were largely consistent with the alteration processes defined in the literature. Physical alterations (cracking, abrasion, fragmentation) are particularly common in continental climate regions where temperature fluctuations are intense. (D. G. Price, 1995; Tokmak & Dal, 2020). Gaziantep's climate, which is hot and dry in summer and cold and rainy in winter, makes stone materials vulnerable to processes such as thermal expansion, freezing and thawing, and salt crystallization. This situation was clearly observed in the study and was particularly evident in the widespread cracks and piece losses at the Köseç Ahmet Ağa Fountain.

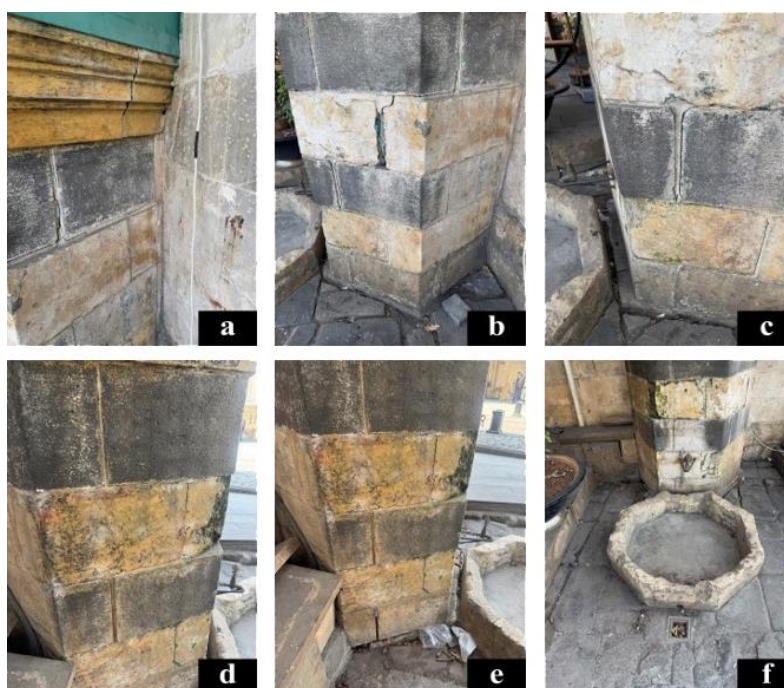
Figure 6. Physical deterioration observed at Kumandan Fountain

Similarly, the physical deterioration observed at Kumandan Fountain is also shown in Figure 6. Due to climatic conditions, cracks (Figures 6a, 6b), piece losses (Figures 6c, 6d, 6e) and abrasions (Figure 6f) have occurred in the structure.

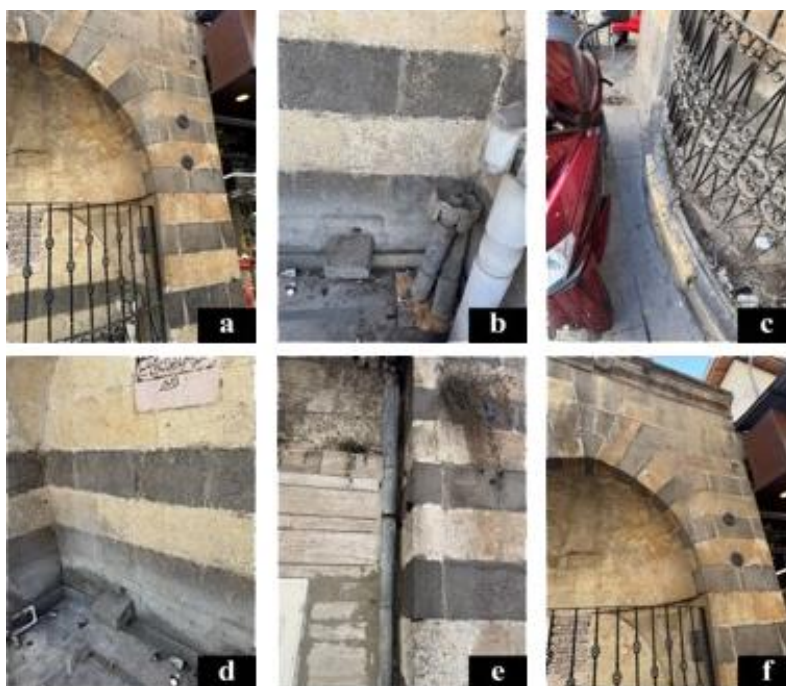
Figure 7. Chemical deterioration observed at the Köseç Ahmet Ağa Fountain

Chemical deterioration due to adverse climatic conditions has been observed at the Köseç Ahmet Ağa Fountain (Figure 7). On the stone surfaces, salt precipitation (Figures 7a, 7b) due to the dissolution and evaporation of salts under the influence of moisture and

temperature, color changes (Figures 7c, 7d) due to the reaction of minerals with atmospheric gases, and atmospheric pollution on the surface (Figures 7e, 7f) have occurred.

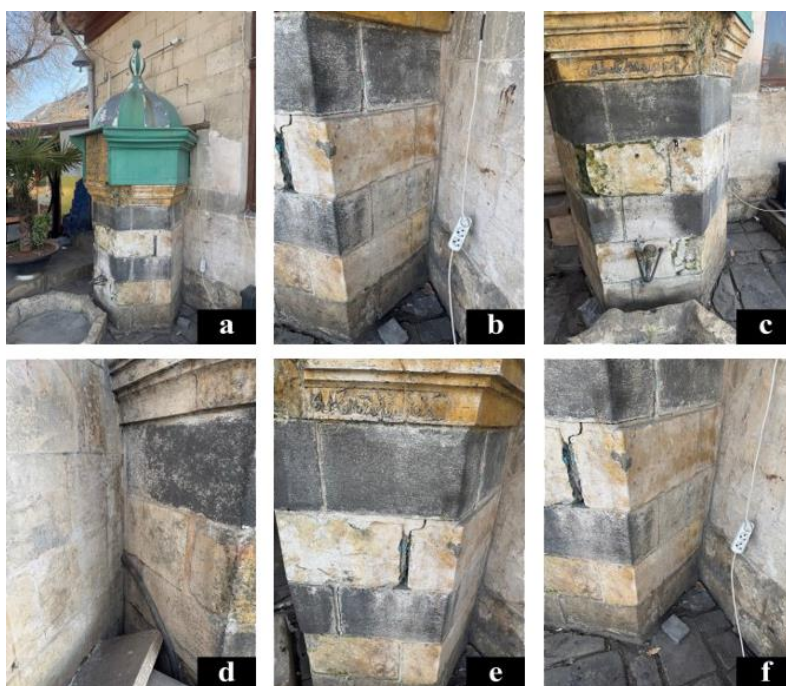
Figure 8. Chemical deterioration observed at Kumandan Fountain

Similar climatic effects caused chemical deterioration at Kumandan Fountain, where surface contamination (Figures 8a and 8b), color changes (Figures 8c and 8d), and salt deposits (Figures 8e and 8f) were observed.

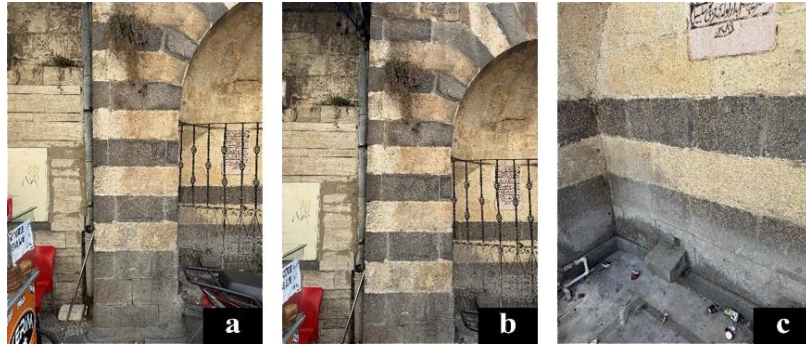
Figure 9. Chemical deterioration observed at the Köseç Ahmet Ağa Fountain.

Biological deterioration caused by organic matter at the Köseç Ahmet Ağa Fountain is shown in Figure 9. Plant growth resulting from the interaction of seeds settled in capillary

cracks in the stones with water (Figures 9a, 9b) and algae traces resulting from the stone surfaces remaining moist due to the fountain's use (Figure 9c) were detected.

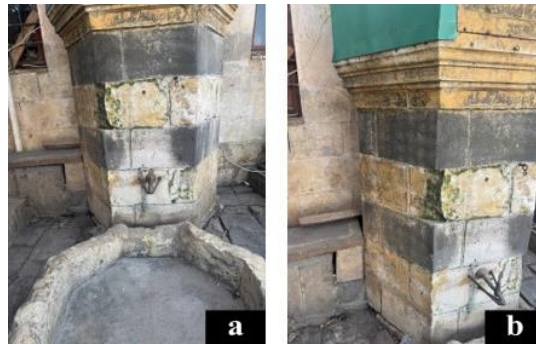
Figure 10. Biological deterioration observed at Kumandan Fountain

At Kumandan Fountain, due to long-term use, the stone surfaces remained damp, causing moss growth and associated spalling, particularly in the fountain area. This biological deterioration is shown in Figure 10.

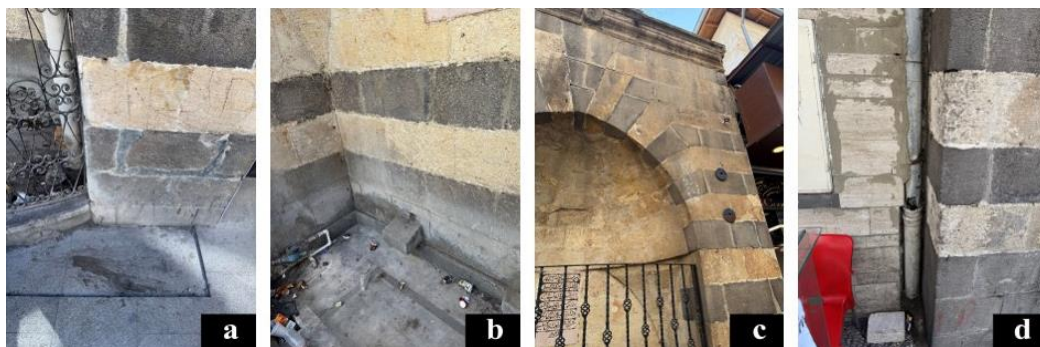
Figure 11. Anthropogenic deterioration observed at the Köseç Ahmet Ağa Fountain

Anthropogenic deterioration caused by humans at the Köseç Ahmet Ağa Fountain is shown in Figure 11. Cement-based joint repairs made to the structure (Figure 11a), neglect due to the structure not being used (Figures 11b, 11c), and spray paint applications damaging the stone surfaces (Figure 11d) were identified.

In terms of anthropogenic effects, structural deterioration has accelerated in both structures due to reasons such as lack of maintenance, inappropriate intervention, and vandalism. Cement-based repairs, in particular, reduce the breathing capacity of the stone, increasing both physical and chemical deterioration (Dal & Öcal, 2017). This finding highlights the importance of material compatibility in conservation practices.

- **Technical Training Programs for Local Practitioners Should Be Organized:** In order to prevent interventions that cause material incompatibility, such as cement-based repairs, training programs on stone materials, types of deterioration, and appropriate intervention techniques should be prepared for local practitioners and restorers.

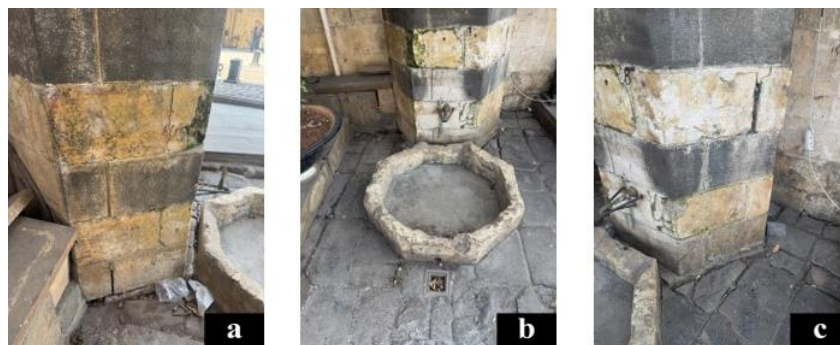
Figure 12. Anthropogenic deterioration observed at Kumandan Fountain

Similar anthropogenic effects are also observed at Kumandan Çeşmesi. Due to prolonged disuse, the structure has suffered deterioration of its stone surfaces due to neglect, which has led to increased physical, chemical, and biological alterations. The anthropogenic deterioration at Kumandan Çeşmesi is presented in Figure 12.
