Damage Assessment of Building Materials and Conservation Recommendations for Karacabey Ulu Mosque in Bursa

Lale Karataş Billor

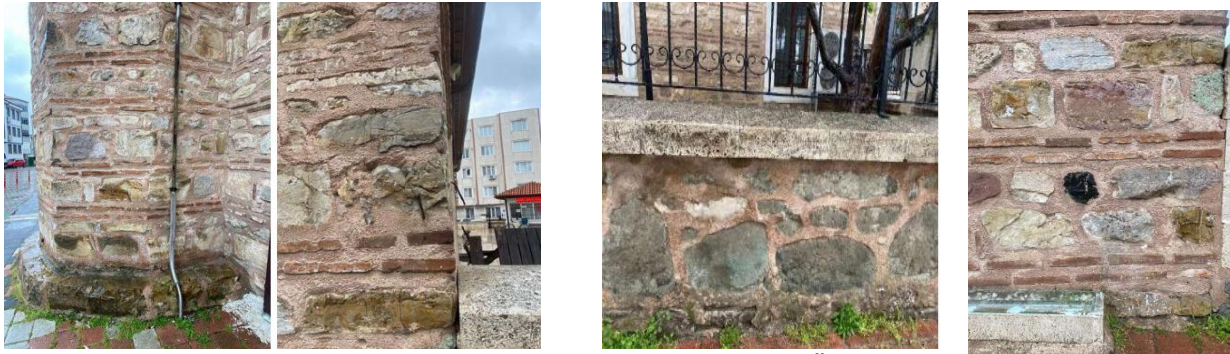
The most common deterioration observed on the walls includes intense discolouration visible across nearly all surfaces, along with dirt accumulation and surface soiling (soiling and deposit). Biological colonization is also widespread, particularly in lower and humid areas, in the form of moss and algae growth (Figure 3).

Figure 3. Material deterioration observed on walls (Özçelik, Z. S., 2026)

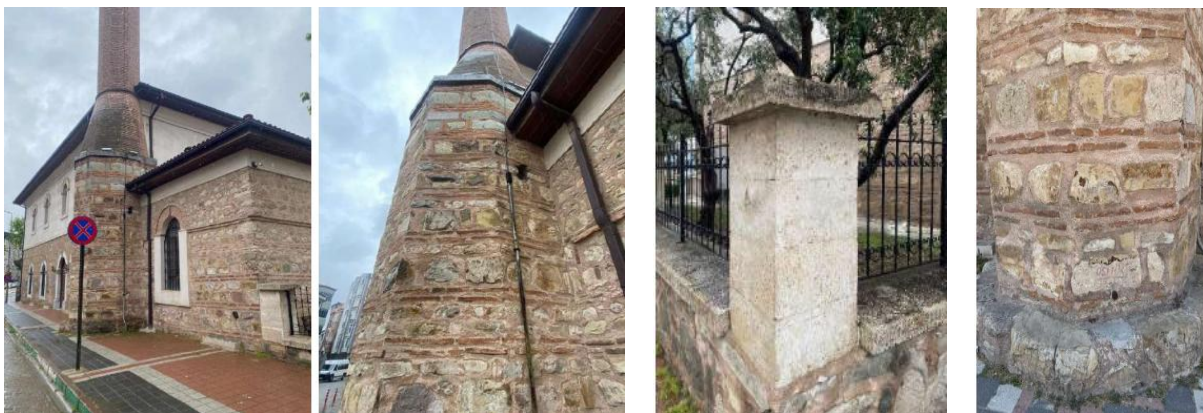
Significant erosion and material loss are evident on stone surfaces, while cracks are commonly observed in both stone and brick elements. Material detachment is present in the form of blistering, peeling, and scaling. In certain areas, structural disintegration of stones is observed, along with localized loss of small stone parts (missing parts). Some stones exhibit patina formation, and slight efflorescence is visible near the eaves. Additionally, crust formation is observed in the white plastered areas. No deterioration was identified in the wooden columns visible in the interior, as they have undergone restoration (Figure 4).

Figure 4. Material deterioration observed on walls (Özçelik, Z. S., 2026)

For the cracks exposed after surface cleaning (*raspa*) on the walls, epoxy resin injection is recommended. For cracks too wide for injection, a portion of the brick or stone material along the crack should be carefully removed and repaired using compatible materials and stitching techniques. It is essential to investigate whether the observed cracks are caused by earthquakes or other structural factors. In future studies on the stone structure, it would be more appropriate to first examine seismic effects and then develop restoration proposals for the cracks accordingly. Cracking problems in historic stone structures may arise from multiple causes, including natural weather conditions, foundation movements, soil problems, deficiencies in the load-bearing system, structural inadequacies, and earthquakes. In addition, cracks in stone and the processes leading to their formation are influenced not only by climatic and anthropogenic external factors but also by intrinsic material properties such as texture, mineralogy, porosity, and pore size distribution. In this context, future studies should adopt an integrated approach that combines experimental analysis of existing materials with investigations of seismic effects in order to inform the design of appropriate restoration materials. Failure to accurately identify the causes of cracking and the implementation of inappropriate interventions may lead to irreversible consequences.

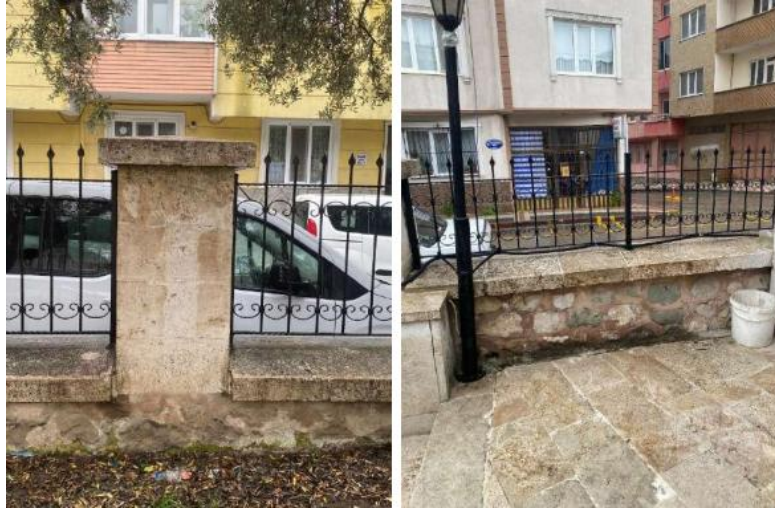
The most prominent issues observed on the floors include intensive erosion caused by human use and environmental factors, as well as mechanical damage. Particularly along circulation paths and entrance areas, significant wear and polishing of stone surfaces are evident. In some areas, cracks have developed, along with moisture-related discolouration and surface soiling. Biological colonization in the form of moss and algae layers has also been identified in certain areas, and small fragments have detached from stone edges (detachment and missing part) (Figure 5).

Figure 5. Material deterioration observed on floors (Özçelik, Z. S., 2026)

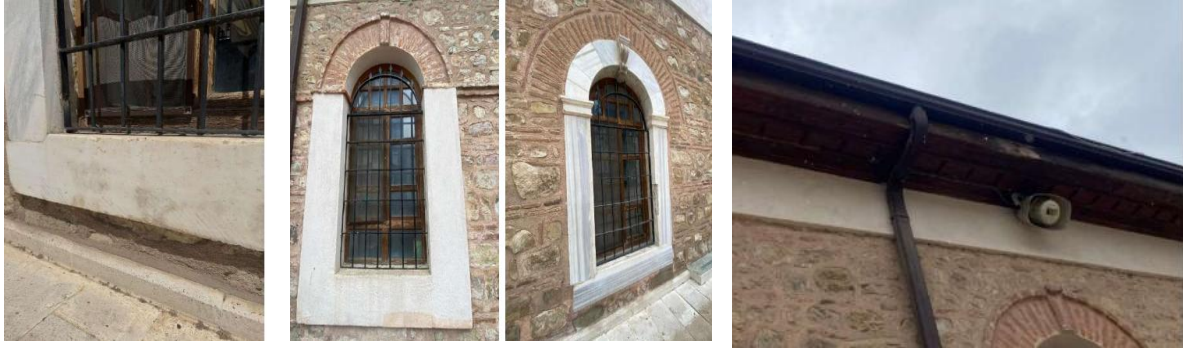
In auxiliary elements such as decorative features, mouldings, arches, chimneys, window pediments, and eaves, several types of deterioration have been identified. Chimneys, eaves, and window mouldings exhibit intense discolouration, along with significant dirt accumulation (soiling and deposit), particularly in chimney and eaves areas. Erosion leading to surface loss is observed on chimney stones. In lower and humid areas, widespread biological colonization in the form of moss and algae is present. Cracks have developed on mouldings and around window elements, while material detachment in the form of peeling is observed on window mouldings. Additionally, crust formation is evident in the areas beneath the eaves (Figure 5).

Figure 6. Material deterioration observed on auxiliary elements (Özçelik, Z. S., 2026)
