A Study on Restoration of Ayaş Şeyh Muhittin Mosque which is an Example of Ankara Traditional Mosque Architecture

Filiz KARAKUŞ *

In this study, Şeyh Muhittin Mosque in Ayas district of Ankara is examined in terms of traditional architectural features and the restoration carried out by Ankara Regional Directorate of Foundations in 2018-2019 are discussed. The mosque, which is owned by the General Directorate of Foundations and has no construction inscription, dates back to the 16th century. The mosque has no last congregation space and has a transverse rectangular plan. The walls of the mosque are rubble stone up to the basin level and the walls of the body are built with masonry technique with wooden beams and mud-brick. Traditional materials such as rubble, mudbrick and wood are used extensively in the structure. In the interior of the mosque, wood is used in building elements such as wooden posts and beams of women section, minbar, floor and ceiling coverings. The plaster mihrab has the characteristics of 18th century traditional Ankara mosques. Seyh Muhittin Mosque was examined in terms of traditional architecture and art history, and the data obtained during the last restora

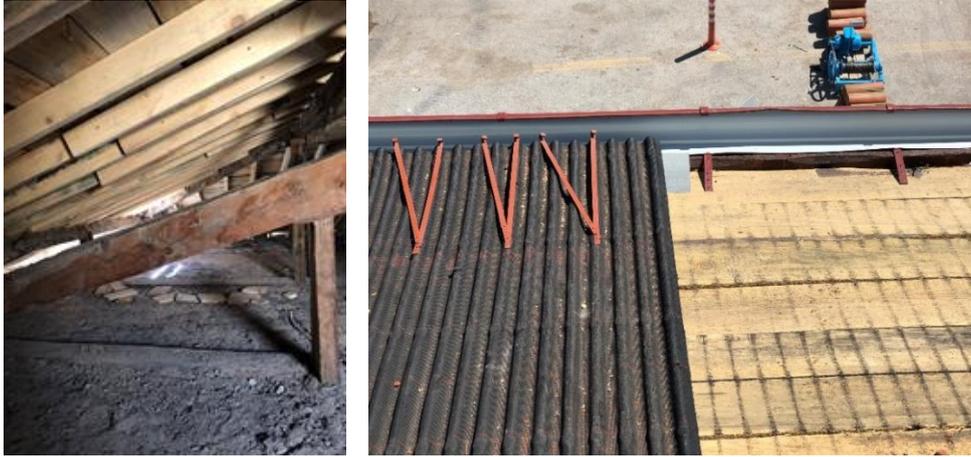
Figure 5. Roof reinforcement and insulation applications [16]

On the roof of the Seyh Muhittin Mosque, the marseille-type roof tiles and decaying wooden cladding boards were removed. The decaying of the carrier pillars and beams in the roof were changed and some of them were reinforced with wooden material. Following the consolidation process, a re-coating board was built and waterproofing was laid and a classical type tile was laid on it (Figure 5).

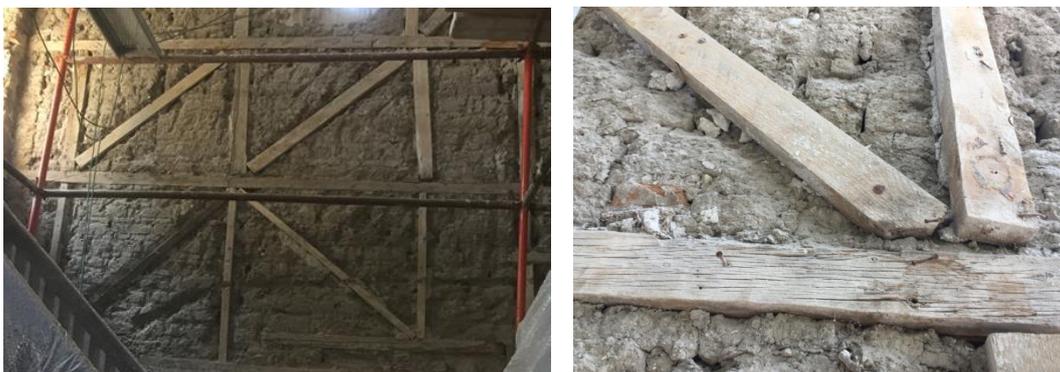
The survey and restoration project of the mosque was drawn by the Ankara Regional Directorate of Foundations in 2008. In this context, laboratory analysis of materials such as stone, mortar and plaster taken from the building was carried out by the Department of Restoration and Conservation of Ankara University and suggestions were made for the materials to be used in the restoration of the building. In the analyzes, cement based plasters detected on the inner and outer walls of the mosque were scrapped. When the plaster blasting was completed, the thickness of the mudbrick walls was 95-100 cm on the western side and 85-90 cm on the other sides. The structure was built with mudbrick technique of 32x32x8 or 32x16x8 between 10x10 cm or 15x15 cm wooden beams on the rubble stone wall, ranging from 60-80 to the basement level. Among the horizontal beams, there were discontinuous and variable sizes of wooden pillars and irregular nailed 4-5x8-10 cm cross beams corresponding to the wooden beams and beams. But; it was found that the cross frames were not properly connected with the struts and beams, the joining geometries were faulty and their workmanship was very poor (Figure 6). While these cross beams were used on the entire façade of the building, it was not used on the northern interior walls (Figure 7). In order to clarify the determinations, a few of the cross frames were removed and it was determined that the mudbrick surfaces coming under them were carved by intervention to make places for cross woods (Figure 8).

Figure 6. Wood frame irregularities and damage in mud-brick [16]

With this evaluation it was concluded that the wall detail was later changed and there were no crosses in the original. In order to eliminate the damages in the structural system of the building, it was decided to remove the rotting pillars and horizontal beams and all the diagonals, and replace the rotting horizontals and replace the verticals. It was decided that the crosses should be canceled and the damaged parts of the mud-brick should be filled with mud mortar or if the destruction was large, it would be completed with mud-brick.

In accordance with this decision, complements were made by using mudbrick material, rotting horizontal and vertical woods were renewed and the protected ones were strengthened by impregnation. Mudbrick is a building material obtained by mixing straw or other additives into clay and suitable soil, kneading with water, pouring into molds and shaping and drying in the open air [17]. Following the consolidation of the structural system, metal lath was applied to the mudbrick surfaces and the integration and consolidation of the plaster to the surface was realized (Figure 9).

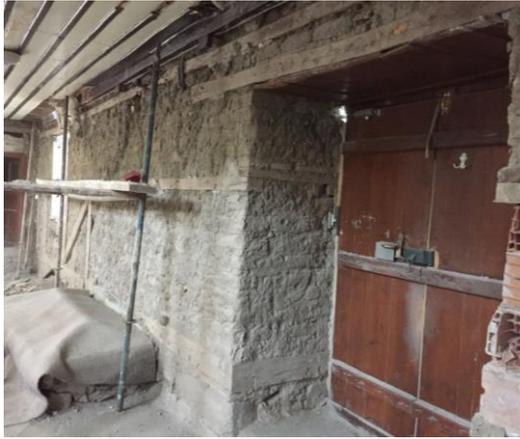
Figure 7. Uncrossed sections [16]

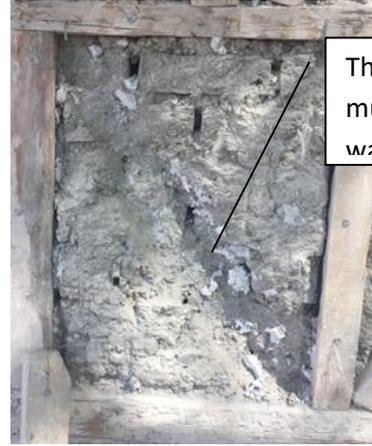
Figure 8. After removal of wooden cross [16]

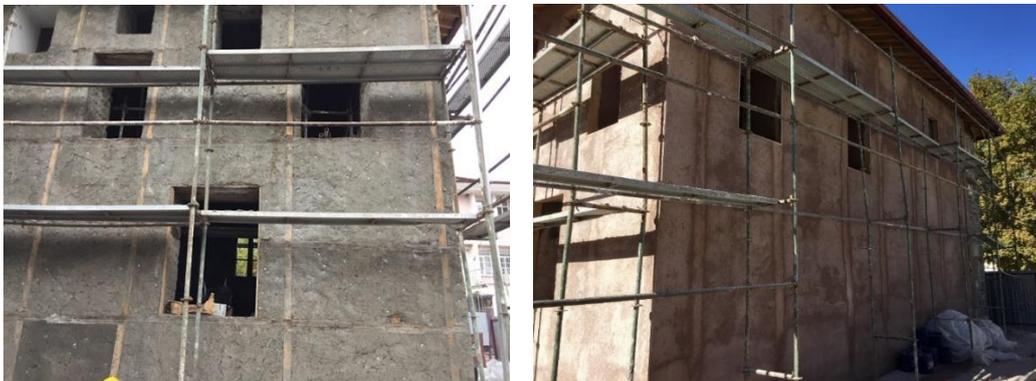
Figure 9. Metal lath and plaster application on walls [16]

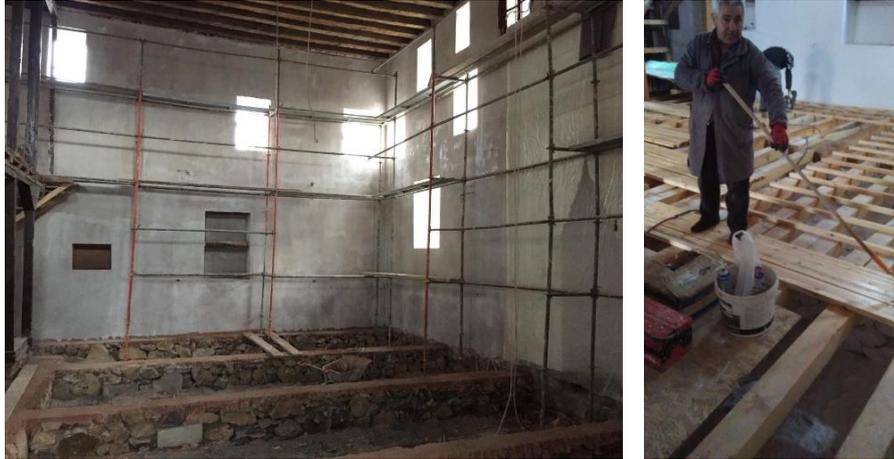
Figure 10. Rubble stone wall and wooden floor beams [16]

In the research conducted under the existing wooden flooring in Seyh Muhittin Mosque, concrete screed was laid under the flooring. For this reason, the wooden floor was dismantled, the concrete screed underneath was broken and the soil filling was removed to allow the floor to breathe. A rubble stone wall of 40 cm height and 250 cm axle spacing was built to fit the wooden beams. Wooden floor beams measuring 15x15 cm were installed on these walls and the floor ground was reinforced (Figure 10).

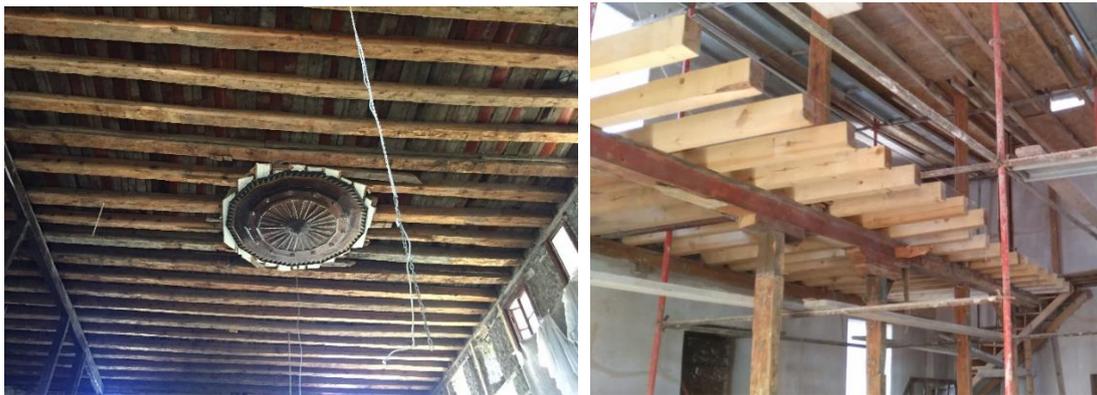
Figure 11. Wooden ceiling beams of main prayer area and women's section [16]

The rotten wooden ceiling coverings of the mosque were removed and the wooden beams and the wooden ceiling core where the ceiling was mounted were preserved. The sections where the wooden ceiling beams were damaged were consolidated (Figure 11) and the bearing system was reinforced. Later, wooden ceiling coverings and laths were rebuilt in accordance with the original. After dismantling the floor covering and ceiling covering of the women's section, the beams bearing the floor layer, the floor covering and the ceiling covering of the women's section were renewed.

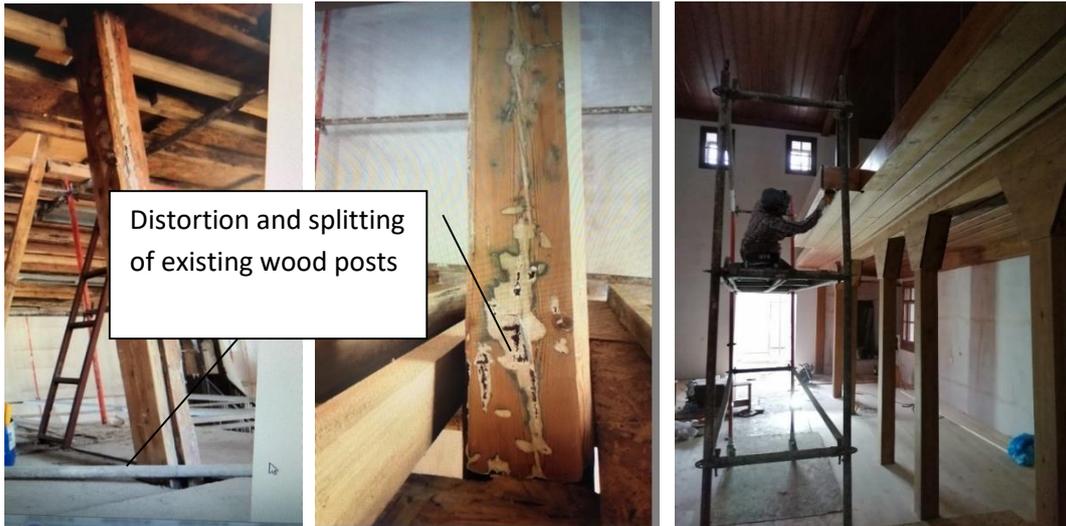
Figure 12. Distortion and splitting of existing wood posts and new posts and ceiling [16]

In the approved restoration project, it is envisaged to clean the oil paint in the protected wood productions in the main prayer area (protected ceiling hub, pillars bearing the ceiling beam and minbar). In this direction, oil paints were cleaned on wooden posts and human interventions such as nailing, hanging, and also cracking and worming were observed depending on time (Figure 12). According to the decision of the Conservation Board, these posts were renewed.

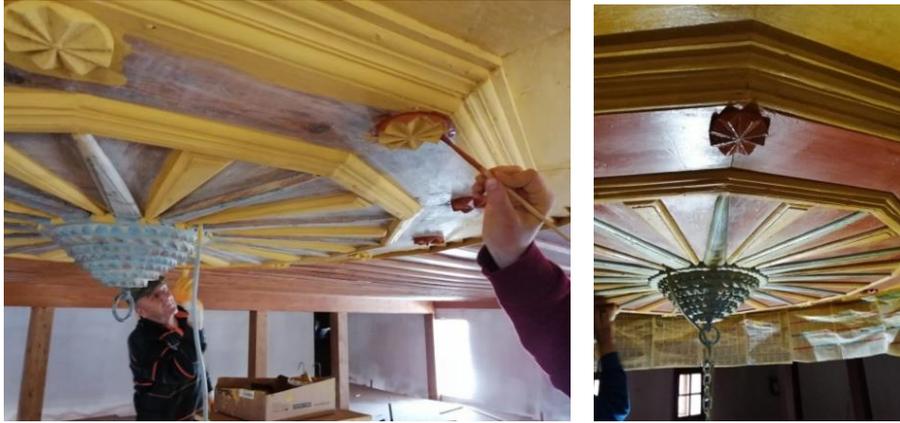
Figure 14. Wood ceiling hub orche paint application [16]

In the cleaning of the wooden ceiling hub (Figure 14) and the wooden minbar, which is envisaged to be protected according to the approved project, two layers of brown oil paint and two layers of green oil paint have been identified as very thick oil paint layers. As a result of the removal of these layers with paint remover and scalpel, green, yellow and orange ochre was seen at the bottom. In addition, cypress and carnation patterns were found in the minbar (Figure 15). According to the decision of the Conservation Board, after the oil paint cleaning was completed on the wooden ceiling hub, it was completed with orche paint suitable for the original tone and shellac polish was applied on it. The chasings on the wooden minbar were completed in accordance with the original and shellac polish was applied on it.

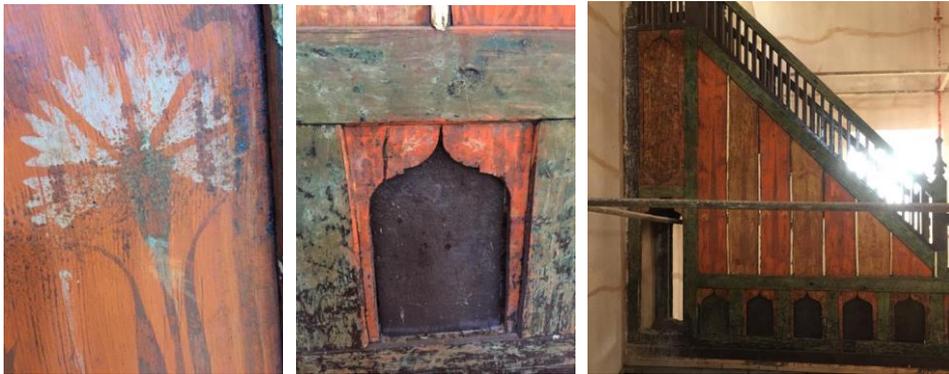
Figure 15. Cleaning the oil paint in the minbar [16]

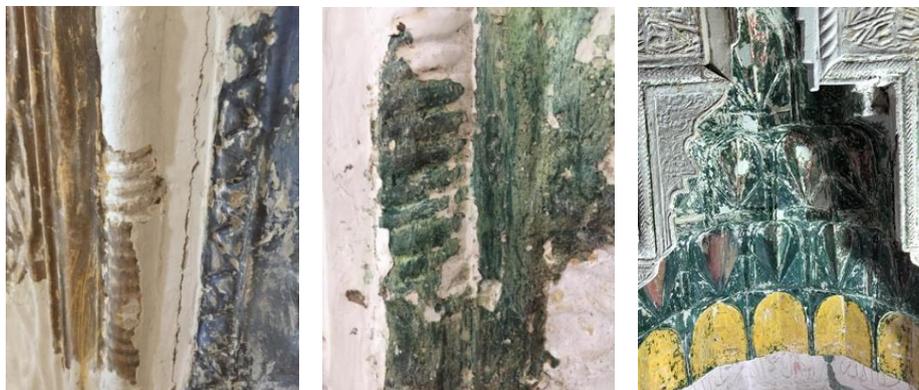
Figure 16. Mihrab cleaning works [16]

In the approved restoration project; It is envisaged that the paint layers applied in layers over time prevent the perception of the plaster mihrab motifs to a great extent, and therefore, paint cleaning is performed with suitable methods in order to reveal the original surface. In this direction, firstly mechanical cleaning has started in plaster mihrab. During the cleaning of the paint, different colors of ochre paint were found in the lower layers (Figure 16). For this reason, the cleaning activities were carried out more precisely, paint cleaning was continued with paint remover and scalpel and orche paint was determined in most of the mihrab. After the cleaning works were completed, the fractures and cavities in the mihrab were consolidated by injection (Figure 17). Afterwards, completion and revitalization was done with orche.

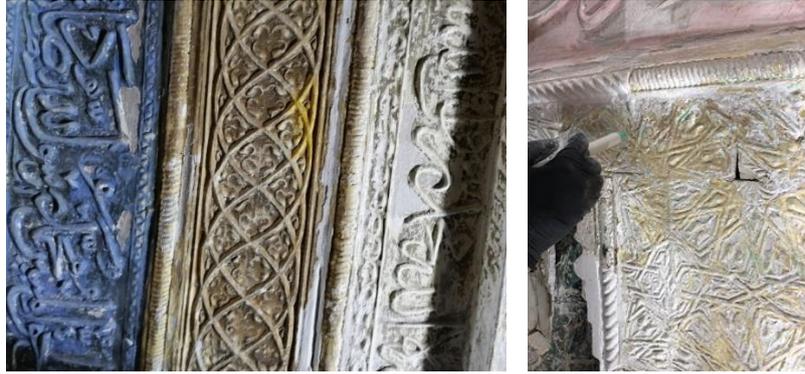
Figure 17. Cleaning and injection works [16]

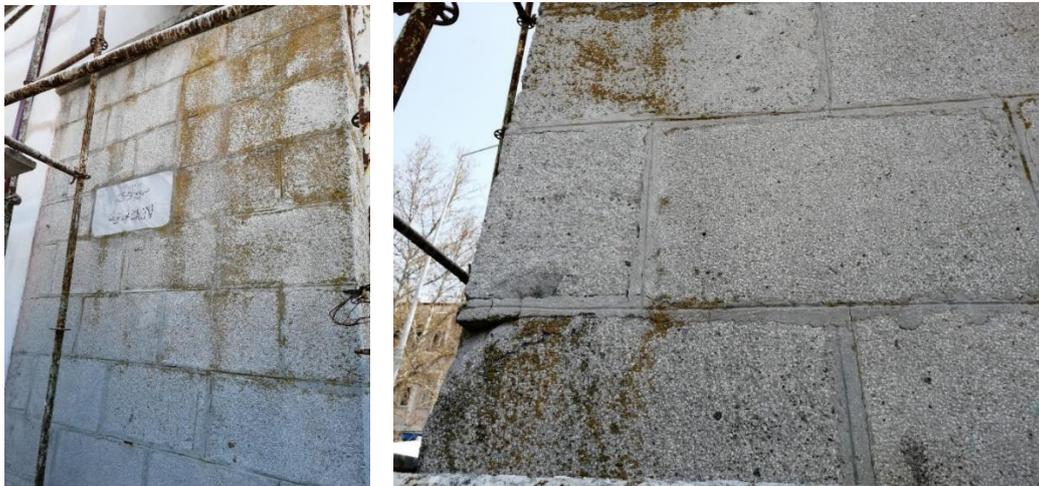
Dirt layer and algae have formed over time on the surface of the non-original stone imitation reinforced concrete minaret. In addition, cement residues from previous repairs were identified on the surface of the minaret (Figure 18). In the scope of the restoration, the remains of ossified mortar on the surface of the minaret, which provided adherence with the structure, local fillings made with cement-based unreinforced mortar, and cement slurries flowing on the facade were cleaned with small hand tools without damaging the wall surface and the surface was washed with arabic soap and water (Figure 19).

Figure 18. Algae and cement residues on the surface of the minaret [16]

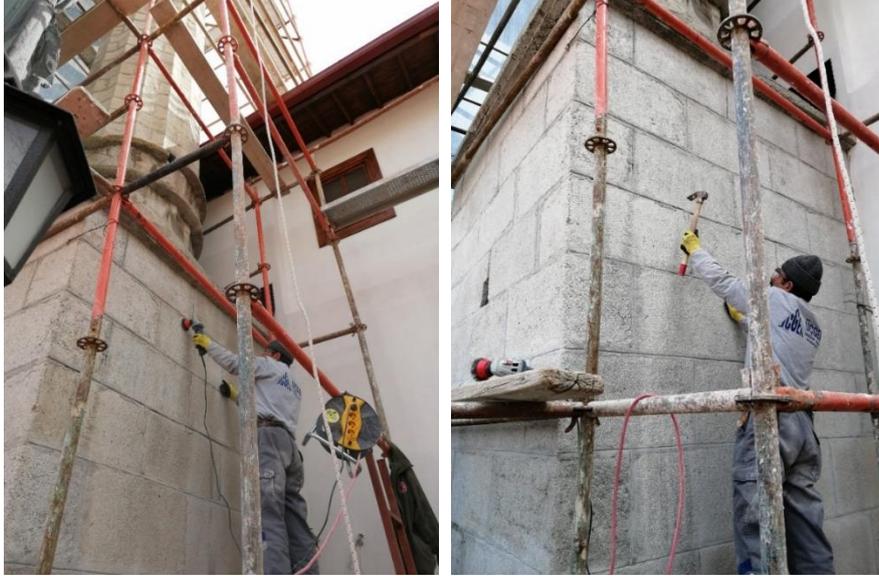
Figure 19. Minaret cleaning and repair work [16]

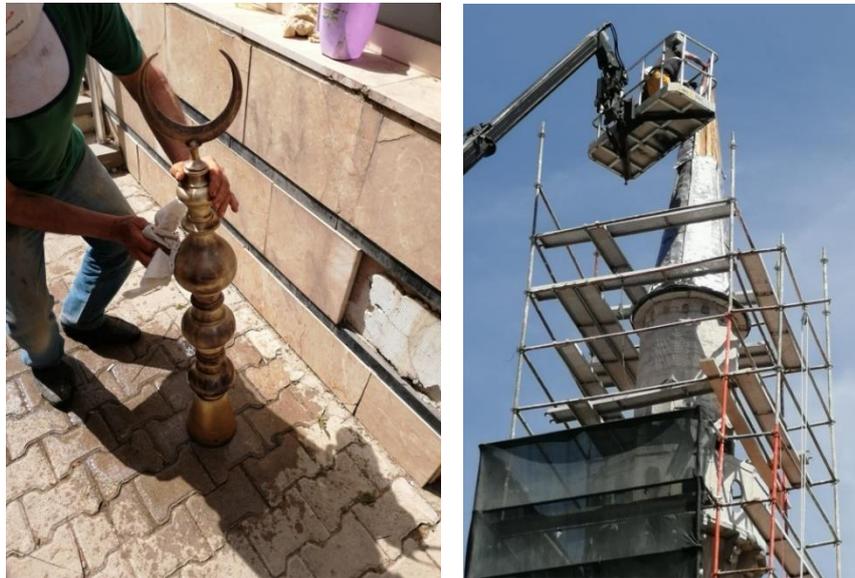
Figure 20. Lead coating in minaret cone and cleaning of finial [16]

The metal coating in the minaret cone was removed and the stability of the wooden coating under the cone was checked and the wood was impregnated and reinforced. Then the lead was coated on the cone. The copper finial in the cone was removed and cleaned and assembled in place by applying protection (Figure 20).
