## **Investigation of Structural Irregularities in Malatya Province After the February 6 Kahramanmaraş Earthquakes in Turkey**

**Assoc.Prof.Dr. Tuğba İNAN GÜNAYDIN**

*Niğde Ömer Halisdemir University, Department of Architecture, Niğde/TURKEY  
tinan@ohu.edu.tr ORCID: 0000-0003-0861-4835*

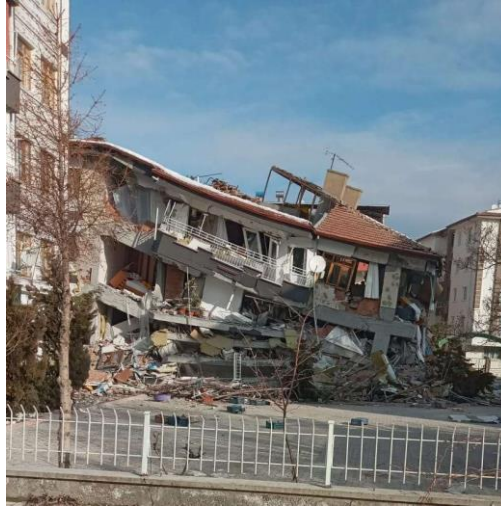
**Figure 3:** Torsional irregularity damages in Malatya

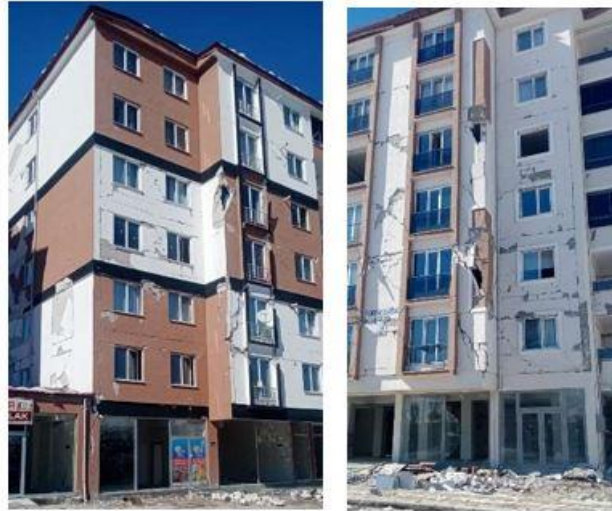
The projection irregularity is defined in the TBEC as the cases where projections beyond the re-entrant corners in both of the two principal directions in plan exceed the total plan dimensions of the building in the respective directions by more than 20%. Open and closed heavy cantilevered buildings caused serious destruction after the Kahramanmaraş earthquakes in Malatya. These type of cantilevers creates projection irregularity in that floor and cause various irregularity such as torsional irregularity, pounding irregularity, stiffness differences between floors, etc. The buildings in Fig. 5 were severely damaged due to the overhangs and projection irregularity.

**Figure 5:** Projection damages in Malatya

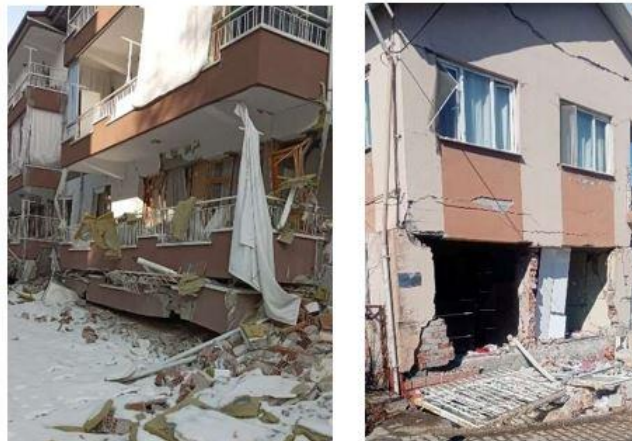
The weak storey irregularity is defined in the TBEC that in reinforced concrete buildings, the case where in each of the orthogonal earthquake directions, Strength Irregularity Factor  $\eta_{ci}$ , which is defined as the ratio of the effective shear area of any storey to the effective shear area of the storey immediately above, is less than 0.80. If the ratio is between 0.8 and 0.6, there exists weak storey irregularity in structure. But, if it is less than 0.6, the structure must be redesigned until appropriate range of values are gained. This irregularity is related on vertical configuration issue in which there is a major reduction in strength between storeys. Although it is so dangerous when it occurs at ground storey due to the greatest load accumulation at this storey, it can be observed at any storey of a building. This irregularity generally occurs due to the lesser strength or major flexibility between stories. If all stories of the building are nearly equal in terms of strength or stiffness, earthquake forces can be distributed nearly equal to each storey under earthquake loading. The buildings illustrated in Fig. 6 were severely damaged due to the weak storey problem.

**Figure 6:** Weak storey damages in Malatya

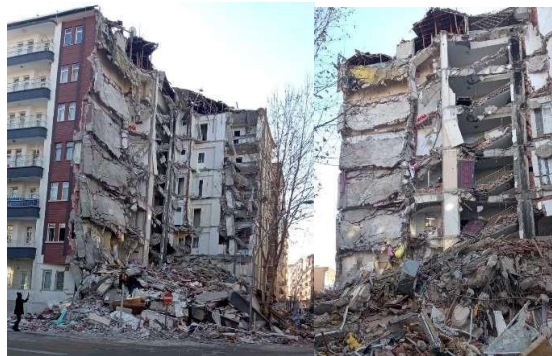
**Figure 9:** Insufficient design of structural elements

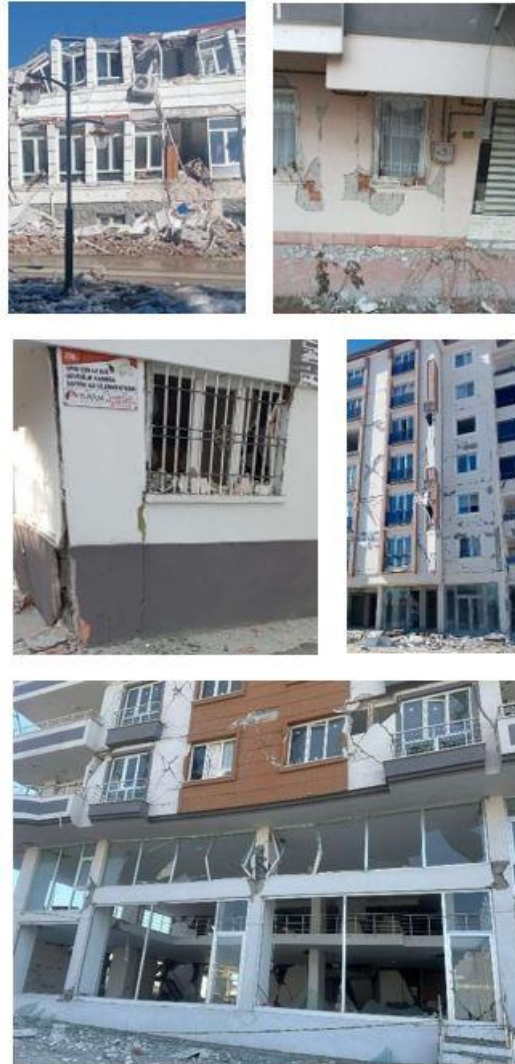
Short columns are defined as the columns that are shorter than the columns on the same floor. When a building has both long and short columns in the same storey, the columns expose to different shear forces due to their height differences. The lateral loads firstly come to the long and flexible columns, after go towards to the short column and accumulate in there. Due to the excessive accumulation of the seismic energy, shear cracks occurs at both ends of the columns. The damage in these short columns is often in the form of X-shaped cracking that occurs due to shear failures. Mezzanine floors, mechanical floor, hillside sides, graded foundation, ribbon windows, partial openings adjacent to the structural elements and stair landings are the most commonly encountered design problems caused short column effect. Short column effects in Malatya after the Kahramanmaraş earthquakes were illustrated in Fig. 10.

**Figure 10:** Short column effect

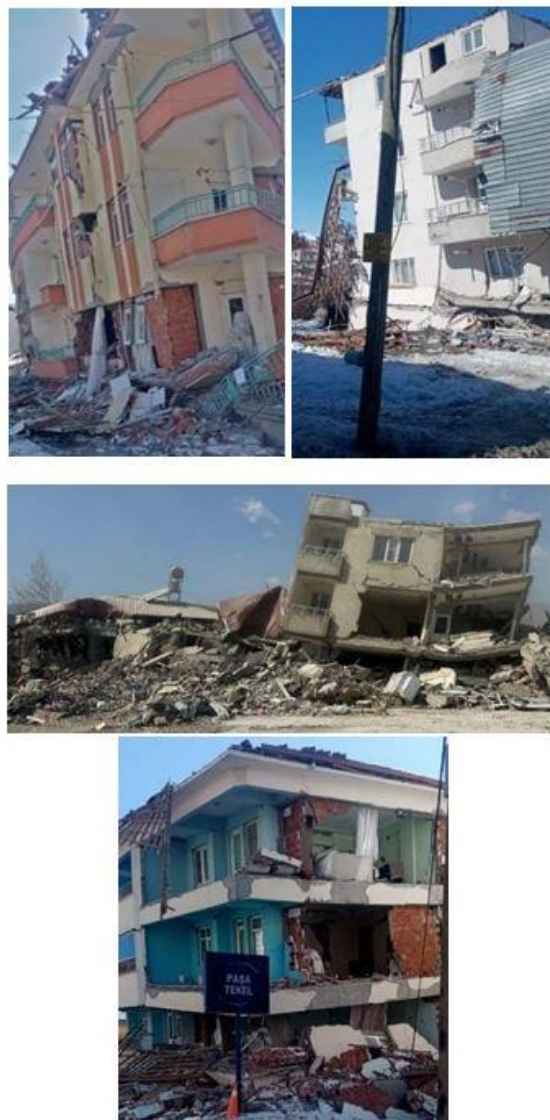
Many buildings are damaged in earthquakes due to poor ground structure in Turkey. Local soil types are divided into six main groups in the TEBC, named from ZA to ZF, from good ground to poor soil. The soil type ZA consists of solid hard rock and ZB consists of slightly weathered, medium- solid rocks. Besides, ZC comprises of considerable dense layers of sand, gravel and hard clay or weathered, highly fractured weak rocks. ZD consists of medium firm, firm sand, gravel or considerable stiff clay layers. Moreover, ZE comprises of loose sand, gravel or soft-solid clay layers. ZF refers to grounds that require site-specific research and evaluation. Buildings with ground liquefaction generally have this soil type. Some of the soil type related damages noticed after the Kahramanmaraş earthquakes in Malatya were shown in Fig. 13. In examinations carried out in areas where collapsed or heavily damaged buildings are located, the fact that there are slightly damaged neighboring buildings on the same ground layer shows that the demolitions are not only caused by the ground.

**Figure 13:** Soil type related problems
