## **Architectural History and Conservation Considerations of the Wooden *Minbar* in the *Kundekari* Technique in the Taşkın Pasha Mosque**

**Dr. Fatma Sezin DOĞRUER**

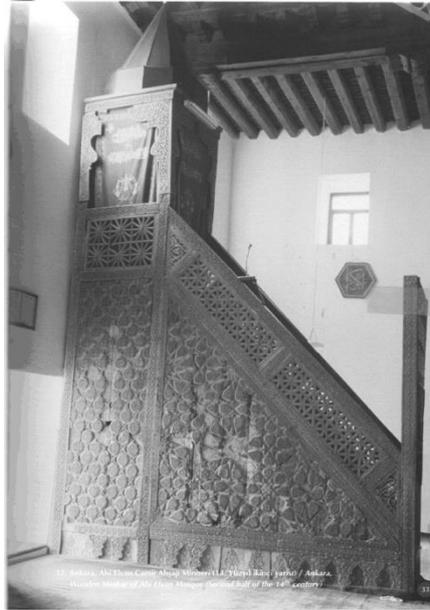
Figure 1. Ahi Evran Mosque (Ankara), wooden *minbar* (Republic of Turkey General Directorate of Foundations, 1999, 33)

The *Minbars* of Aksaray Great Mosque, Harput Sare Hatun Mosque (Elazığ), Kayseri Huan Hatun Mosque, Divriği Great Mosque (Sivas), Arslanhane Mosque and Ahi Elvan Mosque (Ankara) (Figure 1), Sivrihisar Great Mosque, Ayaş Great Mosque, Beyşehir Eşrefoğlu Mosque are other good examples of woodworking in Turkey (Öney, 1992: 137).

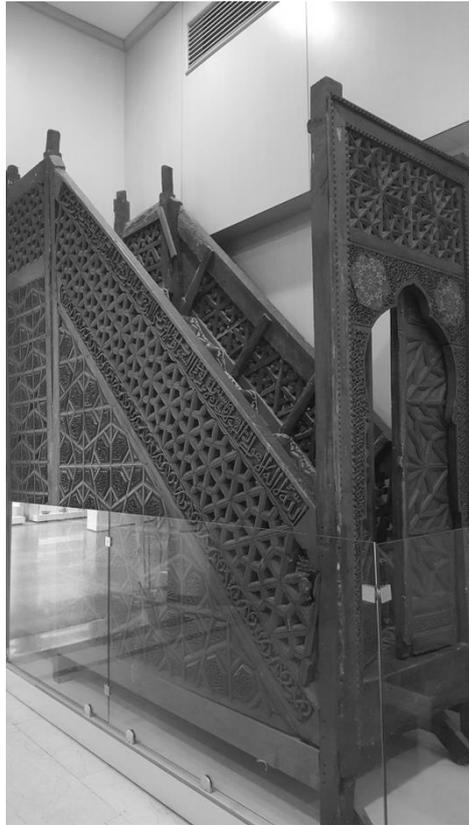
Figure 5. Taşkın Pasha Mosque, *minbar* (Author, December 2018)

Taşkın Pasha Mosque is one of the mosques of Seljuk period and period of principalities (*beyliks*) in Anatolia, which occurs in a complex (*külliyeye*) next to the Taşkın Pasha Madrasa and tomb. Although there is no inscription panel giving information about the construction date, the mosque is thought to be probably built at the same dates of the madrasa (Çiftçioğlu, 2001: 21). The Mosque is made of cut stone in walls, earth in the roof; and timber in *minbar* and *mihrab*. The wooden *minbar* of Taşkın Pasha Mosque is recently exhibited in Ankara Ethnography Museum with inventory number 11928. It was taken to this museum in 1940 with the *mihrab* (Semen Uzar, 2003: 254-258). The *Minbar* is composed of stairs, kiosk and a door (Figure 5), which is made of walnut tree (Bozkurt and Bozkurt, 2010: 3). The dimensions of *minbar* are 318 x 290 x 92cm. gained from the inventory card of the *minbar* in Ankara Ethnography Museum. The *minbar* stands on a wheeled platform made of medium density fiberboard with a glass balustrade.

It is seen that *minbar* in the Taşkın Pasha Mosque, which was made of walnut tree (hardwood) is mostly durable. Only some infill pieces of the side board are either fallen or destroyed. It is understood from visual investigation that the *minbar* had not been exposed to physical forces or fire. Walnut tree wood used in the *minbar* is classified in the medium grade of durable trees (Güler, 2011: 21). Durability is provided because of the construction system of actual *Kundekari*, which is made by interfacing small geometrical wooden pieces by placing the directions of the wood fiber at different angles to form a geometric composition. Although loss of elements is mostly seen in wooden structures, there is not much splitting or loosening of joined components since the undesirable actions of wood are prevented by putting the veins of the elements oppositely.
