## Determining the Changes of Cultural Landscapes in the Historical Process: Germir District, Kayseri, Turkey

Assistant Prof. Dr. D. Merve ÇETINKAYA SÖNMEZ<sup>1</sup>, Associate Prof. Dr. Parisa GÖKER<sup>2</sup>, Asst. Research Adiva Begül BULUT<sup>3</sup>

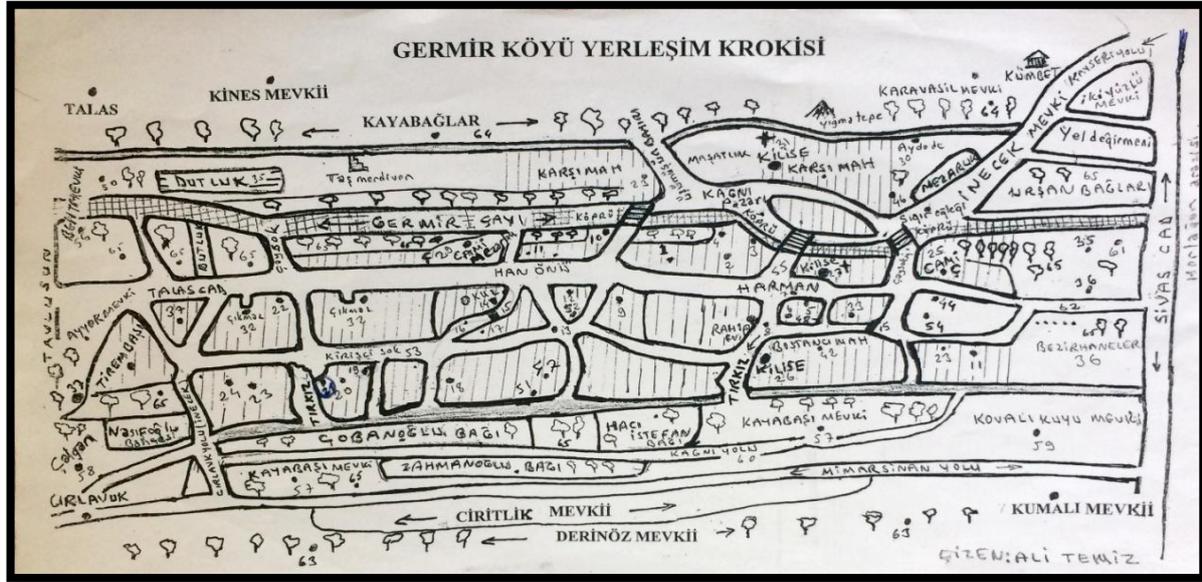
**Figure 2.** Site Diagram of Germir District (Cömert, 2014)

Hacı Sehak and Bostancı. (Cömert, 2014). (Figure 2). According to the population data from 1875, there were 1214 households in Germir (203 Turkish, 405 Armenian and 606 Greek) with a population of 6070. During this period, the land width of Germir was 819.4 ha, where mulberry fields, lucerns and buckthorn berry fields were present (Anonim, 2018).

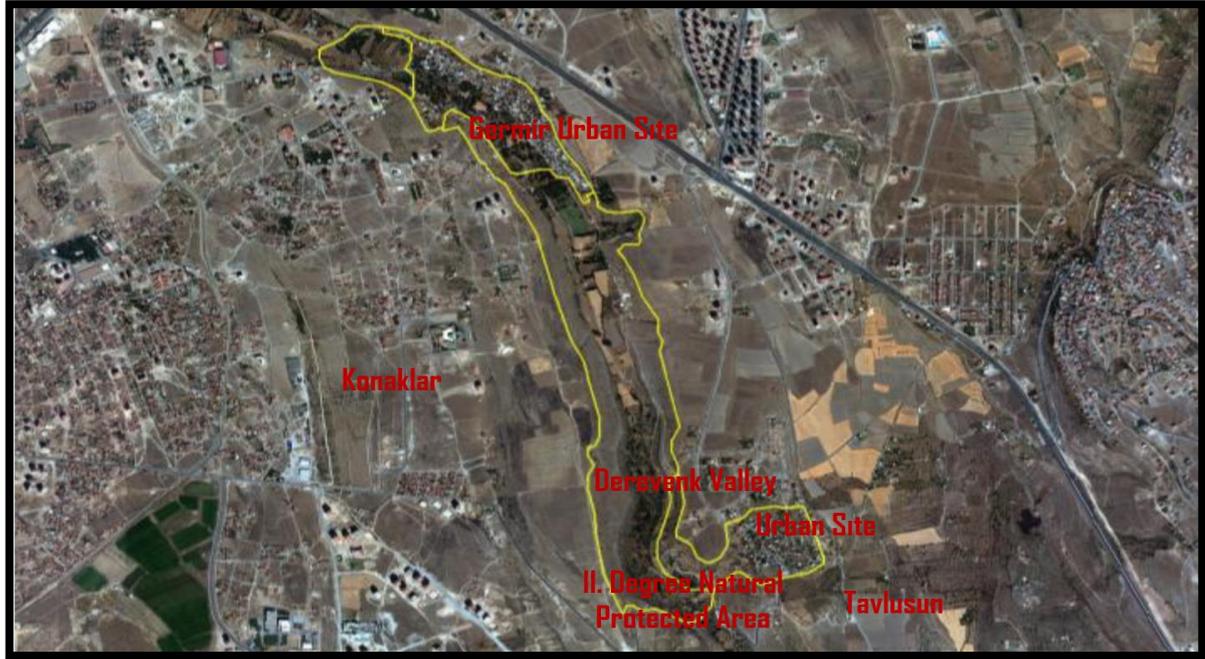
**Figure 5.** Germir District and Relations with the Immediate Vicinity (Kayseri KUDEB Archive, 2020)

There were 20 stores, 95 shops, 15 linseed oil facilities, 13 bakehouses, 2 slaughterhouses and 1 tavern. Moreover, there were a number of residences that are used as large-scale mansions in the settlement area (Cömert, 2014). According to this data, it can be clearly seen that Germir was a significant settlement area with a developed socio-cultural structure in 19<sup>th</sup> century (Figure 5).

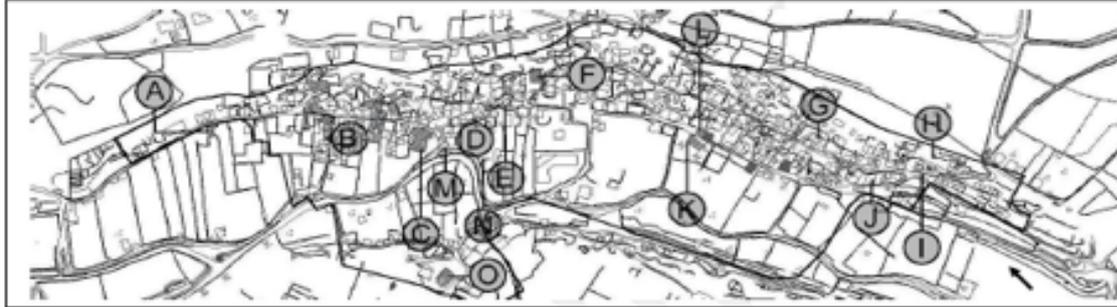
**Figure 7.** Germir District Monumental Structures and Important Civil Structures (Kuzu-Dinçbaşı, 2019)

Build Number	427. Street (Aşağı İslam Quarter/ Kuma(r)lı Street./Bezirhane Street /Balaban Quarter./Sığreğleği mey/Harman Quarter/Hacı (acı) Şehak Quarter)
A	Münip Deneme Bezirhanesi 11294 block 7 parcel
B	Ağaşı Quarter Mosque No:49 11294 block 23 parcel
C	Surp Stephanos Armenian Church No:17 11295 block 11 parcel
D	Fountain (Nasuhoglu Fountain) 1398 parcel
E	Jewelery shops 11300 block 7 parcels

430. Street (Bostancı (Bahçeci) Quarter)	
F	Agios Teodoros Greek Church, block 11304, parcel 4
429. Street (Kirişçi Quarter)	
G	Bakery 11333 block 11 parcel
H	Bakery 11338 block 22 parcel
I	Fountain 1772 parcel

431. Street	
J	Hamdi Yavuz Bezirhanesi No:5, block 11345, parcel 3
434. Street (Yukarı İslam Quarter. /Hanönü/Bakkal Quarter.)	
K	Yukarı Quarter Mosque, block 11354, parcel 3
L	Germir (İptida-i) School No:19, block 11330, plot 19,2
Germir Street (İncek mevkii. Kağnı pazarı)	
M	Konak (Harman) Bridge
N	Sadık Çelen Mansion Bath (Hacı Aydın Ağa's Bath, block 11313, parcel 4

437. Street (Karşı Quarter./Karşı geçe)	
O	Aya Panayia Greek Church 11443 block 1 parcel

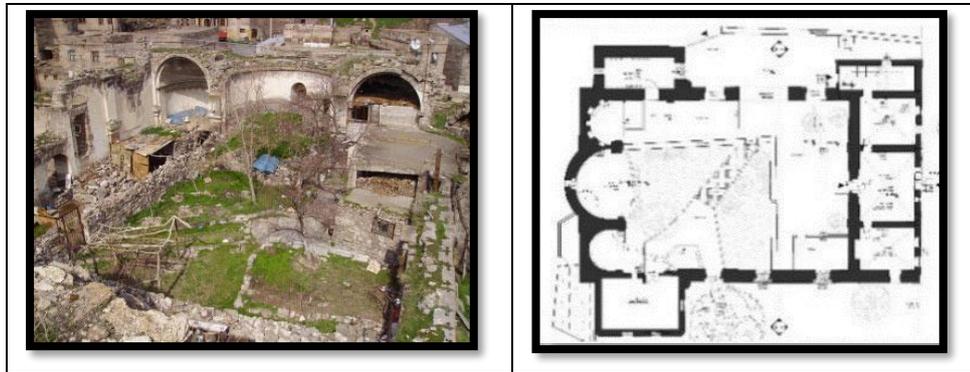
**Figure 8.** Surp stephanos Church naos and apsis sections (Taniş, 2006) (on the left) and layout plan (on the right) (Çetinkaya-Kencer, 2018)

This church is located in Germir District, street number: 428. A significant part of the church is ruined today. There two different information concerning the layout plan in the written resources. It can be seen that it has a layout plan of tri-nave longitudinal church plan, while according to the second resource, it is, again, tri-nave, yet with basilica church plan (Figure 8) (Taniş, 2006)

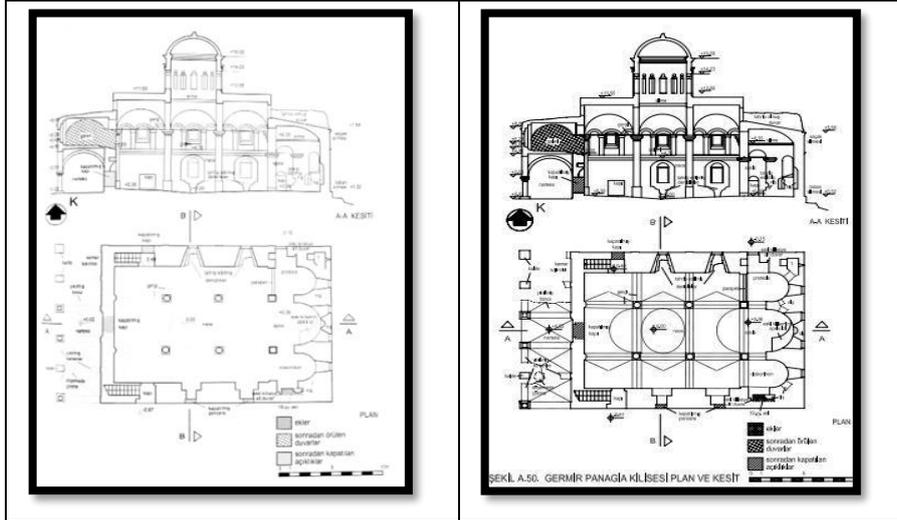
**Figure 9.** Panagia/Panayia Church Layout (Church) Plan (on the right) (Güngör-Açıkgöz, 2007)

Located on the Street no.: 437 in Germir District, the church has a layout plan of tri-nave with basilica church plan. The middle nave is wider compared to other two naves. Panagia/Panayia Church has been constructed from dimension stone materials in masonry order. It was registered pursuant to the decision no.: 1619 dated as 06.11.1993 taken by the Kayseri Regional Board of Cultural and Natural Heritage Preservation (Figure 9-10) (Taniş, 2006).

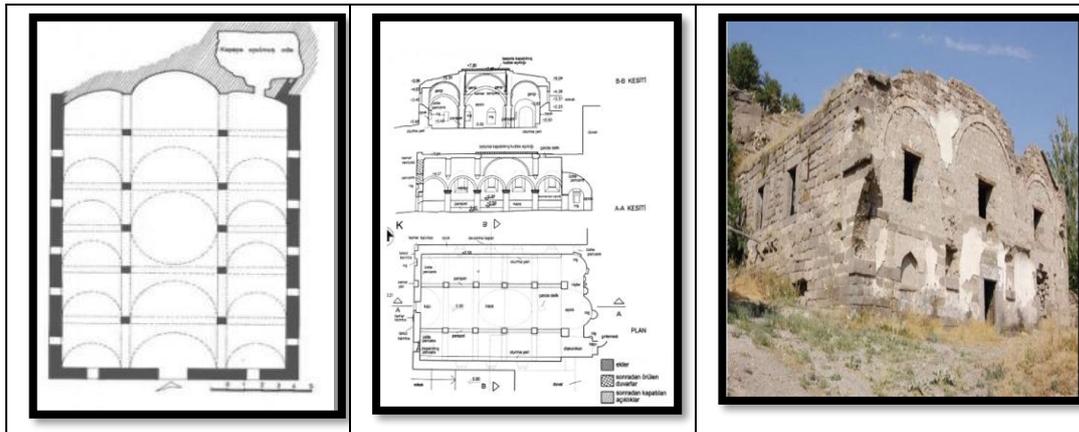
**Figure 11.** Agios Teodoros Church layout (church) plan (İlter 1988, Güngör-Açıkgöz 2007). Agios Teodoros Church (on the left) (Özbek & Arslan , 2008)

This church is located on the Street no.: 428 in Germir District. It was registered pursuant to the decision no.: 1619 dated as 06.11.1993 taken by the Kayseri Regional Board of Cultural and Natural Heritage Preservation. Constructed in 1725, this church was renovated in 1835. It was constructed with fine dimension stones in masonry order (Figure 11 (Özbek & Arslan , 2008)).

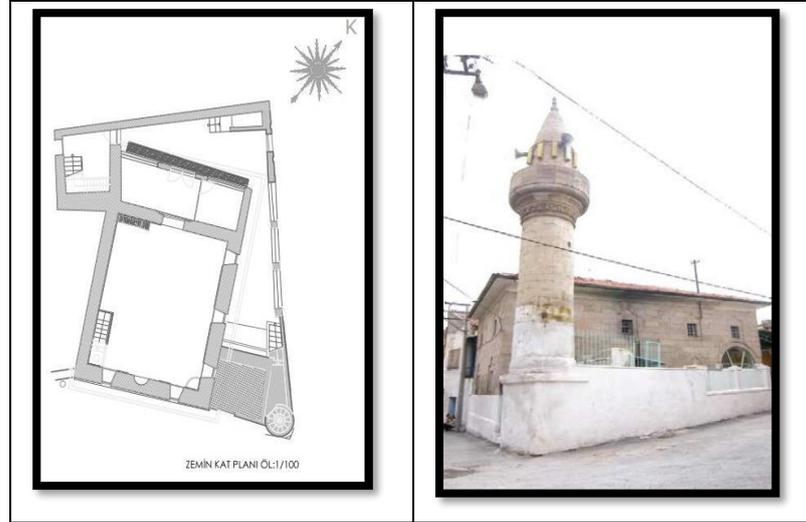
**Figure 12.** Aşağı Mahalle Mosque Relievo Plan (Kırık, 2019) view (Özbek & Arslan , 2008)

This mosque is located on the cross-section of the streets numbered as 426 and 427 in Germir District. It was registered pursuant to the decision no.: 1619 dated as 06.11.1993 taken by the Kayseri Regional Board of Cultural and Natural Heritage Preservation. There is no clear information concerning the date of construction, since the mosque does not possess an epitaph. However, it is thought/envisioned that it was constructed at the end of 19<sup>th</sup> century based on its construction technique and the construction materials used. It was constructed from rectangular form fine dimension stones in masonry order. On the northern frontal, there is a three-section narthex. There are ornaments on the mihrab, where the baroque influences can be seen (Figure 12) (Anonymous, 2017).

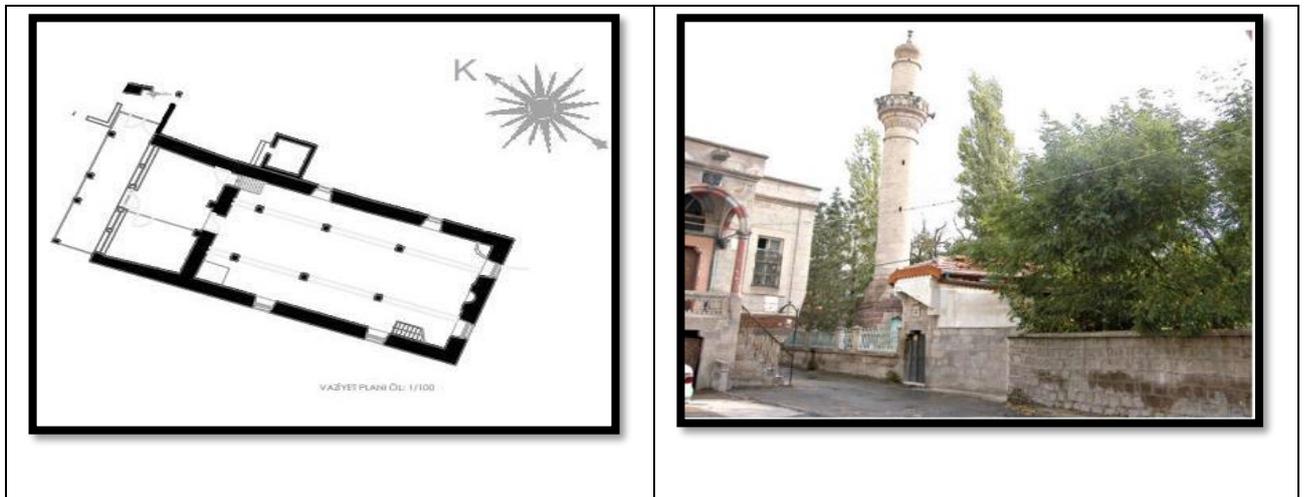
**Figure 13.** Yukarı Mahalle Mosque Relievo Plan (Kırık, 2019) view (Özbek & Arslan , 2008)

There is no clear information concerning the date of construction, since the mosque does not possess an epitaph. However, it is thought/envisioned that it was constructed at the end of 18<sup>th</sup> century or at the beginning of 19<sup>th</sup> century based on its construction technique and the construction materials used. Stone and wooden materials were both used for construction. The narthex of the rectangular form mosque is located in the northern frontal. Moreover, there is a praying area in the eastern part of the mosque (Figure 13) (Anonymous, 2017)

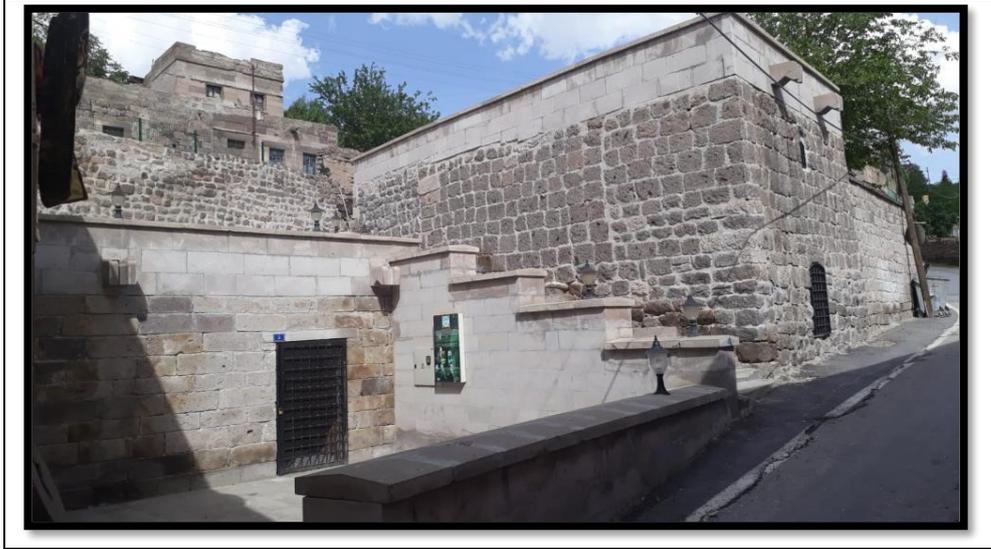
**Figure 14.** Linseed Oil Facility (Kırık, 2019)

It is located on the Street no.: 428 in Germir District (Figure 14). The linseed oil facility comprises of two spaces that are connected to each other facing to North-South on one side and East-West on the other. The cover coating is flat roof over the wooden beams. However, it is thought that the facility was constructed in 19<sup>th</sup> century based on the verbal information obtained from the local community. It was constructed from fine dimension stones in masonry order. (Anonymous, 2017). The pitch-faced frontal was built from rubble stones (AKS, 2015).

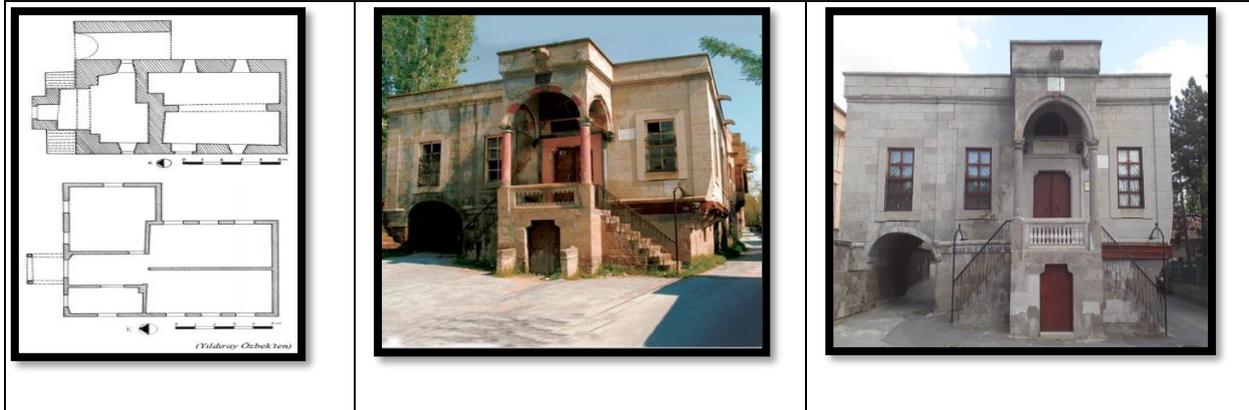
**Figure 15.** Germir School Layout Plan (Özbek & Arslan , 2008) Germir School (Anonymous, 2017) (on the right) Germir School (Original 2018)

It was registered pursuant to the decision no.: 869 dated as 09.01.2014 taken by the Kayseri Regional Board of Cultural and Natural Heritage Preservation. It is a two-storey building constructed in rectangular form from fine dimension stones in masonry order (Figure 15).

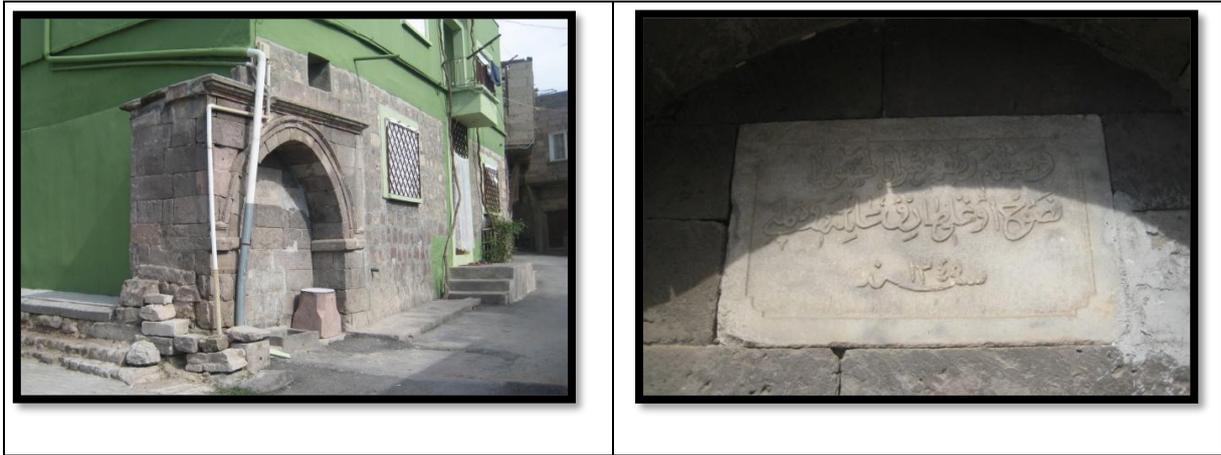
**Figure 16.** Yukarı mahalle fountain (Kuzu-Dinçbaş, 2019).

Built in 1927 (Gregorian Calendar) / 1345 (Muslim Calendar), this fountain is located on the Street no.: 427. The fountain is built to the Wall of a house in the Street, having a single frontal with single vaulted structure. The round-shaped vault covering the niche of the fountain is placed on the masonry stands near it. The vault pediment is set brisked up by means of being framed with a single line of linear profile moulding. There is also a moulded cornice bleeding from the right side of the fountain. Marble was used on its epitaph made of fine dimension stone (AKS, 2015). Today, it is not actively used. (Figure 16).

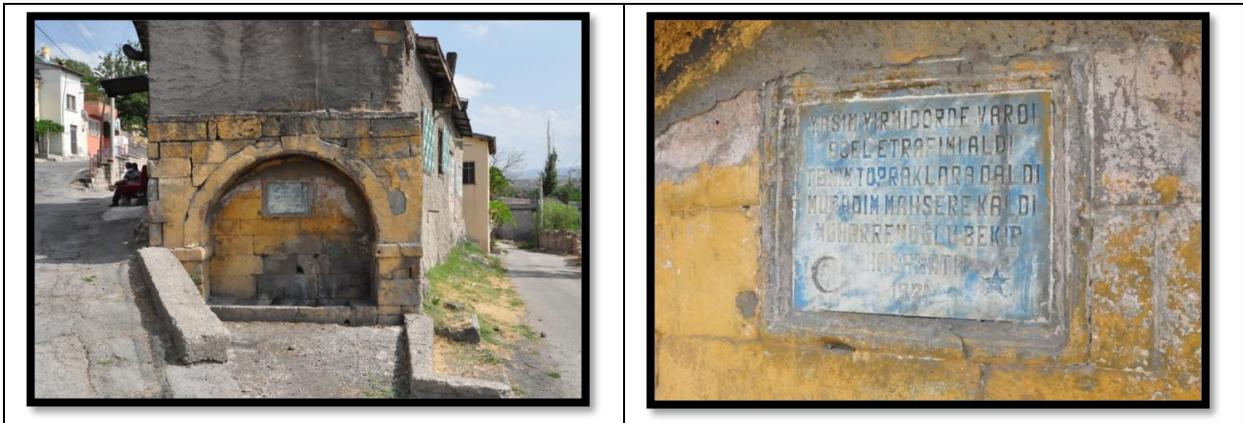
**Figure 17.** Kirişçi Quarter Fountain (Kuzu-Dinçbaş, 2019).

This fountain was built adjacent to the Wall of another building in the intersection point of two streets on the parcel no.: 1772. This structure is not actively in use at the present time. The following lines are written down on its epitaph "I'm 24 now, the death took everyone around me, my skin is deep in the earth, my wishes are to come true in the judgement day – Muharremoğlu Bekir Hasanatı, 1921" (Kuzu-Dinçbaş, 2019). (Figure 17).

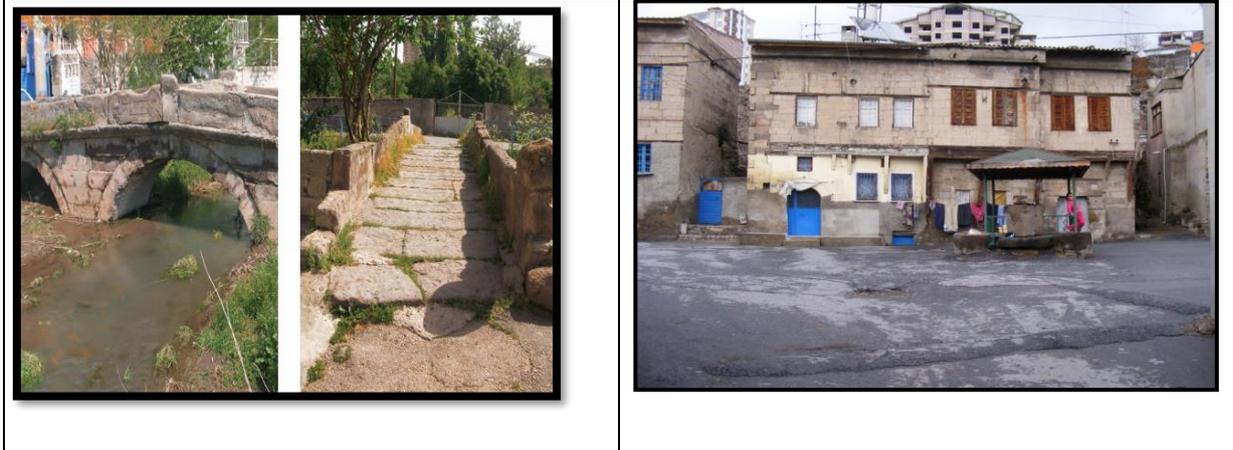
**Figure 18.** Germir Bridge (Anonymous, 2017) The Square where Germir Bridge is connected (AKS, 2015)

It was registered pursuant to the decision no.: 1619 dated as 06.11.1993 taken by the Kayseri Regional Board of Cultural and Natural Heritage Preservation. According to its registry papers, it was built in 19<sup>th</sup> century (Figure 18).

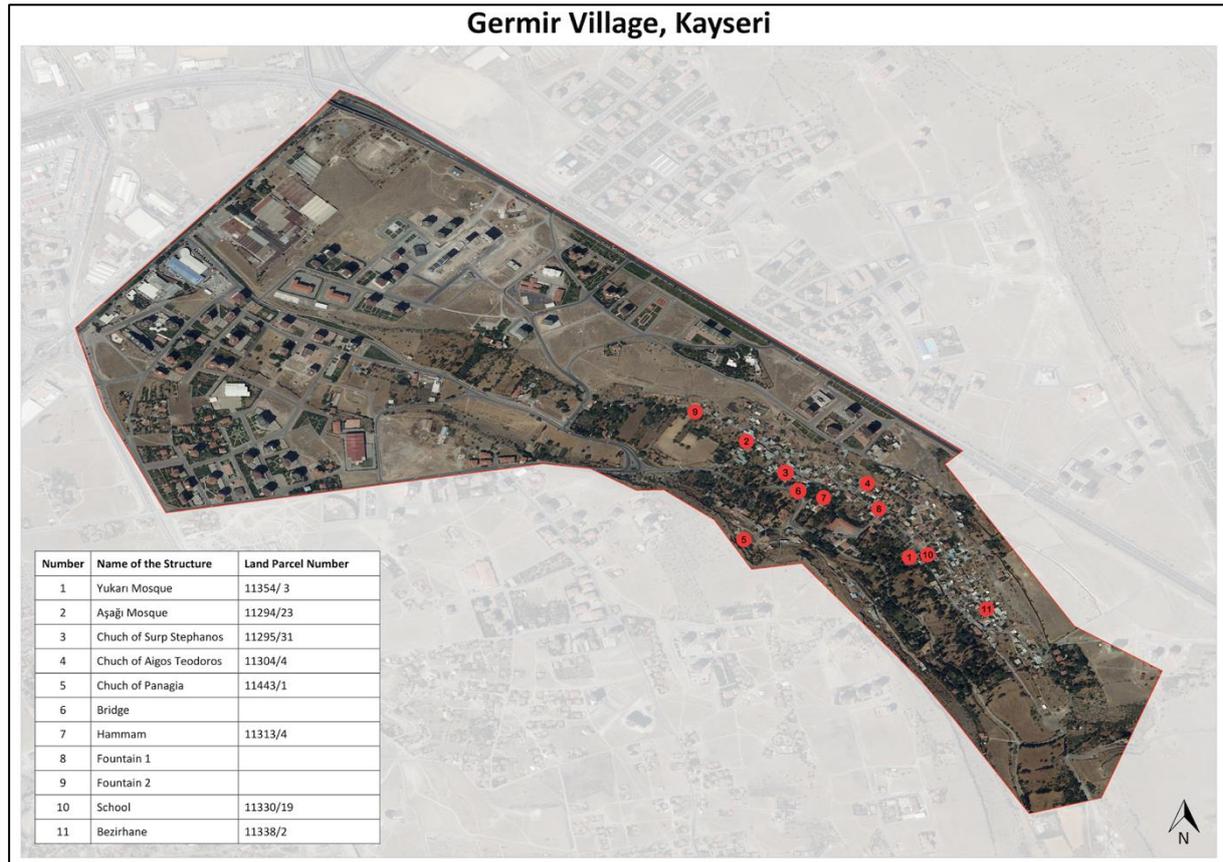
**Figure 20.** Germir District – Tangible Cultural Heritage (Original, 2021)

What has also been determined is that the tangible cultural heritage values existing within the boundaries of the quarter have changed over time, along with the changes that the historical quarter has undergone within its built environment. With a history dating back to the Ottoman period, this settlement area has hosted a number of tribes from past to the present. Today, some of these works survive in the urban landscape, thus preserving their aesthetic value. Some of these, on the other hand, have been exposed to many structural and functional changes. These changes that the tangible cultural heritage values have undergone were determined following the use of area-survey and on-site inspection methods. (Table 1 and Figure 20).

<b>Tangible Cultural Heritage Elements</b>	<b>Structures that are not in use</b>	<b>Structures that function the same as designated</b>	<b>Structures that function different than designated</b>
<b>Surp Stephanos Church</b>			Being used as a house
<b>Panagia/Panayia Church</b>	x		
<b>Agios Teodoros Church</b>	x		
<b>Aşağı Mahalle Mosque</b>		x	
<b>Yukarı Mahalle Mosque</b>		x	
<b>Linseed Oil Facility</b>			x
<b>Primary School</b>			x
<b>Turkish Bath</b>			
<b>Fountains</b>	x		
<b>Bridge</b>		x
