Evaluations on the Traditional Ankara-Ayaş Houses

Gülşah Çelik Başok

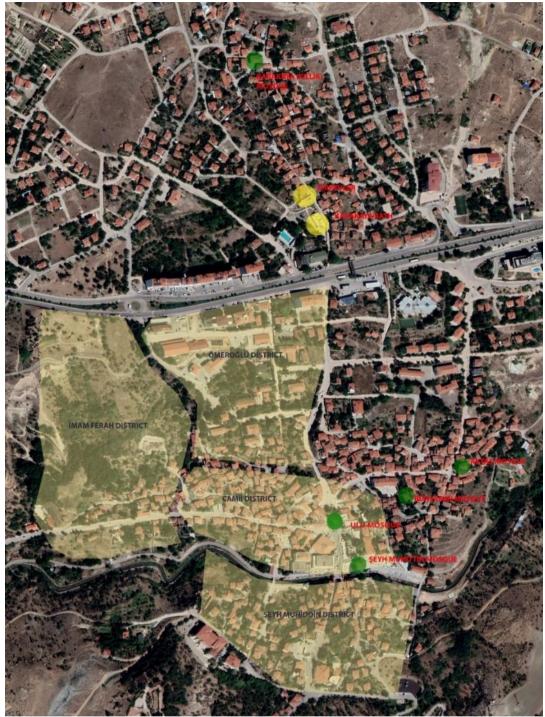
Figure 2. Four of the districts mentioned in the Ankara Sanjak Foundation Register.

According to the archive documents in history, the name of Ayaş was first encountered in the foundation registrations of the Number 9 Ankara Cadastral Register Books dated 1462 (Demirkan, 2006). Whereas the other written documents of the Ottoman period are the "Ankara Cadastral Record" dated 1523, the "Ankara Foundation Register" dated 1532, the "Ankara Sanjak Detailed Register" dated 1571, and the "Ankara Sanjak Foundation Register" dated 1571, and the "Ankara Sanjak Foundation Register", which are İmam Ferah, Ömeroğlu, Cami, and Şeyh Muhiddin, remain today without a change in their names (Fig. 2).

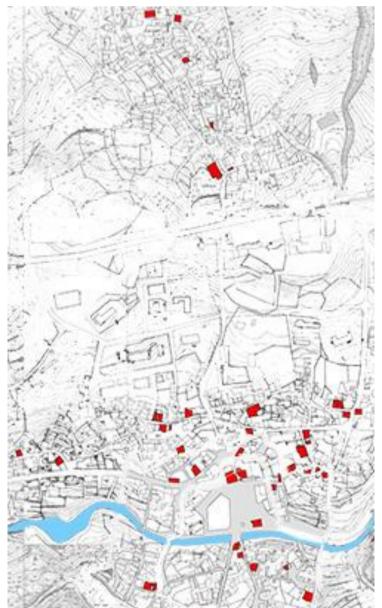
Figure 4. Map of the registered buildings.

According to the Ankara Province Immovable Cultural Assets Inventory list, there were 98 immovable cultural assets in Ayaş County. Of these, 43 were houses and the other structures were fountains, tumuli, mosques, etc. While four of the houses belonged to the Republic period, 39 were traditional houses that belonged to the Ottoman period. The official registration of these works of art was conducted in 1962 (Fig. 4).

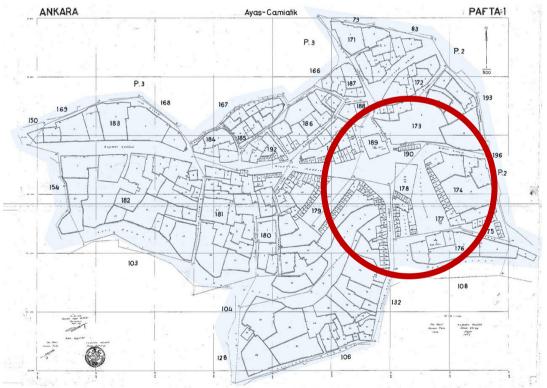
Figure 5. Cadastral Map of Ayaş in 1957.

The Cumhuriyet (Republic) Square is an important focus point for the Ayaş center. The Great Mosque, Pasha Hammam, Sheikh Muhiddin Mosque, and the Municipal Building is an important area defined by the Cumhuriyet Square. This square, which is the center of Ayaş, is a significant square where the commercial center, bazaar, and bus stops are located (Figs. 5-6).

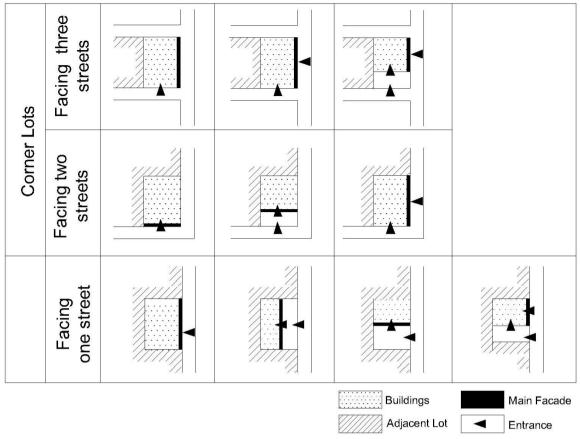
Figure 8. Entrance typology.

It is possible to classify the location of the houses as houses entered only from the street, only from the courtyard, and both from the street and from the courtyard (Fig. 8).

Houses entering the house directly from the street are generally in an attached order, without garden or with a back garden. In houses that are not attached and have back gardens, there is an exit to the back garden either from behind or at the side of the house. The main outer walls of these houses entered from the street are shaped according to the form of the plot. Houses with a street texture are formed with the main outer walls for those with an attached order. Generally, entrance into the house from the street is provided with timber, double doors. The doors open to the areas given the name of *aralık* (corridor) for the service spaces on the ground floor.

The courtyard of the houses entered from the street to the courtyard and from the courtyard to the house are generally with eaves covered with clay roofing tiles and entrance is provided with a timber double courtyard door. Additions to the building, such as poultry coops, barns, and granaries are in the courtyard.

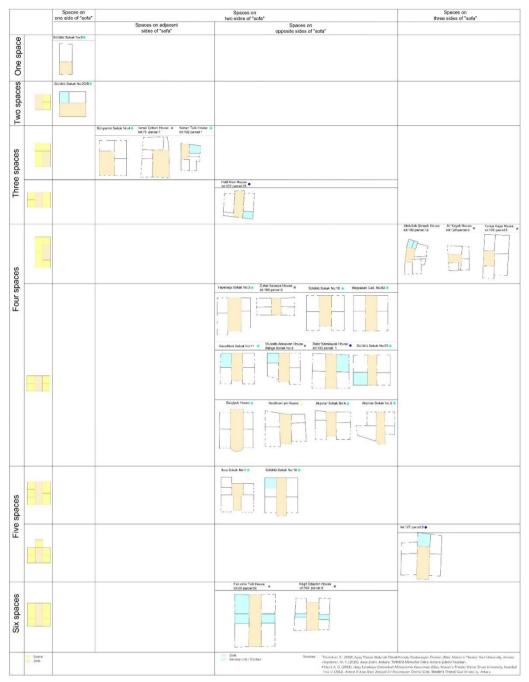
Figure 9. Plan typology.

The plan typology was prepared by studying 26 buildings. The information on the buildings was obtained from the plan drawings showing the original designs of the buildings, from theses, from books, and from the field studies. The plan typology of the Ayaş houses was made according to the upper story plans, which are called "living stories" (Fig. 9).

According to the plan typology, the buildings were first divided into three groups: "spaces on one side of *sofa*," "spaces on two sides of *sofa*," and "spaces on three sides of *sofa*." In addition, these 26 buildings were separated into six sub-groups from the aspect of the number of spaces surrounding the *sofa*.

Among the 26 buildings, only two buildings had plans with "spaces on one side of *sofa."* There are 20 traditional buildings having the plan type of "spaces on two sides of *sofa."* Within this group, they were divided in two as *spaces on adjacent sides of "sofa"* and *spaces on opposite sides of "sofa."*

When the buildings in this group were studied carefully, one of them had three spaces on opposite sides of "sofa", three of them had three spaces on adjacent sides of "sofa", 12 of

them had four spaces on opposite sides of "sofa", two of them had five spaces on opposite sides of "sofa" and two of them had six spaces on opposite sides of "sofa".

There were four traditional buildings in the group having the plan type "Spaces on three sides of *sofa."* Three of them had four spaces and one of them had five spaces.

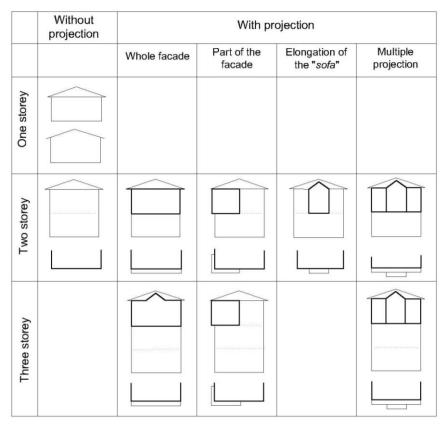
Figure 12. Façade and projection typology of traditional Ayaş houses.

In some buildings, the projection was made in the form of a continuation of the *sofa*. These projections, which are called oriel windows, are supported with buttresses. These projections provide advantages for expanding the space, directing towards the street and/or view, and for illumination, and ventilation. In facades with many projections, generally one more projection is made that would emphasize the *sofa* in the form of an oriel window on the projections made throughout the façade for elongating the space (Fig. 12).

There are two façade forms, with projection and without projection, in the traditional Ayaş houses examined. Facades without projections are generally plain and unostentatious facades. In some buildings, in the part that corresponds to the place of the *sofa*, there is a roof in the form of a pitched roof covered with a shielded wall.

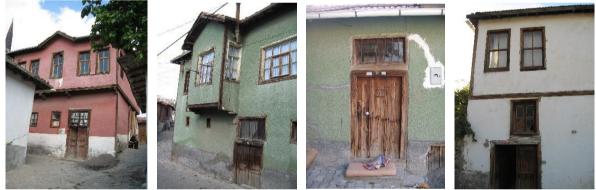
Figure 25. Examples of entrance door and top windows.

Doors that provided entrance from the street to the house were double doors. There were windows in the upper parts above the doors. There were iron railings on top of them. These windows illuminated the corridor (Fig. 25).

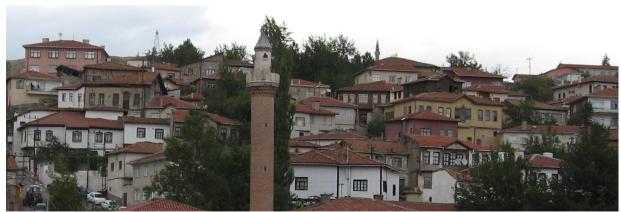
Figure 29. Roof views of Ayaş.

All the houses constructed in Ayaş in the traditional style had hipped roofs. The covering materials of these roofs, which were timber seating, was completely Turkish-style clay roofing tiles (Fig. 29). There were timber eave moldings on the ends of the roof eaves. In these houses, gables were used on the roof on facades, which looked at the road or which showed a front facade attribute.
