The Evaluation of Street Rehabilitation Project Processes in the Case of Isparta Üzüm Bazaar

Ayşe Betül GÖK¹, Duygu KURTOĞLU²

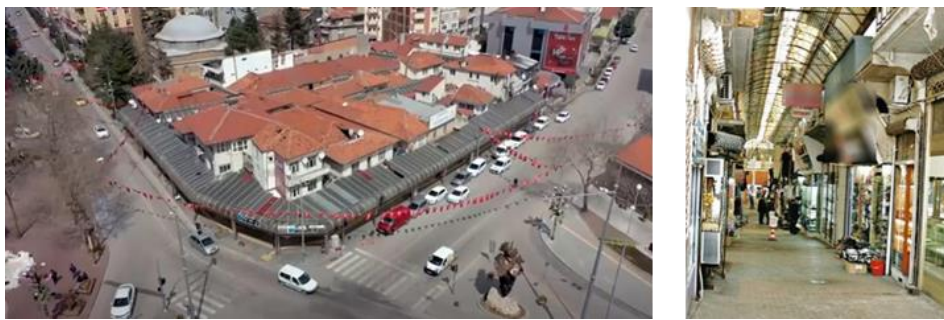
Figure 5. Images from the bazaar before the rehabilitation work (Kültür Portalı,2024)

The unregistered reinforced concrete structures are one, two, or three stories high, most of which have flat terrace roofs. The floor areas of these reinforced concrete buildings range from 2 m² to 50 m², while their facade widths vary between 60 cm and 5 m (Figure 5).

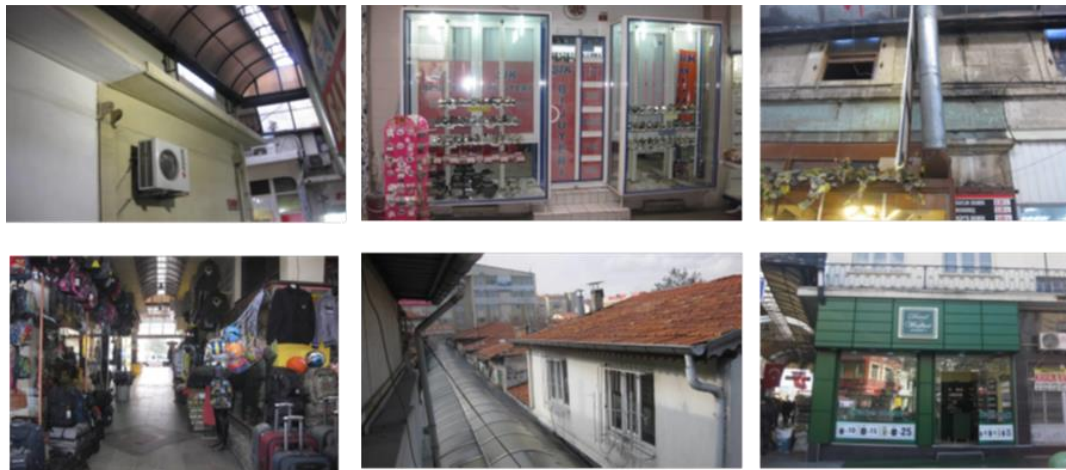
Figure 6. Factors that negatively affect visual perception in the bazaar before restoration (Çevrimli, 2017)

Before the implementation of the street rehabilitation project, the challenges facing Isparta Üzüm Bazaar were analyzed in relation to infrastructure, climate control, parcel dimensions, security, and visual perception-aesthetic considerations (Figure 6) (Çevrimli, 2017).

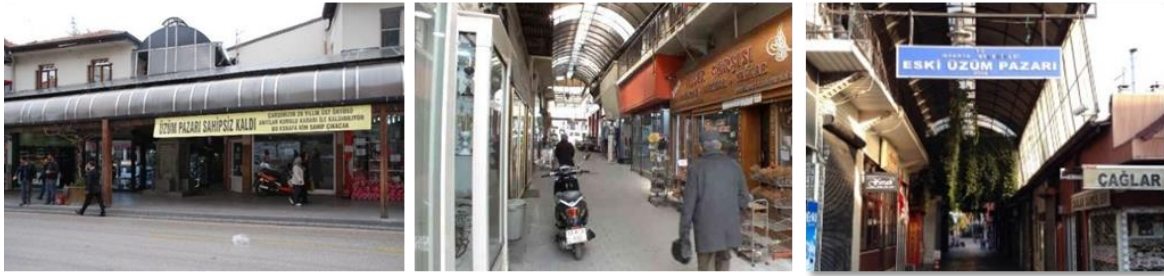
Figure 7. Top cover before the rehabilitation work

Within the scope of this project, the shop roofs were renovated, the street pavements were covered with andesite, and lighting fixtures were installed. However, the shopkeepers of the market reacted negatively to the removal of the covering system (Haber32, 2013) (Figure 7).

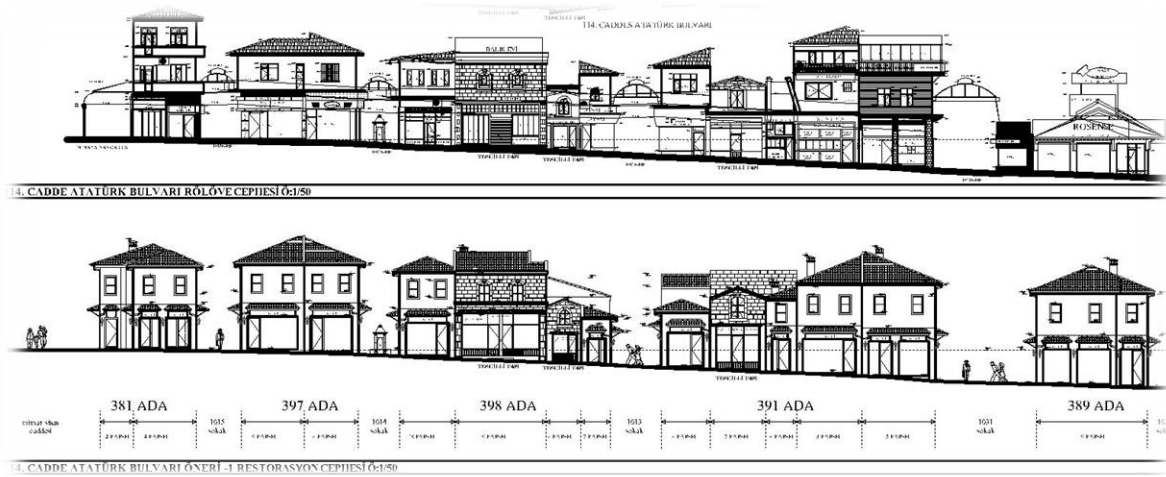
Figure 9. Üzümlü Bazaar Survey and Restoration Facade-Proposal 1 (Isparta Municipality Archive, 2020)

The project entailed the removal of the existing covering system. Andesite cladding was selected for the pavement, and rainwater drainage channels were integrated into the design. Given that the majority of the buildings in the bazaar consist of ground-level structures with a single upper floor (ground+1), all non-registered buildings (excluding basements) were converted to a ground+1 configuration to harmonize their heights. The facades of the registered buildings were restored in accordance with their original appearance. The designs of the unregistered (reinforced concrete) structures were addressed in a manner that referenced traditional architectural styles. Fixed-height signage spaces were allocated above the entrance doors of the unregistered buildings, with tile-covered eaves added above. Sash windows were incorporated on the upper floors. The roofs of all structures within the market were redesigned as gable or hip roofs. To enhance the facades, authentic wall-mounted appliques were installed (Figure 9).

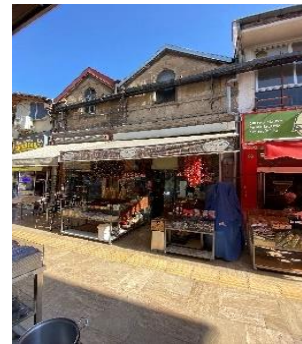
Figure 12. Block not included in the Isparta Üzüm Bazaar Street Rehabilitation Project

a. Structural change: The failure to restore Block 389 of it as part of the street rehabilitation project has negatively impacted the visual perception of the bazaar, particularly on 1031 Street (Figure 12).

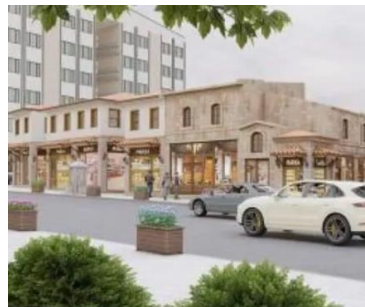
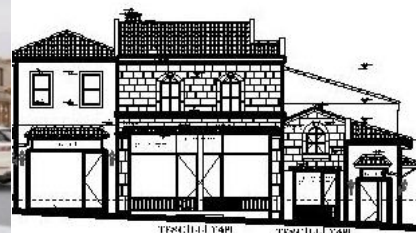
Figure 13. Roof applications that are not suitable for the project

It has been observed that the implementation of roof solutions for certain buildings deviated from the architectural plans and visuals prepared by the municipality. This discrepancy has prevented the standardization of building heights, thereby causing harm to the physical fabric of the bazaar (Figure 13).

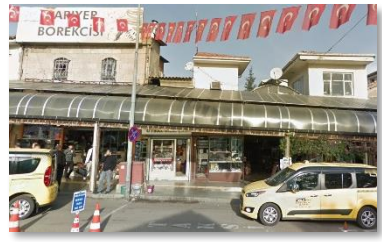
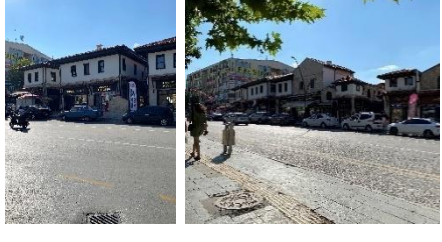
| | | Before Rehabilitation | After Rehabilitation |
|---|--|---|--|
| Equalization of building elevation heights | | | |

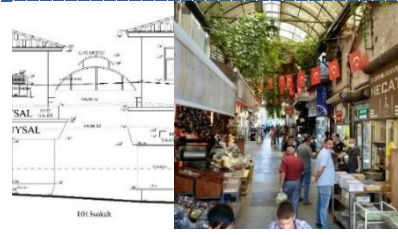
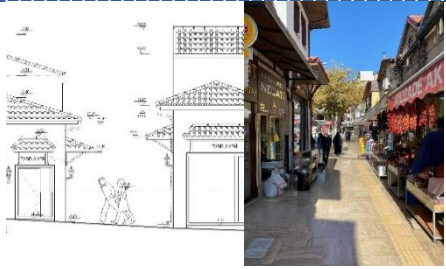
| | | Before Rehabilitation | After Rehabilitation |
|---|--|---|--|
| Increased visibility | | | |

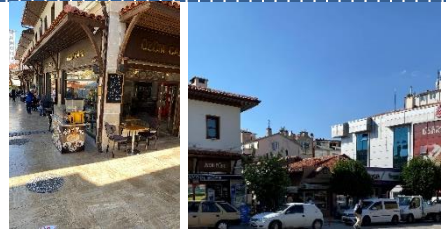
| | | Before Rehabilitation | After Rehabilitation |
|---|--|---|--|
| Unity in facade materials | | The different facades in unrestored buildings partially prevent the unity of materials. | |
