Interpretation of Visual Documents from 20th Century in Restitution of the Towers and Walls at the East Facade at the Inner Walls Area of Diyarbakir

The project of preservation for the area at the tower no. 73 and the one between the towers no. 73 and 75 at the Inner Walls of Diyarbakir was designed based on universal and national principles such as "preservation of structures without demolishing" (Resolution No. 660 of the Board of Preservation of Natural and Historical Heritage) and "A restoration must stop where conjecture begins" (Venice Charter).

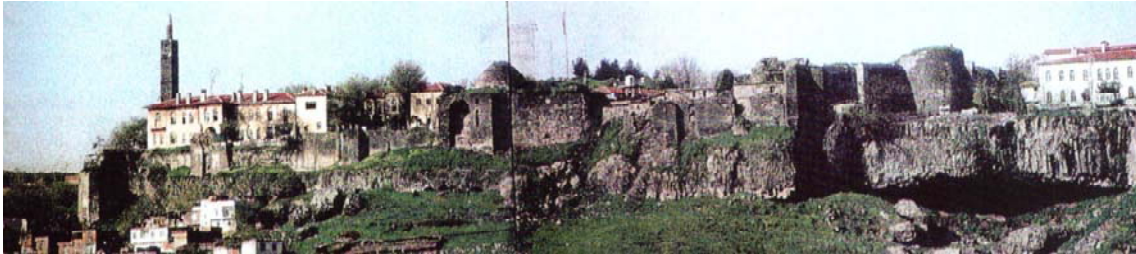
Picture 1. The Eastern Facade of The Inner Walls (Alper 2001)

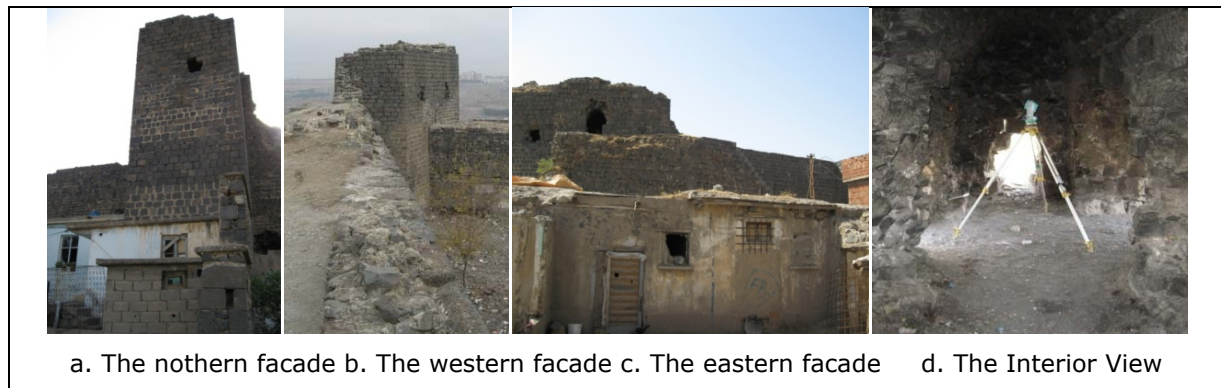
Picture 2. Tower number 73

Tower number 73 has a single storey and has got the measurements of 7.13x 2.10 m on the inside and 10.46x4.95 m on the outside. The access to the tower is through a stairway of 25 steps on the northern side (with the approximate height of 14m) from the recoil road which is now covered with earth, from an arched gateway. There is one vestibule window on the north and east side of the tower and two on the southern side. The tower is covered with a cradle vault and it stands robust despite the stones that fell from its ceiling and walls. The tower can be climbed through the stairway resting on the side of the tower on the northern side. The stones and the reinforced concrete that had been obtained from the wall of the citadel on the northern side had been used to

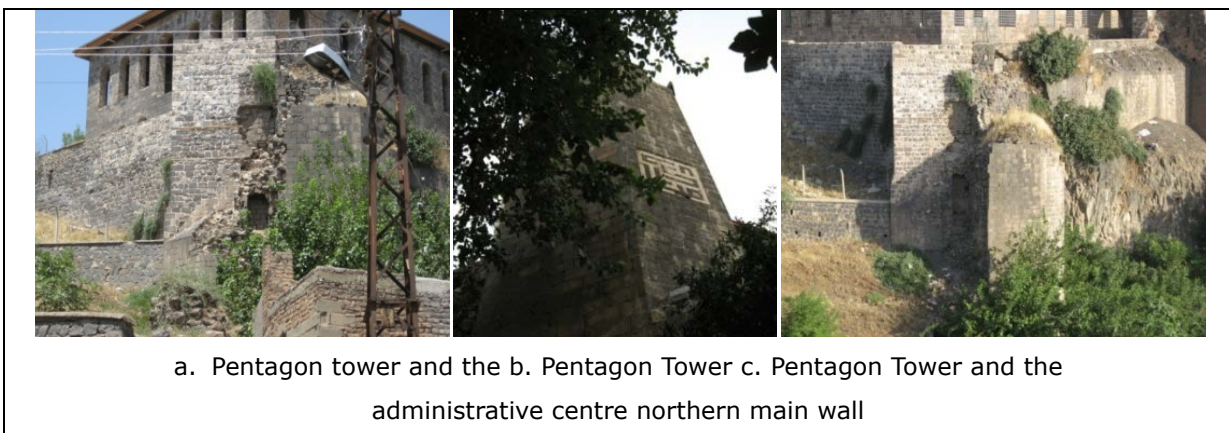
a pedestal with a triangular cut (bigger in comparison to a buttress and smaller in comparison to a tower). This pedestal that allows the water flow on legs of the bridge had been built in the form of a flood splitter and had been partially ruined (Picture 4).

The pentagon tower being the second of the strong support points is located to the north of the road connecting the Inner Citadel to the Tigris Valley and has a height of 11 m. The first wall of the Inner Citadel is Hz. Suleiman Mosque which is located on the continuation of the Lion Road. Although the top and bottom portions of the tower wall and main wall have been ruined its wholeness is preserved. There is a Ma'kili inscription on the tower (Parla, Tuncer 2016:139). The tower is the southern-most tip of the Inner Citadel and built out of properly cut stones without lap joints. This part leans over the Inner Citadel platform which is the administrative and military area.

Picture 4. The platform where the pentagon tower and the Inner Citadel leans against

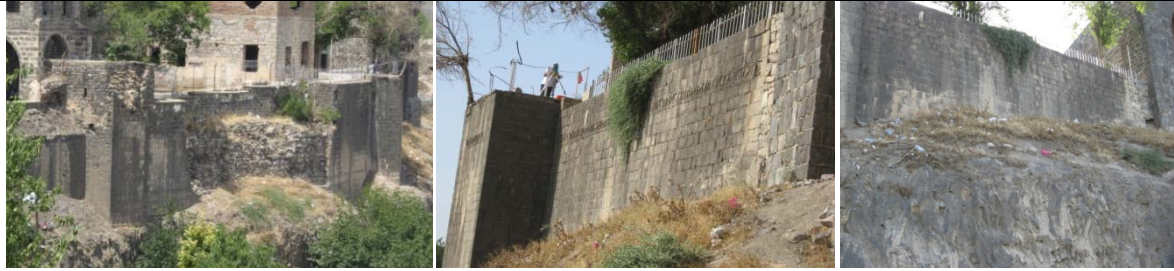
The tower has a square plan and has two cloister windows. There is an entombed saint inside the tower that has been sacralised by the local people. The main wall is located on the rocky terrain on different elevations on both sides of the tower. The main walls have been kept short on the spots where there is a precipice on the rocky terrain. In order to avoid its destruction the properly ordered main wall had been repaired using the fallen debris stones with mortar and thus the main wall has been re-enforced. On the continuation of the tower, on the main wall where the Marwani Inscription lies the stone pattern is robust and preserved other the destruction on the northern tip (Picture 5).

a. Visiting tower and the main wall b. Mervani inscription c. The southern wall adjacent to the church

Picture 5. Visiting tower and the eastern facade of the Inner Citadel

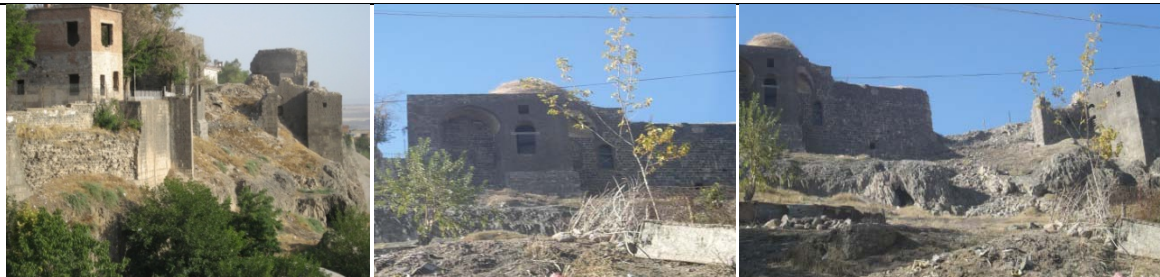
a. Viewing terrace and the excavation ground b. Saint George Church c. Saint George Church and the excavation ground

Picture 6. The main wall on the north and south of Saint George Church

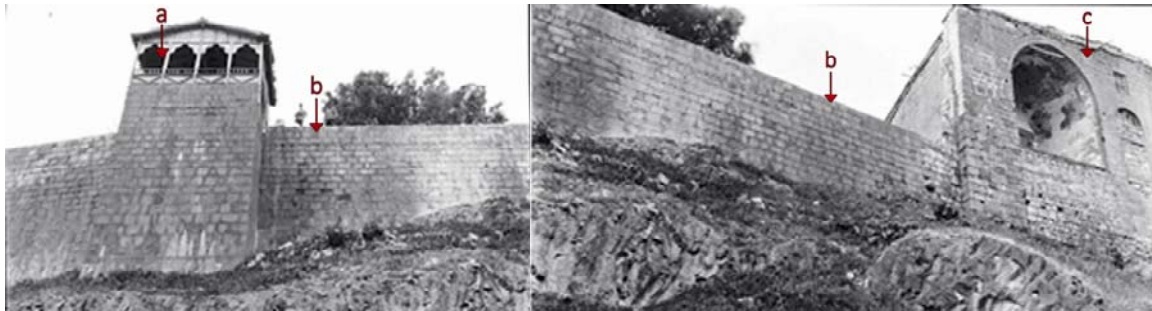
6. *Visual Material (GK6)*: This is the visual material taken in the year 1909 by Gertrude Bell from the viewing terrace where the Marwanian inscription is carved and from the wall as well (Bell 1909: picture number T 013, T014). The properly ordered freestone main wall (b) have reached to our day. The camellia on the viewing terrace built for the commandment of the garrison (a) has not reached to our day. On the church wall – on the arch that has been drawn inside (c) there is shedding on the plastered surfaces, and it is observed that the window gaps had been filled, and the original stone surfaces are in a proper order (Picture 13).

Picture 13. The eastern facade of the Inner Citadel and the Marwanian inscription and the tower number 74 (Bell 1911)

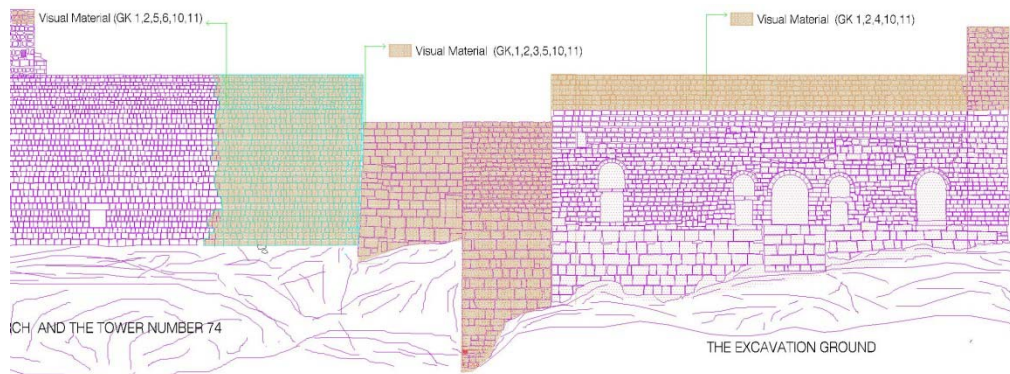
Figure 9.The restitution interpretation in accordance with the visual materials numbered 1, 2, 4, 6, 10, and 11 for the wall between the Saint George Church and tower number 75.
