Vertical Structural Irregularities in Earthquake Codes within the Scope of Architectural Design

Zeynep Yeşim İLERİSOY

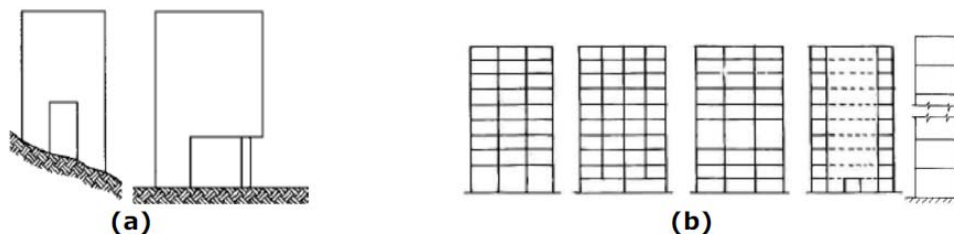
Figure 2. Images related to stiffness irregularity in the earthquake codes of (a) New Zealand, (b) India

In the light of the codes and standards examined, stiffness irregularities are defined according to the horizontal stiffness of the storeys by using the earthquake load design criteria of each seismic code. However, the ranges of the limit values are different. In the Turkish Earthquake Code, average storey drift ratio is used; in the codes of China, Iran, New Zealand, India and ASCE; the ratio of the horizontal stiffness of a floor to the stiffness of the adjacent floor is defined as stiffness irregularity. Also, a detailed classification is made as severe, significant and insignificant, according to the value of the stiffness ratio in the New Zealand code. However, the Mexican code and Eurocode-8 do not give a definition of this significant irregularity. In terms of addressing the architects; only New Zealand and India codes contains explanatory images that increase the levels of perception and providing interactive learning opportunities (Figure 2).

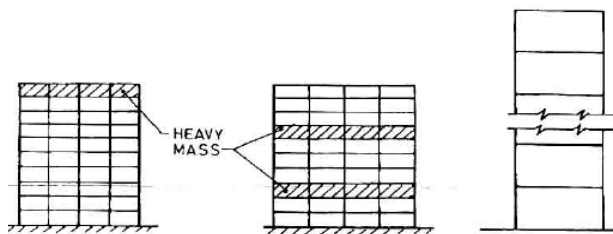
Figure 3. Images related to Mass irregularity in the India earthquake code

It was emphasized that if the mass distributions of the floors are not equal this irregularity would occur but the accepted limit values are different for each earthquake code. The difference of mass between floors is taken as; 50% in the Iranian code, 70% in the Mexican code, 150% in the ASCE code and 200% in the Indian code. The Eurocode-8 regulation mentioned that the sudden changes in mass between the floors should be avoided but do not provide a numerical limitation. The New Zealand code classifies the situation that mass of a floor exceeding the mass of the neighboring floor as severe, significant and insignificant. However, in Turkey Building Seismic Code (TBDY-2018) and China code, there is no definition regarding this type of irregularity. In terms of the components, Explanatory images that may assist in understanding the given definitions by visualizing are presented only in New Zealand and India regulations (Figure 3).

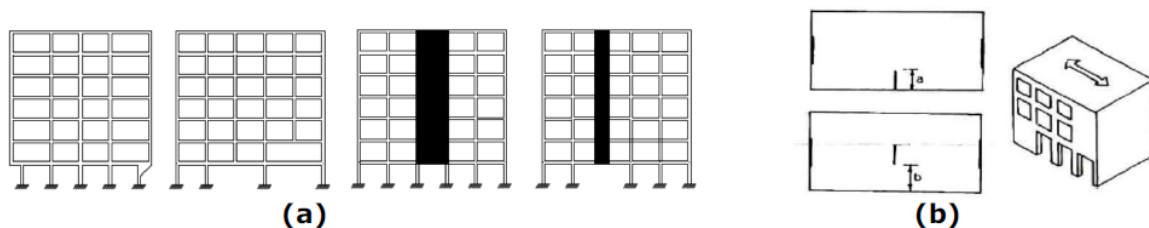
Figure 4. Images related to Vertical force-resisting elements irregularity in the earthquake codes of (a) Turkey, (b) India

In the definitions of vertical force-resisting elements irregularity in the regulations and standards examined; the standards of Turkey, China and Eurocode-8 mentions that the vertical elements of the structural system must be continuous, and it is presented some restrictions about vertical discontinuities in the Turkey Building Seismic Code (TBDY-2018) in detail. The code of India emphasize that this type of irregularity emerges for the situation that when the change of position of the vertical members according to the adjacent storeys is larger than the length of the member and ASCE/SEI 7/10 states that this type of irregularity causes overturning forces on the other structural members. In Iran and New Zealand regulations, there are no such restrictions about mentioned irregularity. In terms of transfer the knowledge of this irregularity to the architects efficiently; explanatory visuals are reached only in the TBDY-2018 and India regulations. (Figure4)

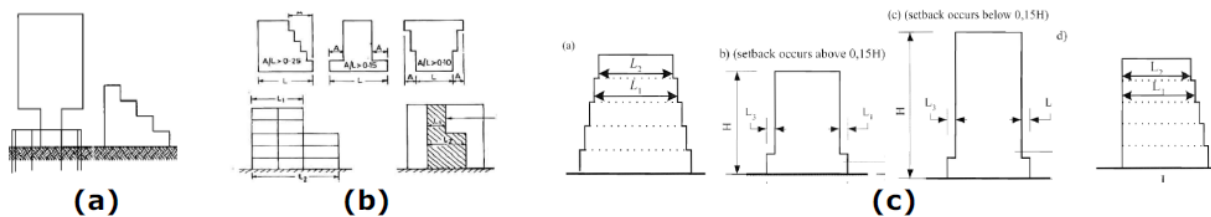
Figure 5. Images related to Vertical geometry irregularity in the earthquake codes of (a) New Zealand, (b) India and (c) Eurocode-8

limiting ratios both in the horizontal and the vertical geometry of the building. To make it more clear, Eurocode-8 states such criteria that differ according the axial symmetry such that recess and the changing of setbacks should be within the lower 15% of the total height of the structure. In the New Zealand code, this irregularity is classified as severe, significant and insignificant according to the stiffness/strength ratio of lateral force resisting members. On the other hand, Turkey, Iran and Mexico seismic codes impose no restriction or identification of this type of geometrical irregularity. Descriptive images of this irregularity, which have the most visuals compared to other irregularities, were obtained in New Zealand, India and Eurocode-8 regulations (Figure 5).

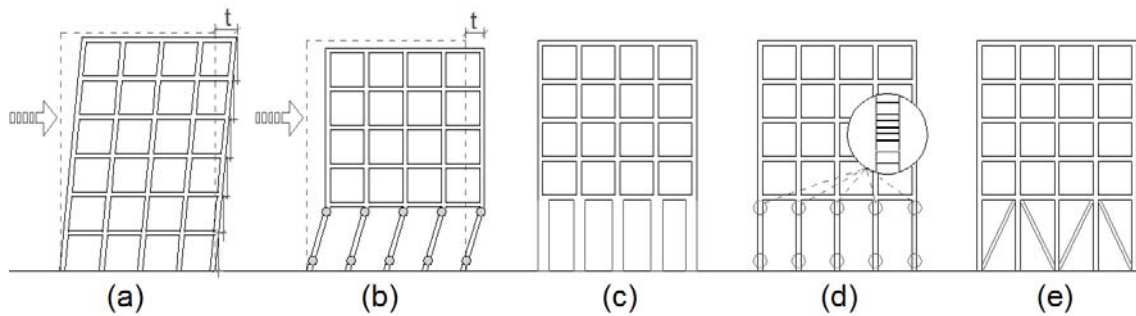
- Stiffness irregularity (Soft story) causing from the sudden reduction of storey stiffness with respect to adjacent storeys; is a significant irregularity heading among the eight codes with the exception of Mexico and Eurocode-8 codes. As a result of this irregularity; the total displacement occurring under the influence of the earthquake forces in the structure is not shared between the floors and hence the floors having less rigidity experience larger displacements (İnan& Korkmaz, 2012). Therefore, non-elastic displacements occur on the structural elements which cause the formation of plastic hinges on the vertical elements which are difficult to repair. (Figure 6a,6b) The most basic solution for avoiding this irregularity in which the earthquake energy is concentrated on a single floor with the effect of the lateral earthquake loads; is to ensure that the occurrence of plastic hinges is transposed on beams instead of columns when excessive displacements occur during earthquakes. In this respect, increasing the cross-sections of the vertical structural elements at the floor with soft floor irregularity (Figure 6c), or providing these elements more closely located stirrups (Figure 6d). Furthermore, additional vertical bearing elements or bracings can prevent this irregularity (Figure 6e) (Dowric, 1987; İnan& Korkmaz, 2012). The visual expression technique, which is considered to be an effective way for the perception of this irregularity, especially for the discipline of architecture, has been found only in New Zealand and India codes. However, for this irregularity, more understandable information transfer will be provided by the drawings as in Figure 6 that expresses both the type of damage and the solution suggestions.

Figure 6. Explanatory figures for stiffness irregularity suggested in this study

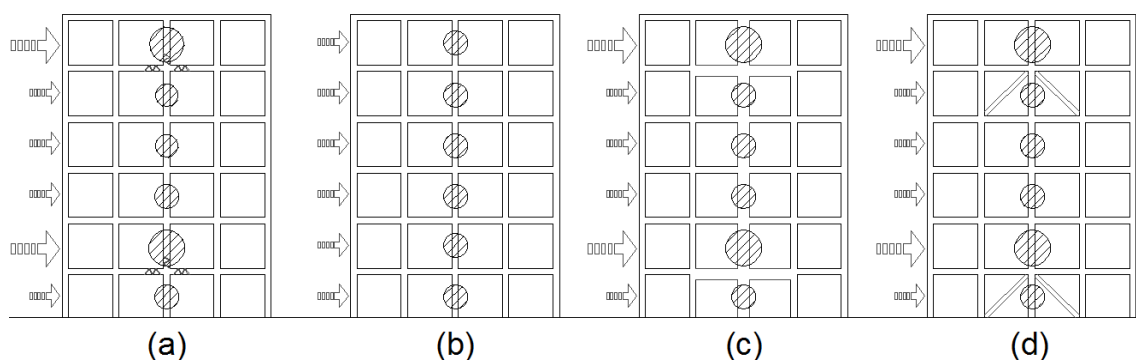
- Heavy masses which are added to the structure for architectural or technical reasons cause the lateral forces to increase. This situation causes excessive loads during the earthquakes on the beams and columns near the heavy masses and hence increases the damage risk of the system at an earthquake. As a result of moving away from the principle of minimizing the structure mass and its homogenous distribution, mass irregularity emerges. The basic precautions that can be taken against for this irregularity dealt with in six earthquake codes, except ones for the China and Turkey are; to provide a homogeneous mass distribution during the design phase (Figure 7b), expanding the cross-sections of the load-bearing elements (Figure 7c) or additional load-bearing elements (columns, shear walls, bracings) (Figure 7d). In this regard, the explanatory visuals are given only in the Indian seismic code in terms of supporting the subject with visual expression techniques. However, with the drawings as in Figure 7, it will draw attention to this irregularity and the precautions to be taken during the design phase.

Figure 7. Explanatory figures for mass irregularity suggested in this study

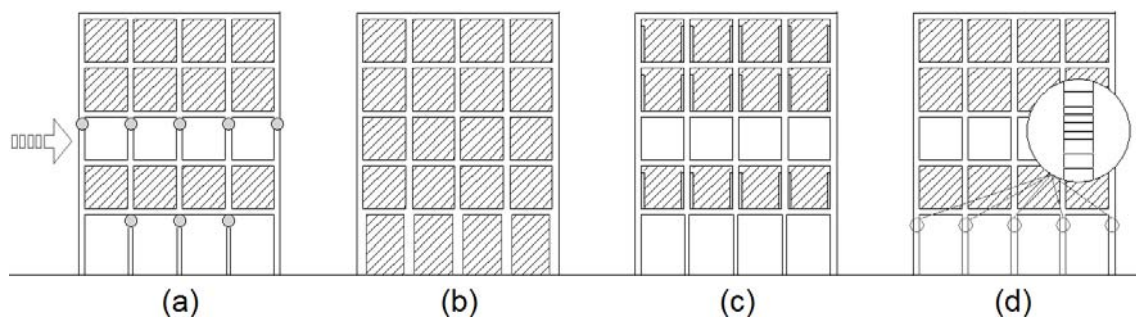
the vertical load bearing elements in meeting the increasing forces as moving down to the ground floors, the use of the drawings as illustrated in Figure 8 will provide great convenience. Precautions to be taken to prevent this irregularity, in addition to the measures mentioned in the stiffness irregularities (Figure 6) are; using the same wall materials on all floors with the same configuration (Figure 8b) or in all floors, by isolating the walls from the columns and beams making the frame independent from the walls (Figure 8c) (Guevara-Perez, 2012). Moreover, the rearrangement of the reinforcements of all columns and shear walls on the floors where this irregularity is present will also increase the horizontal load strengths (Figure 8d).

Figure 8. Explanatory figures for strength irregularity suggested in this study

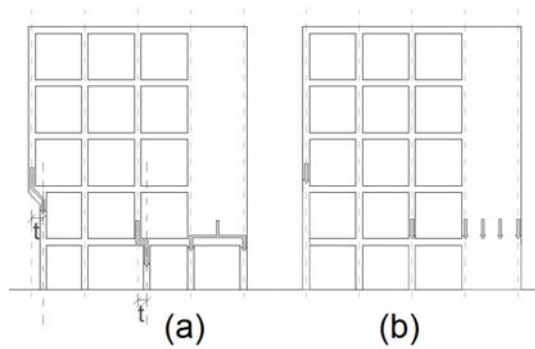
- Six of the reviewed earthquake codes (Turkey, China, Mexico, India, Eurocode-8 and ASCE/ SEI 7/10) among the total of eight include definitions and limitations related to the discontinuity of the vertical load-bearing members (Figure 9a) causing from the axial misalignment due to architectural or technical reasons during sizing or configuration of these members. The basic solution of this irregularity is the continuation of the forces acting on the structure without interruption and / or sudden reduction during the transmission to the ground (Figure 9b) (Dražić&Vatin, 2016). By designing the load bearing system in a regular and continuous manner, the load capacity and number of plastic hinges will be increased and the energy dissipating part of the structure will grow beyond the limit of elastic behavior during an earthquake (Öğütçü, 2016). This issue, which directly affects the building behavior in the face of the earthquake, needs to be meticulously handled during the architectural design phase. However, only two of the six codes (Turkey and India) contain images for explaining this irregularity to the architects. However, a drawing as in Figure 9 which embodies the technical description will provide an effective benefit to the perception of this irregularity.

Figure 9. Explanatory figures for vertical lateral force-resisting elements irregularity suggested in this study

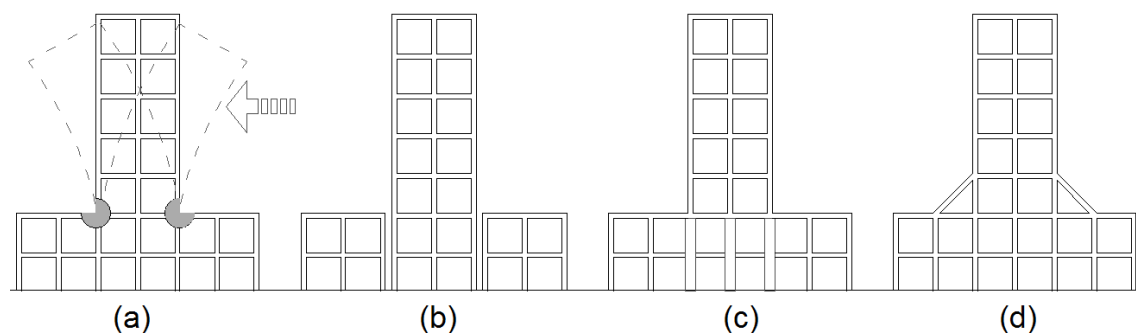
- Vertical geometry irregularity formed by changing the building boundaries throughout the building height; is the least mentioned structural irregularity among the eight examined codes. However, setbacks and offset along the height of the structure form are common practice. It should not be forgotten that there will be a stiffness change between the upper and the lower floors where the geometric difference occurs (Guevara-Perez, 2008). The best precaution to avoid this irregularity when moving from a large mass to a small mass (i) is separating the masses at a sufficient distance from each other (Figure 10b). With the dilatation, which is defined as the space separating the structural system between the building units, it is prevented negative impact of masses on each other that have different dynamic behavior characteristics and also unexpected damage as a result of collision. If dilatation cannot be made, stress accumulations arising from the formation of setbacks or offsets (Figure 10a) should be prevented. In this regard, to use larger vertical load bearing elements which provide more rigidity to the structure against torsion and separation behavior at the joining corners (Figure 10c), or provide smoother transitions rather than right angles at the joint corners (Figure 10d) are other solutions.

Figure 10. Explanatory figures for vertical geometry irregularity suggested in the study

This irregularity, which complicates the behavior of the structure against the earthquake forces, is the topic supported by the highest number of visuals, although the coverage is least included in the codes. As an alternative to the illustrative drawings in New Zealand, India and Eurocode regulations, a more comprehensible information transfer related to this irregularity will be provided with the drawings as in Figure 10.
