Spatial Analysis of Traditional Ayvalık Houses

Serpil Özker

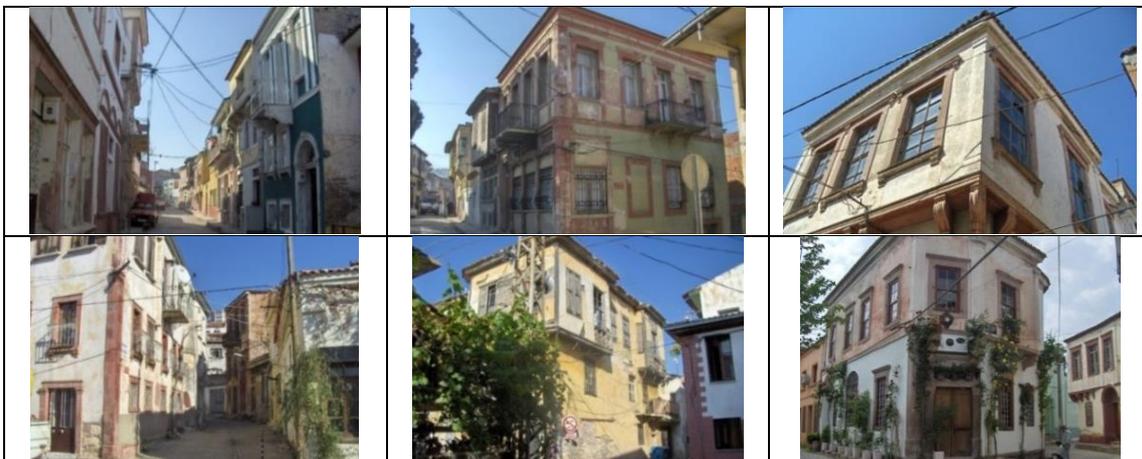
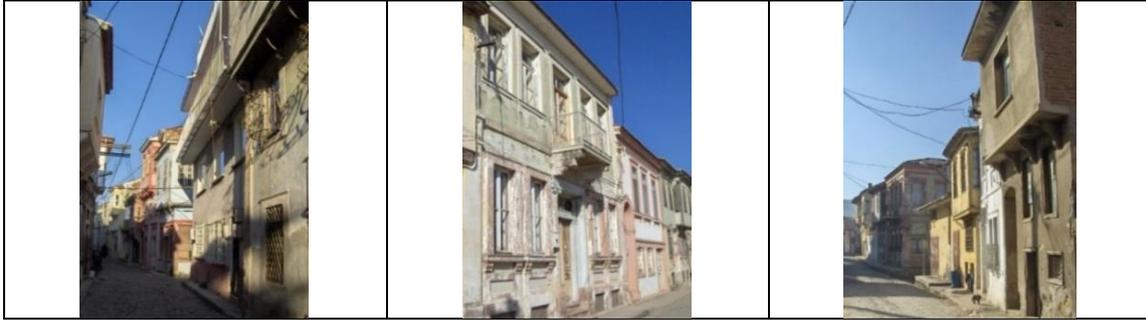
Figure 4-12. Ayvalık Houses

Ayvalık (Figures 4-12), which has houses deemed to be within the traditional residential architecture, is like an open air museum rich in historical urban textures. In this respect, approximately one thousand traditional houses dating back to the 19th and 20th centuries are protected and usable (Işık, Teker, 2019). The city texture formed by Neoclassical civil architecture examples increases the cultural heritage and tourism demand of the region across the district center of Ayvalık and nearby Cunda Island; there are around 1800 registered historical buildings in these regions called "old city" (Gökdeniz, 2015). Neoclassical understanding is the general character of European architecture where there is no eclectic understanding consisting of reflection of styles such as Neo-Greek and Neo-Gothic in architecture (Erpi, 1987). Neoclassical understanding forms the eclectic understanding consisting of the reflection of styles such as Neo-Greek and Neo-Gothic and it is the general character of European architecture, where no particular style exists (Erpi, 1987). Traditional Ayvalık houses are shaped by the influence of Neoclassical style with their ethnic cultural structures, doors, door knockers, facade layouts. In this sense, Traditional Ayvalık houses are clearly distinguished from other traditional buildings with their "space, facade and construction" features as a result of their historical and cultural textures. Accordingly, the "space, facade and construction" features that determine the characteristic structure of the Ayvalık houses that emerged as a result of the literature studies are as follows:

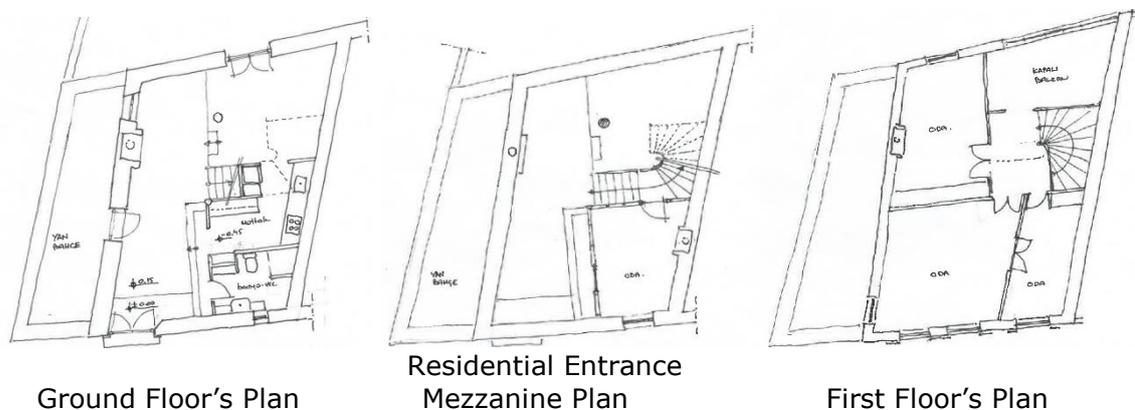
Figures 13-14-15 House 1 - Floor Plans

The first house (hereinafter referred to as "House 1") evaluated within the scope of the study was built in 1871 as a masonry structure in Ismet Pasa neighborhood. The building has 2.5 floors including ground, mezzanine and first floor. On the side of the building, there is a 150 cm wide side courtyard surrounded by a high wall (Figures 13-14-15). The spatial analysis of the structure is as follows:

House 1 is on a square-shaped parcel, one of its facades facing the street while another facade adjacent to the neighboring building and surrounded by high-walled side courtyard and backyard. The entrance door of the house opens directly to the hall; it has an L-shaped hall. When the building was first built, there was a toilet in the side courtyard, but in the new planning, the toilet was located on the ground floor. The building, which has 2.5 floors in neoclassical style, has a double-winged door opening to the street. On the ground floor, there is a kitchen, living room and bathroom/WC. On the mezzanine, there is a sleeping area and on the first floor, there are sleeping areas and a balcony. The bathroom/WC and kitchen are on the ground floor and sleeping area on the mezzanine and living area have been added to the building after renovation works.

House 1 has three facades, one facing the street, one facing the garden/sea and one facing the garden. The door of the house which can be reached with a stairs tread is one of the important symbols of traditional architecture of Ayvalık houses. The doors, joinery and knockers of the building retain their original features. On the cast iron of the high wooden door is written "1871", which specifies the year when the house was constructed. The windows are wide, rectangular, with wooden shutters and wide jambs. The original wooden shutters of the windows on some facades have been replaced with metal. There are lime-plastered original decorations on the front of the building.

House 1 is made of 50-60 cm thick walls on rubble stone foundation. Rubble stones are used on the exterior walls while cut stones are used on the walls corners. Wooden beams and wood covers are used on floors and ceilings and partition walls are made of wood with plasterboard. The windows are flat, brick arched or wide rectangular, while balconies are made of metal or stone console. Stone is generally used on the facades of the building (Erdem et al., 2007). Most of the original structures also have lime plaster on the stone. The interior of the first floor is lime plastered on brick, but the lime plaster that deteriorated during renovation has been replaced with cement based plaster. The lime plaster, which deteriorated over time, was renewed with cement plaster, and the original plaster of interior of the upper floor has been preserved. The windows are rectangular-shaped with brick arch.

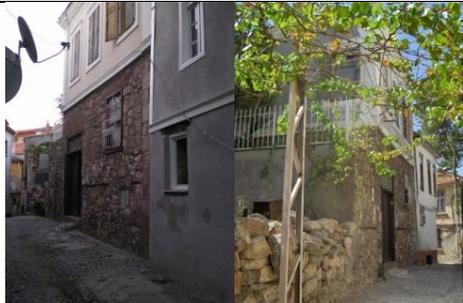
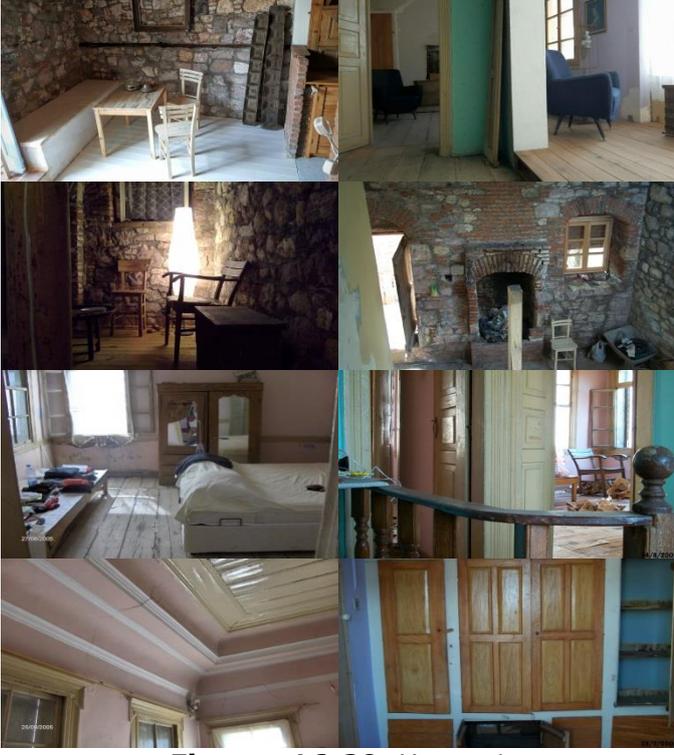
Figures 16-29. House 1

Considering the "space, facade and construction" features of House 1, it is seen that it partially preserves its original texture (Table 1). Within the scope of renovation, partial renovations were made without damaging the original texture of the building.

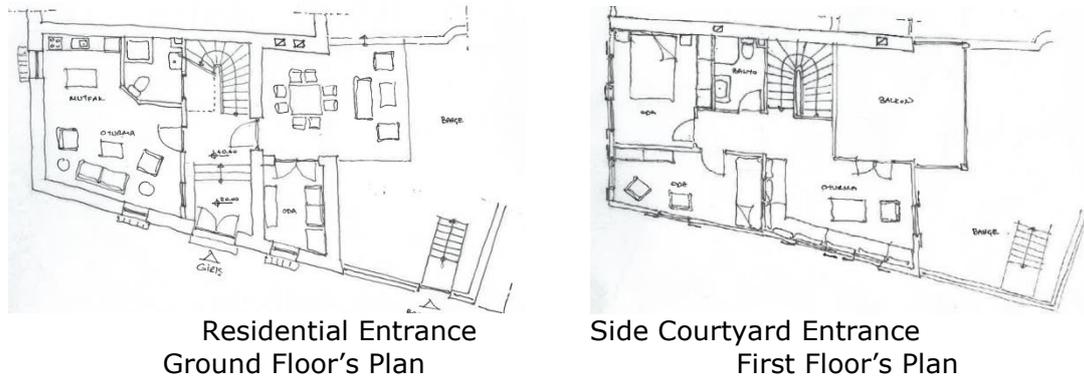
Figures 30-31. House 2-Floors' Plans

The building has 2 floors including ground and first floor. On the side of the building, there is a courtyard as large as two houses surrounded by a high wall (Figures 30-31). The spatial analysis of the structure is as follows:

House 2 is on a rectangle-shaped parcel, one of its facades facing the street while another facade adjacent to the neighboring building and surrounded by high-walled side courtyard. The entrance door of the house opens directly to the hall; it has an L-shaped hall. The building, which has two floors in the neoclassical style, has a door opening to the street. On the ground floor there is a kitchen, living room and bathroom/WC. On the first floor, there are sleeping, living areas, bathroom/WC and also a balcony. The bathroom/WC were originally in the side courtyard; however, a new bathroom/WC were built inside the house after renovations. House 2 also has an entrance door connecting the street and the garden. The courtyard door opens to the stairs and the backyard is reached through the stairs.

House 2 has three facades, two facing the street and one facing the garden/sea. The door of the house which can be reached with a stairs tread is one of the important symbols of traditional architecture of Ayvalik houses. The doors, joinery and knockers of the building retain their original features. The windows are wide and rectangular with wooden shutters. The building's balcony overlooking the side courtyard was renewed and expanded without any resemblance to the original balcony. Although there are no original lime plastered decorations on the facade of the building, it has been observed that renovations were made on both the front facade and side facade without adhering to the original structure.

The House 2 is made of 50-60 cm thick walls on rubble stone foundation. Rubble stones are used on the exterior walls while cut stones are used on the walls corners. Wooden beams and wood covers are used on floors and ceilings partition walls are made of wood with plasterboard. The windows are rectangular and supported by a wooden beam. The exterior and interior facades were replenished with cement plaster instead of lime plaster which deteriorated over time. The outer facade of the building has not been able to preserve its original texture.

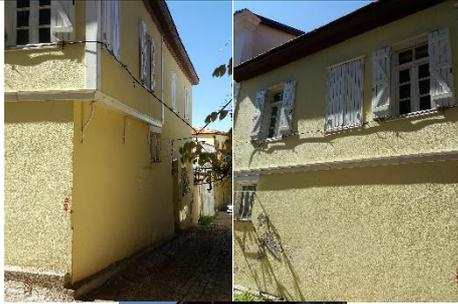
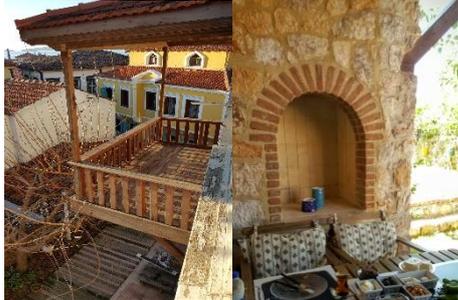
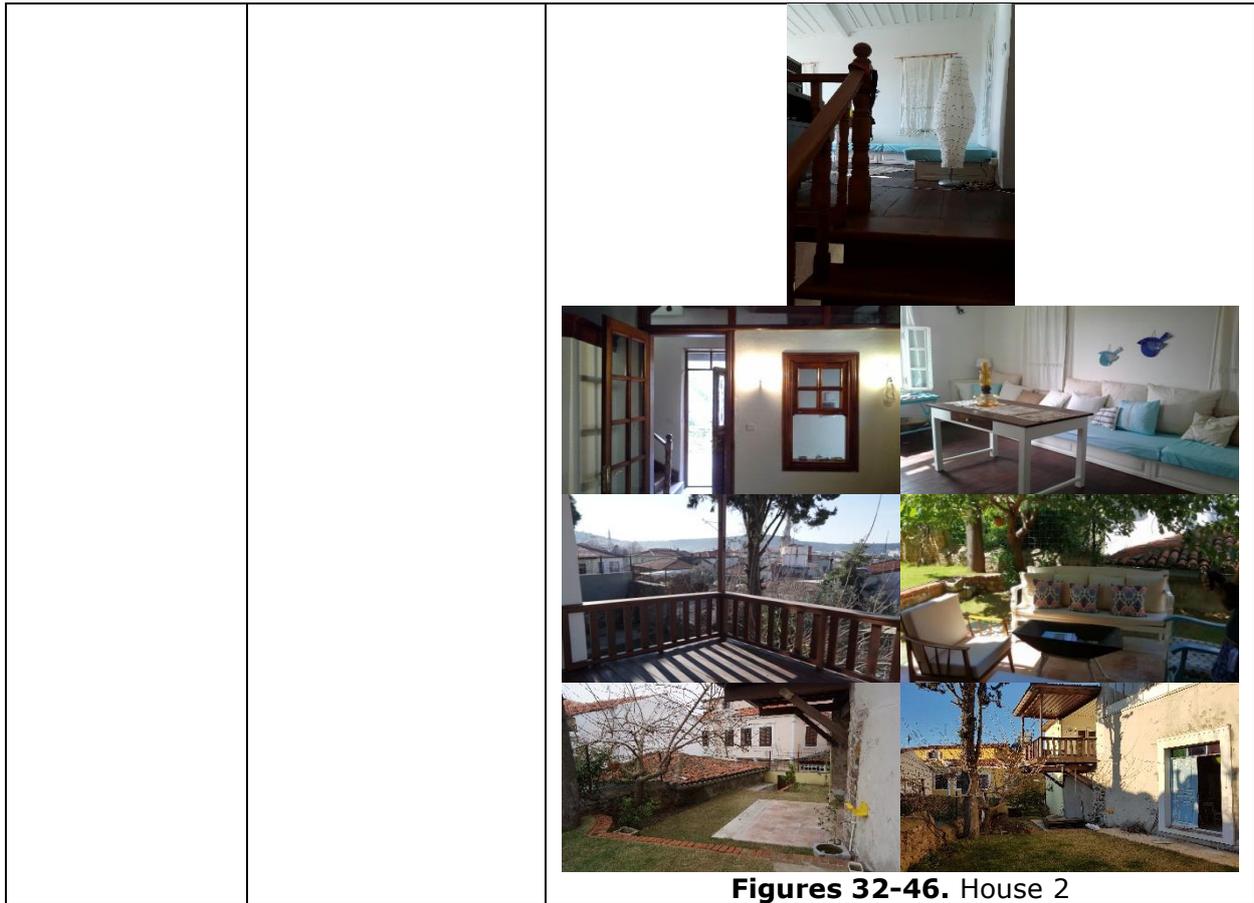
Figures 32-46. House 2

Considering the "space, facade and construction" features of House 2, it is seen that there are some deformations in the original texture of the building (Table 2). Within the scope of renovation, partial renovations were made without damaging the original texture of the building.

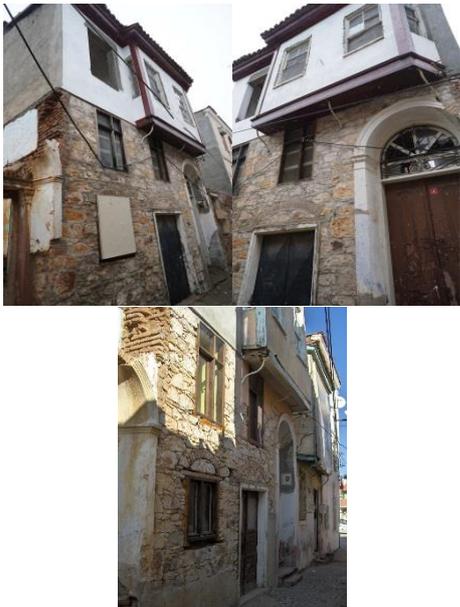
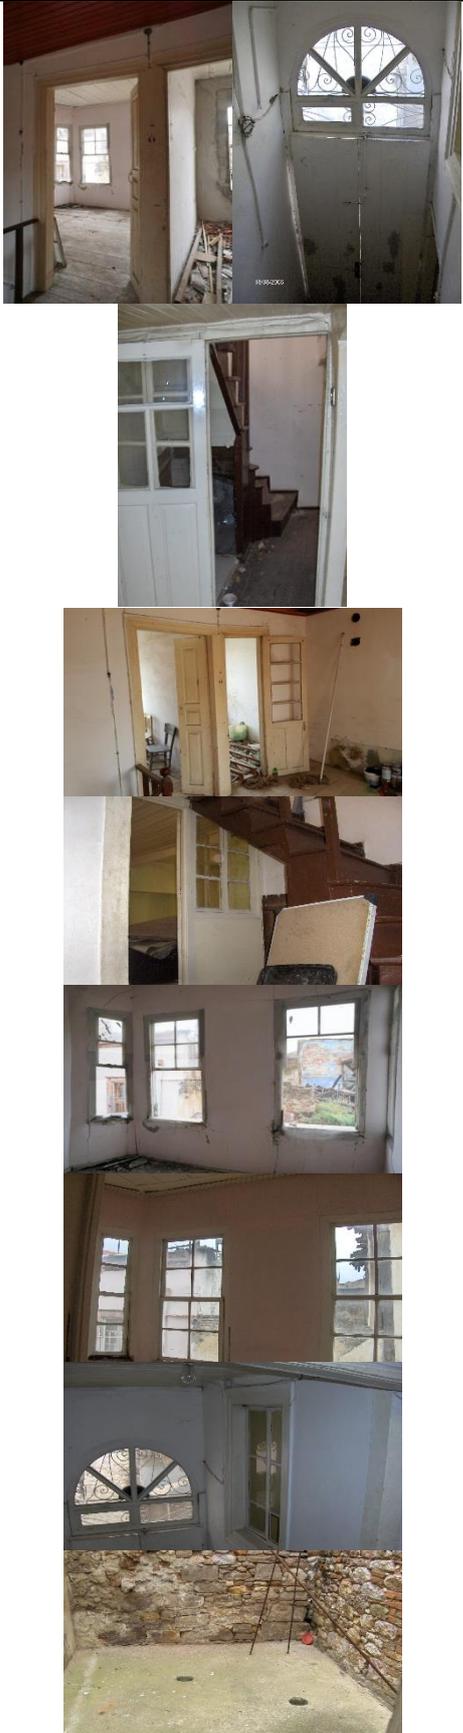
Warehouse Entrance Residential Entrance
Figures 47-48-49. House 3-Floors' Plans

The third house (hereinafter referred to as "House 3") evaluated within the scope of the study was built in 1905 as a masonry structure in Hayrettin Paşa neighborhood. The building has 3 floors including ground, first and second floor. At the back of the building, there is a backyard surrounded by a high wall (Figures 47-48-49). The spatial analysis of the structure is as follows:

House 3 is on a rectangular parcel with its two façades adjacent to the neighboring building and surrounded by high-walled backyard. The building, which has 3 floors, is built in a Neoclassical style. The entrance door of the house opens directly to the staircase, on the left side of the door entrance there is a store/shop door that is entered from inside the house. As well as the house's entrance door, there is a store/shop door

entrance. The area called store/shop was used as a warehouse. On the first floor of the house, there is a kitchen, living area and bathroom/WC. The central hall is on the second floor and there is a passage to two sleeping areas through the hall. The second floor also has a balcony at the back. There is a central hall type plan in the 1st and 2nd floors.

House 3 has two facades, one facing the street and the other facing rear-adjacent structure. Its front facade is asymmetrical. The door of the house which can be reached with three stairs treads is one of the important symbols of traditional architecture of Ayvalık houses. The door is double-winged, wood and quite high. There was originally wrought iron on the door with the date of the construction on it; however, it has been stolen by the thieves. The doors, joinery and knockers of the building retain their original features. The windows are large, rectangular and woodwork; the original wooden shutters of the building are not present.

The House 3 is made of 50-60 cm thick walls on rubble stone foundation. Rubble stones are used on the exterior walls while cut stones are used on the walls corners. Wooden beams and wood covers are used on floors and ceilings and the partition walls are made of wood with plasterboard. The windows are rectangular and supported by a wood lintel. The exterior facades were replaced with cement plaster instead of lime plaster which deteriorated over time. The exterior and interior facade of the building partially preserves their original texture.

Considering the space, facade and construction" features of House 3, it is observed that the original texture of the building is preserved but there is a certain level of degradation as no restoration was made (Table 3). It is seen that the original texture of the exterior of the building is preserved; however, its original texture of the interior has seen partial degradation as the required renovation was not made.

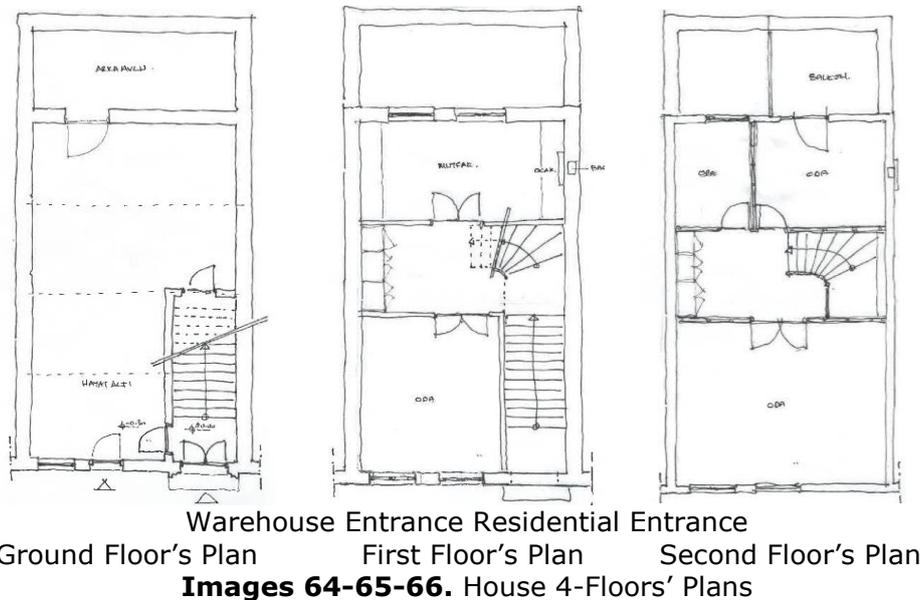
The fourth house (hereinafter referred to as "House 4") evaluated within the scope of the study was built in 1891 as a masonry structure in Hayrettin Paşa neighborhood. The building has 3 floors including ground, first and second floor. On the back of the building, there is a backyard, surrounded by a high wall. (Images 64-65-66). The spatial analysis of the structure is as follows:

House 4 is on a rectangular parcel with its two façades adjacent to the neighboring building and surrounded by high-walled backyard. The building, which has 3 floors, is built in a neoclassical style. The entrance door of the house opens directly to the staircase, on the left side of the door entrance there is a store/shop warehouse door. As well as the house's entrance door, there is a store/shop door entrance. The area called store/shop was used as a warehouse. Adhering to its original texture, the WC is in the backyard. One can pass directly to the central hall from the first floor and also from the hall to the kitchen and living room. There is another hall on the second floor and there is a passage from this hall to three sleeping areas. There is also a balcony in the sleeping area at the back. There is a central hall type plan in the 1st and 2nd floors.

House 4 has two facades, one facing the street and the other facing rear-adjacent structure. Its front facade is asymmetrical. The door of the house which can be reached with two stairs treads is one of the important symbols of traditional architecture of Ayvalik houses. The main entrance door and the warehouse entrance door of the building

The House 4 is made of 50-60 cm thick walls on rubble stone foundation. Rubble stones are used on the exterior walls while cut stones are used on the walls corners. Wooden beams and wood covers are used on floors and ceilings and the partition walls are made of wood with plasterboard and the windows are made of rectangular wooden lintel. The exterior facades were replaced with cement plaster instead of lime plaster which deteriorated over time. The exterior and interior facades of the building do not preserve their original textures and no restoration was made. Considering the "space, facade and construction" features of House 4, it is observed that the original texture of the building is not preserved; ever time it changed hands, it was subjected to different restoration methods and materials. And as it has seen no restoration in recent years, there is some degradation (Table 4). The building needs to be renewed, adhering to its original texture.

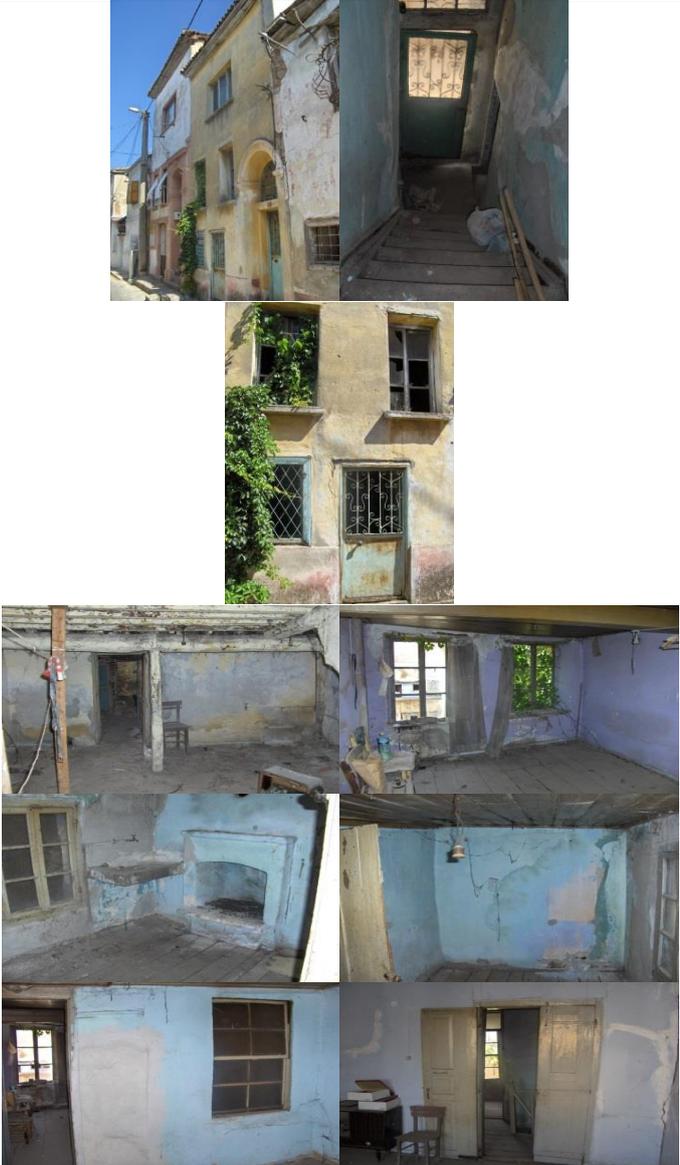
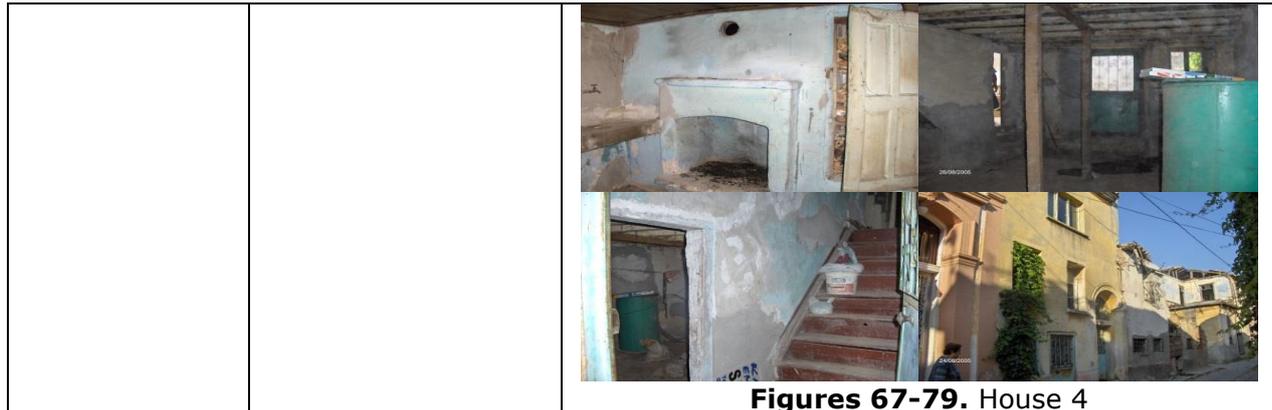
Figures 67-79. House 4

have been renewed as an iron door. The doors, joinery and knockers of the building retain their original features. The windows are rectangular and woodwork but poorly-maintained; the original wooden shutters of the building are not present.
