A Study on Restoration of Ayaş Şeyh Muhittin Mosque which is an Example of Ankara Traditional Mosque Architecture

Filiz KARAKUŞ *

In this study, Şeyh Muhittin Mosque in Ayas district of Ankara is examined in terms of traditional architectural features and the restoration carried out by Ankara Regional Directorate of Foundations in 2018-2019 are discussed. The mosque, which is owned by the General Directorate of Foundations and has no construction inscription, dates back to the 16th century. The mosque has no last congregation space and has a transverse rectangular plan. The walls of the mosque are rubble stone up to the basin level and the walls of the body are built with masonry technique with wooden beams and mud-brick. Traditional materials such as rubble, mudbrick and wood are used extensively in the structure. In the interior of the mosque, wood is used in building elements such as wooden posts and beams of women section, minbar, floor and ceiling coverings. The plaster mihrab has the characteristics of 18th century traditional Ankara mosques. Seyh Muhittin Mosque was examined in terms of traditional architecture and art history, and the data obtained during the last restora

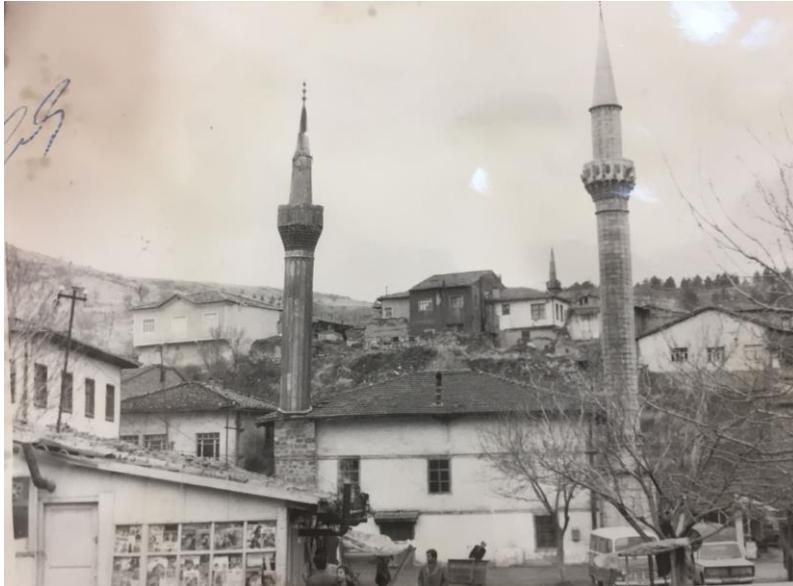
Figure 3. Ayas Seyh Muhittin Mosque wooden and reinforced concrete minaret [9]

The mosque measures approximately 13.20x10x20 m and it has a 2.84 m wide women's section floor and under this floor there is Seyh Muhiddin's sarcophagus. The old minaret in the northeast corner of the mosque has been destroyed and only its base has survived. After the collapse of this minaret, a wooden minaret was built on the stone base. In 1968, a stone imitation reinforced concrete minaret was built on the northwest corner of the mosque. After these two minarets were used together for a while (Figure 3), in accordance with the report prepared by the General Directorate of Foundations, it was decided to demolish the wooden minaret by the decision of the Supreme Council of Immovable Cultural and Natural Assets dated 28.3.1985 and numbered 847 [7]. The original minaret on this stone base is thought to be brick like the other examples in the district (Ulu Mosque and Bünyamin Mosque). Since the information and documents related to this original minaret could not be provided, no changes were made in this direction during the restoration works.

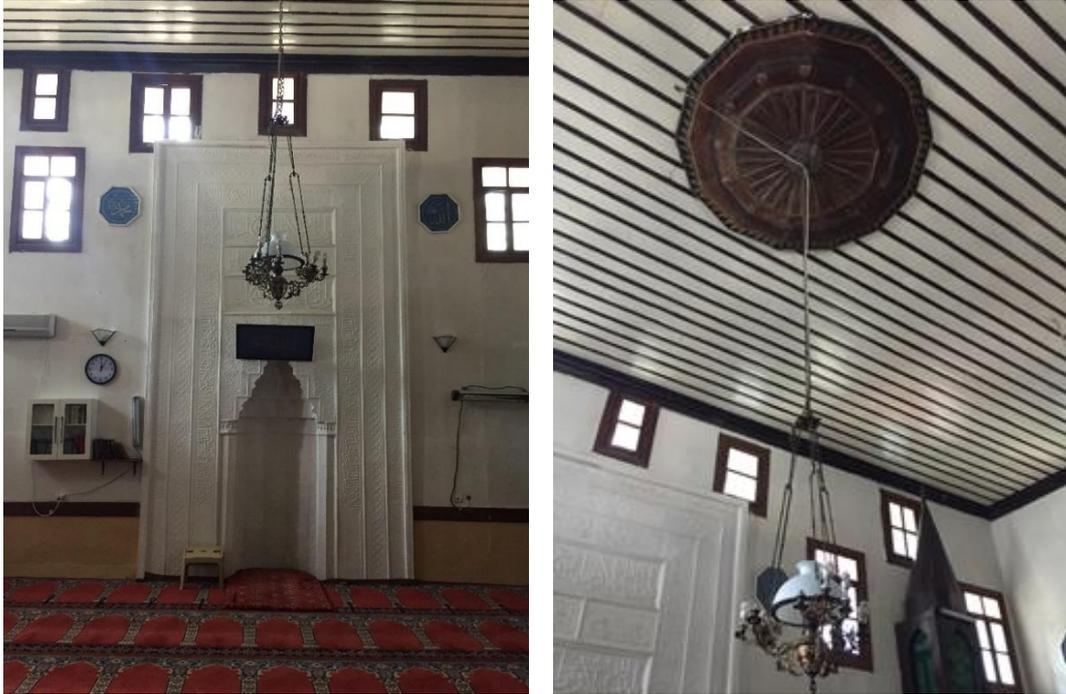
Figure 4. Plaster mihrab and wooden ceiling hub [7]

The mosque has a wooden ceiling and a low relief, geometric inserts, plaster mihrab (Figure 4) and a wooden minbar between the two windows [8]. On the slatted wooden ceiling, there is a ceiling hub which is found to be painted with ochre (Figure 4).

In the cleaning of the wooden ceiling hub (Figure 14) and the wooden minbar, which is envisaged to be protected according to the approved project, two layers of brown oil paint and two layers of green oil paint have been identified as very thick oil paint layers. As a result of the removal of these layers with paint remover and scalpel, green, yellow and orange ochre was seen at the bottom. In addition, cypress and carnation patterns were found in the minbar (Figure 15). According to the decision of the Conservation Board, after the oil paint cleaning was completed on the wooden ceiling hub, it was completed with orche paint suitable for the original tone and shellac polish was applied on it. The chasings on the wooden minbar were completed in accordance with the original and shellac polish was applied on it.

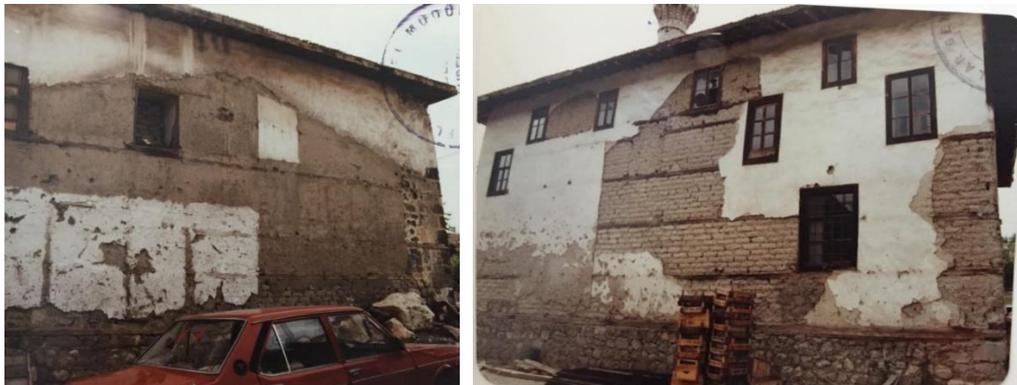
Figure 13. Old exterior photos [9]

Following the start of the restoration work, a research was conducted in the archives of the Conservation Regional Council and old photographs of the building were obtained (Figure 13). In line with the data obtained, the restoration project was revised and the revised restoration project was approved by the Ankara Regional Board of Conservation of Cultural Heritage with the decision dated 06/12/2018 and numbered 6218. According to this project, the wooden door on the left side of the entrance door on the north side of the mosque which was used for the entrance of the women's section was canceled and turned into a window. In line with the data and old photographs, the revision of the east and west facade window system was also carried out. However, an arrangement was not made in the southern facade window system where sufficient data could not be obtained.
