Investigation of Water Dams Built in Istanbul in the Ottoman State Period

Aynur ŞAFAK ARIF

ABSTRACT

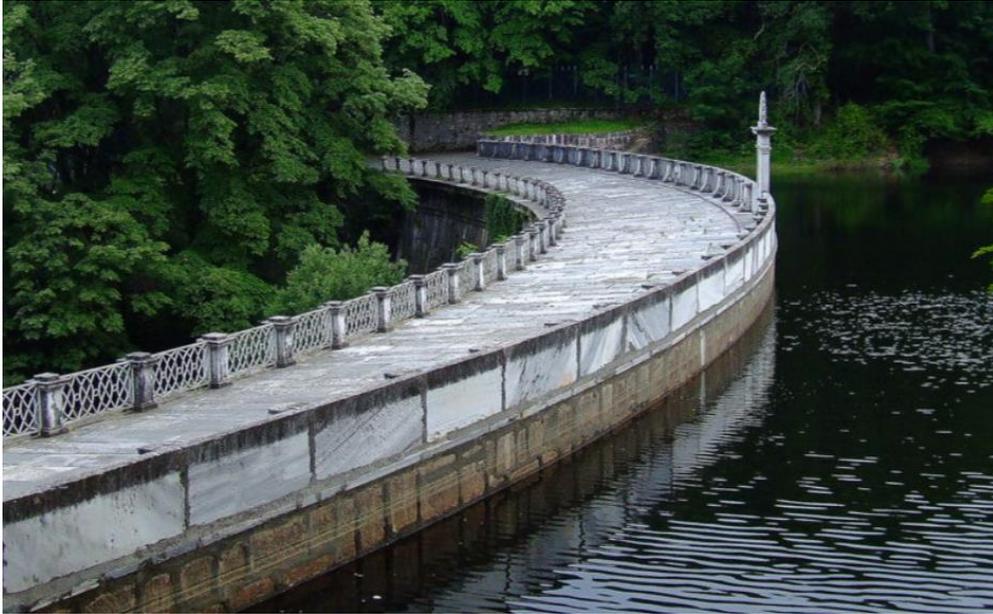
In the Ottoman Empire Period, water dams were built in three different types as flat walls, elbow walls and curved walls (Figure 1). Water dams consist of sections such as body, open sluice and water reservoir [4]. In the valleys, dams made to hold the water coming from above between the two slopes were built using stone and masonry material [1].

Figure 1. Sultan Mahmud Bendi with curved walls [5]

It was built by Sultan Mahmut II in 1839 on the western branch of Arabacı Mandırası Stream. Sultan Mahmut Bendi, also called Bend-i Cedit, is in the shape of an arch and is different from the Topuzlu and Valide Dams. The upstream face of the bend is in the form of a solid cylinder surface and the downstream face in the form of a solid cone surface [24]. It is of the stone weight dam type and the reservoir of the dam is very large compared to its hydrological zone, so many years are not full. The hydrological region of Valide Bendi is much larger than its reservoir; for this reason, water is transferred from the Valide Bendi to the Sultan Mahmut Bendi as the excess water overflows from the war [11, 13]. The top of the bend is inclined towards the downstream side and is covered with marble plates. Marble slabs, supported by marble struts, allow me to collect more water [11, 13]. In the middle of the bend, there is an inscription stone with 13 couplets written by Ziver and its line by Mustafa İzzet [11, 13].

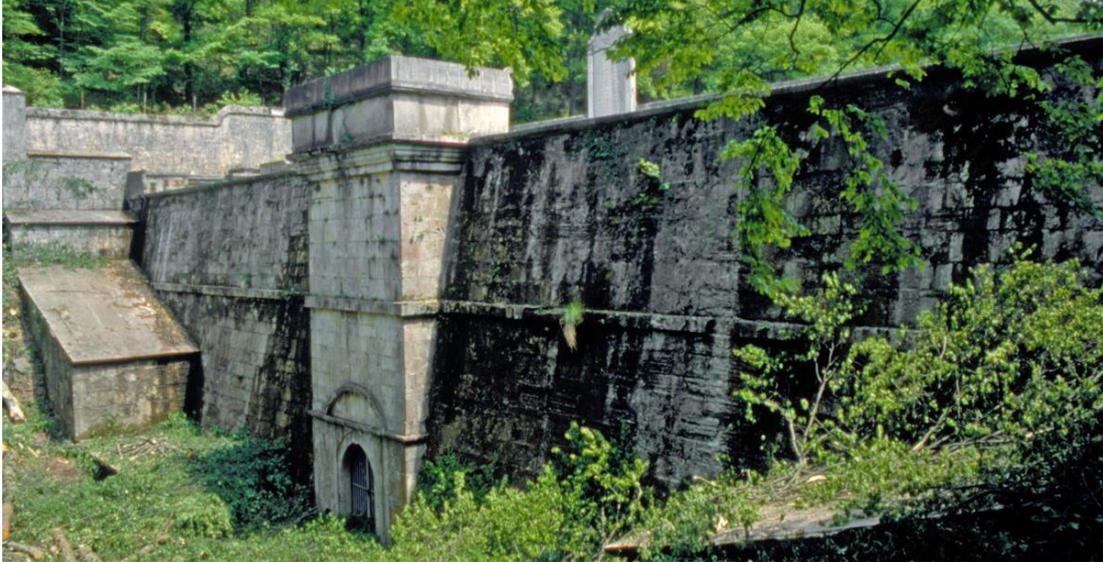
Figure 2. Kirazlibent [15]

Kirazlıbent is on Kirazlı Stream in Belgrat Forest and is located in the southeast of Büyükbent [12, 13]. It was built by Mahmut II in 1818 [8]. The axis of the bend in the plan is linear and is of massive mass. Water can be taken from 11 nozzles on the measuring chest to 56 nozzles (2912 m³ / day) [16].

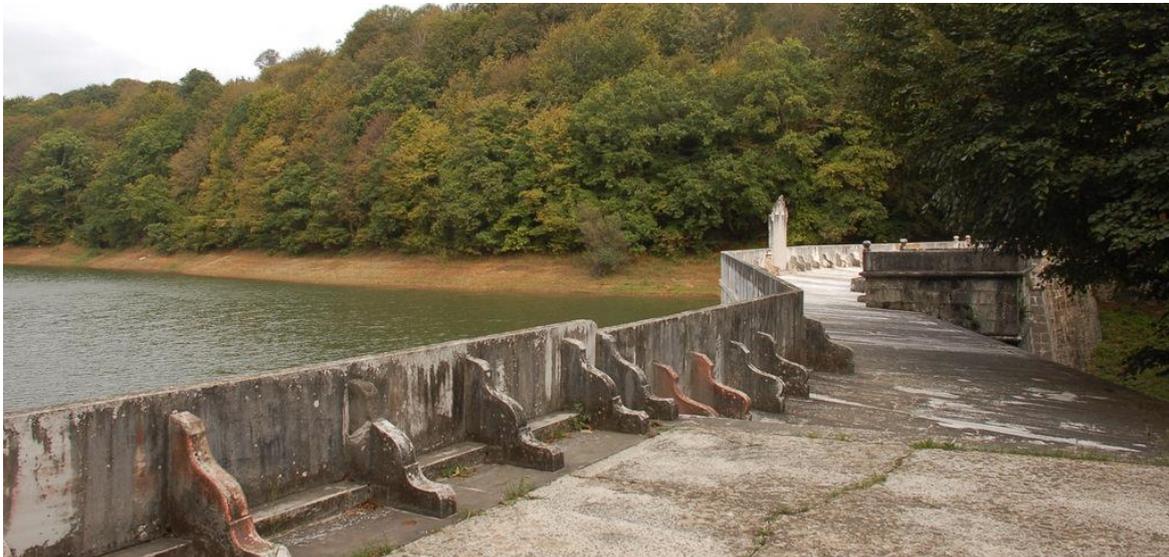
Figure 3. Valide Bendi [18]

Valide Dam was built by Mihrişah Sultan, the mother of Selim III, in 1796 and is on the eastern tributary of the Arabacı Mandırası Stream [11, 24]. The axis of the bend in the plan is broken and two pillars were built on the body [8, 13]. You can climb the buttresses with three steps; this area was arranged as a prayer and a railing was built around it [8]. It is bent masonry dam type. It is covered with marble and the marble railings on the side of the bare are reinforced with marble struts. In the middle, there is an inscription stone with 34 couplets on the upstream side [16, 11].

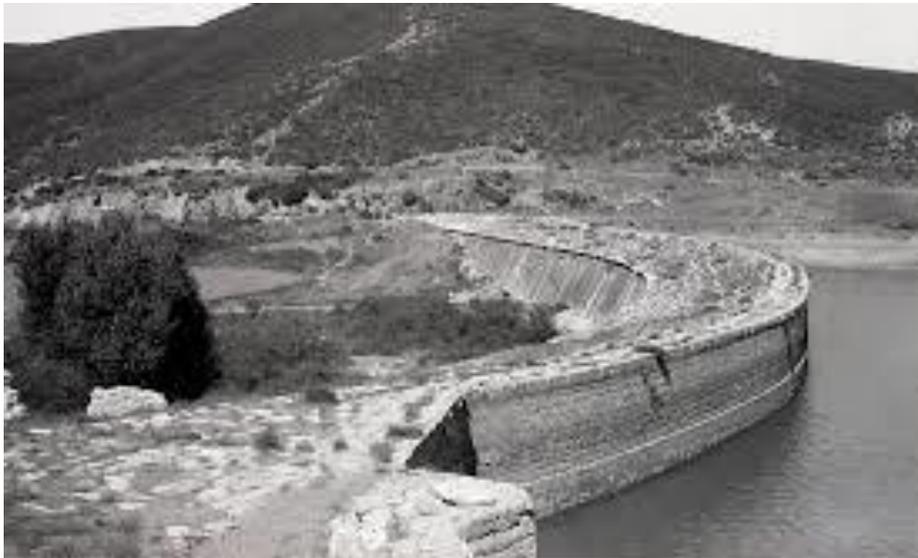
Other dams constructed in Istanbul during the Ottoman Empire Period are Istanbul-Küçükçekmece-Şamlar Bendi (Figure 4) and Elmalı Barajı [19]. Şamlar Bendi was built by Sultan II. Mahmud in 1826-1828 on Sazlı Deresi to meet the water needs of Azatlı Baruthane. Bent is 10,14 m high, 12,22 m peak and 15,58 m base width. Elmalı Dam was built in 1893 on Elmalı Creek to meet the water needs of the Anatolian side. This dam is excluded from the scope of this study since its second part is a Republican Period work built in 1950.

Figure 4. Şamlar Bendi [20]

Bendi because they are in the Belgrad Forests. The marble stones were broken by piercing the walls of Şamlar Bendi by the treasure seekers. Also; this dam has been ruined due to the rubbish spilled around.

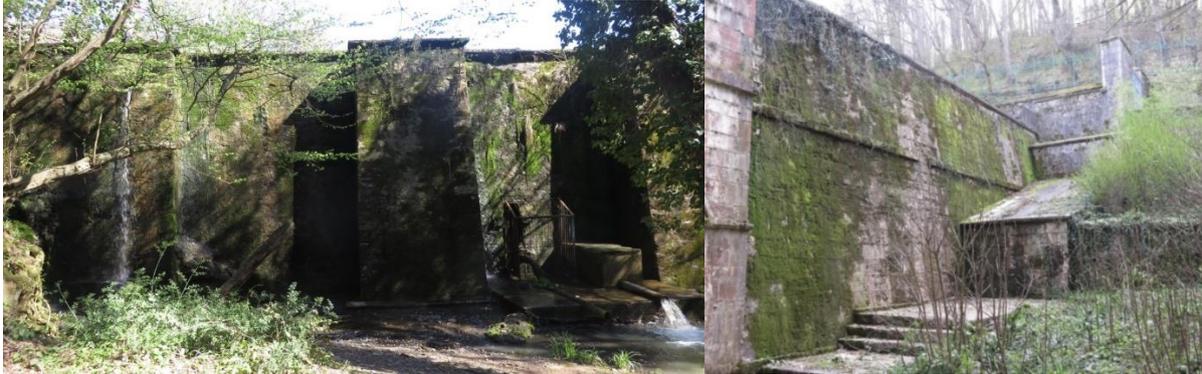
Various problems and deteriorations were identified in the dams covered in this study, in the on-site examinations. The main problems seen in the dams are contamination, algae-lichen formation, vegetation (Figure 5), abrasion and fragmentation on stone surfaces, cracks and cement completions. But; the problem that is thought to be more important than these are water leaks in the bodies of the dams. It is necessary to determine whether the cracks causing these leaks are structural cracks with more detailed studies. The dams in Kırkçeşme Water Facilities and Taksim Water Facilities are better protected than Şamlar

Figure 5. Plantations in Topuz Bendi and Kirazlibent [21]

The causes of these changes and deteriorations can be grouped as nature-based and human-based. [22]. Most of these disruptions are due to long-term natural events. Climate events such as moisture, frost, rain, insects, various microorganisms and groundwater are natural events that cause deterioration in these structures over time. Apart from these, there are distortions caused by people knowingly or unknowingly. Especially during the wrong repairs, it was observed that cement-containing mortars that are not compatible with the original material were used and irreversible damages were given to the dams, causing melting and deterioration in the stones. Apart from that, deliberate damage to the works of art called Vandalism is among the causes of individual deterioration. Also; It causes the deterioration in dams in social factors such as various public works, infrastructure works and road works. [22]. Considering the historical water facilities in Istanbul, many works face the risk of being destroyed due to intense construction, road and tunnel works. Mağlova Aqueduct, which is one of the most important works of Mimar Sinan, has been submerged up to a certain level in the area where Alibey Dam was built. Likewise, Şamlar Bendi is flooded with the increase of the Sazlıbosna Dam waters during the winter months.
